# HMS *Prince of Wales* – Stern Damage Survey<sup>1</sup>

A REPORT ON THE TORPEDO DAMAGE TO THE STERN OF  
HMS *PRINCE OF WALES* PREPARED AND SUBMITTED BY  
KEVIN DENLAY FOR THE SD-7 PANEL MEETING,  
WASHINGTON, D.C., OCTOBER 2008. (*Updated 4/09*)

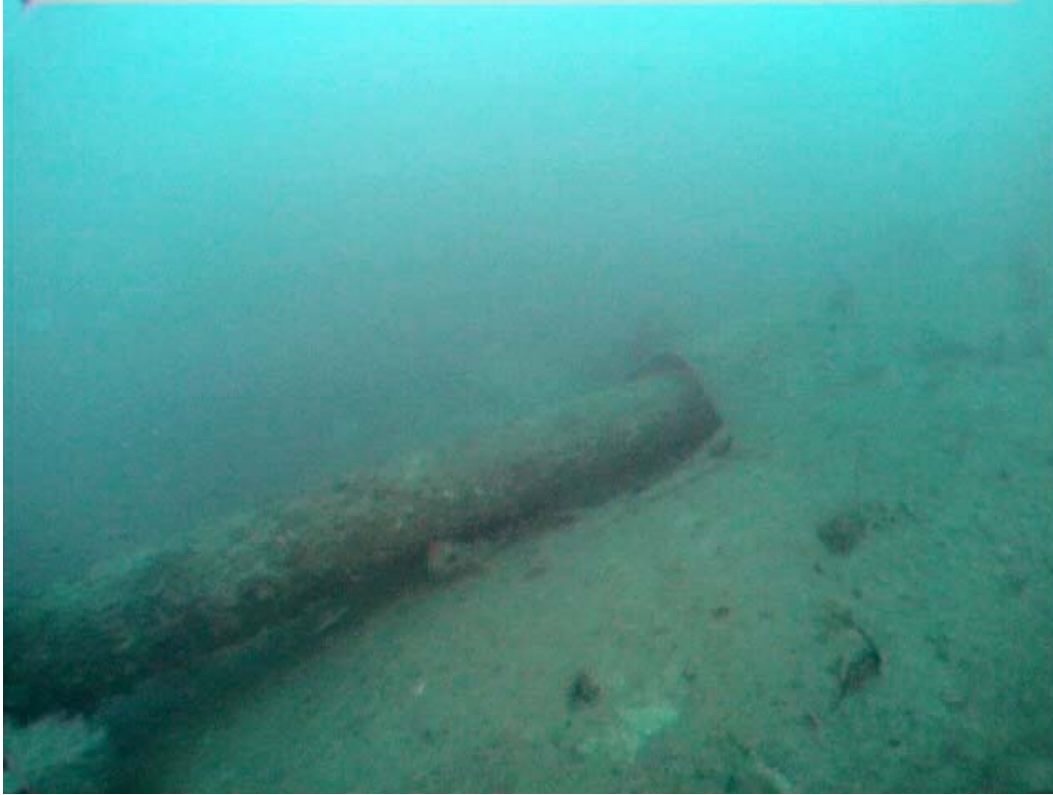
**X1, X2, X3)** These are the exit points out of the hull of the three ‘intact’ shafts at their stern tube glands. The Starboard outer shaft’s exit point - X1- shows only slight signs of deformation – seen underneath the shaft - from the damage caused by the flailing shaft prior to it jamming over the inner shaft. **See following images X1 and X1/1**

X1- The *Starboard* outer propeller shaft where it exits the hull from the stern tube gland.

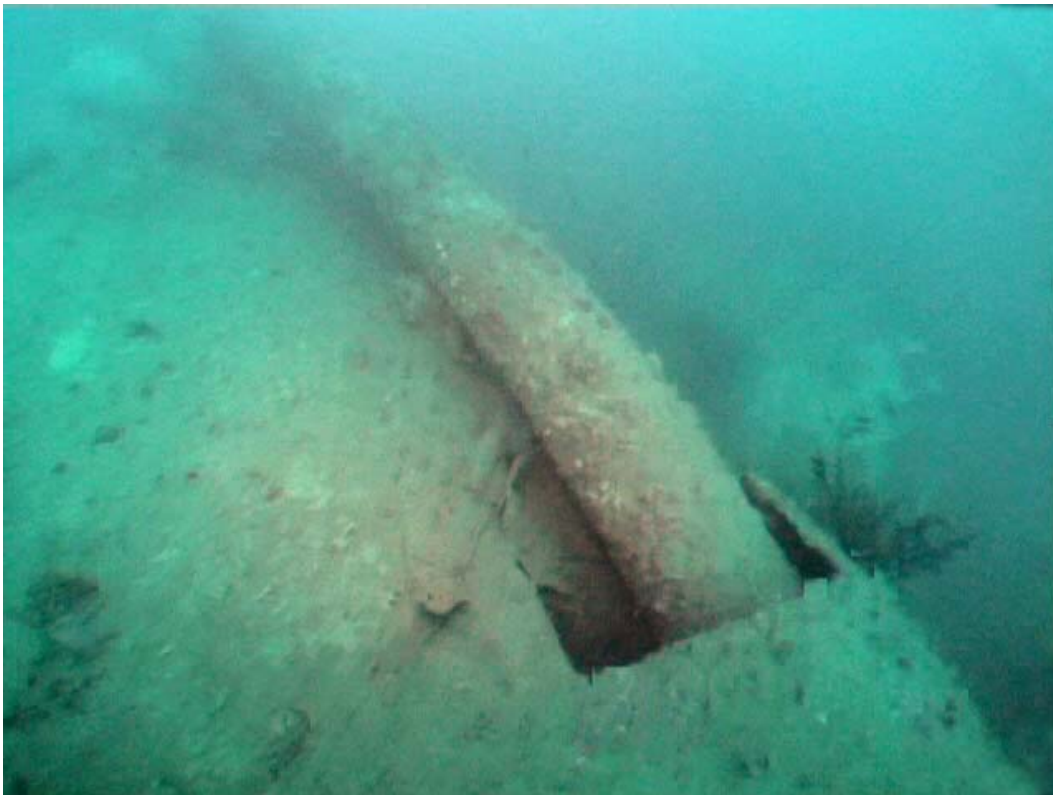
X1/1- Only slight deformation is visible under the outer *Starboard* shaft at hull exit point.

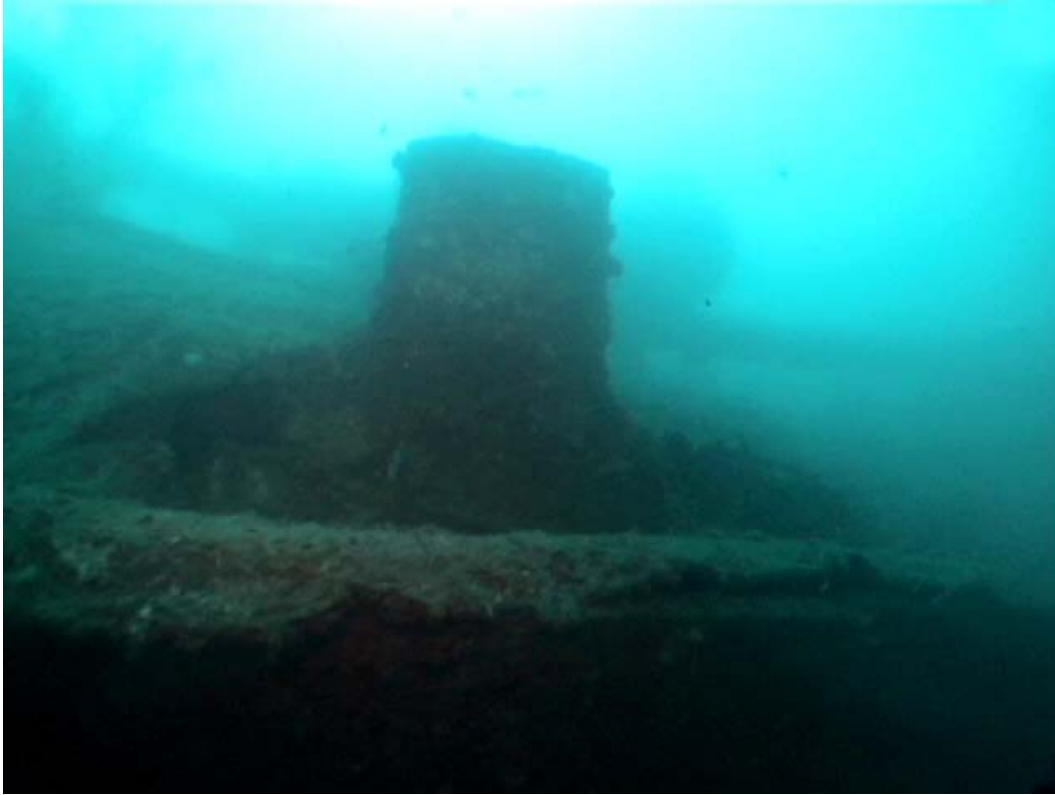
**A)** Only a short stub remains of the *OUTER* strut of the outer Starboard shafts A-Bracket. (The inner strut appears to have sheared clean at the hull.) The Starboard torpedo hole is directly above this stub, and extends almost up to what would have been the lower row of scuttles/portholes in the hull. (Actually a line drawn up from the stub would ‘cut’ the hole approximately in ‘quarters, i.e. leaving about three quarters of the hole *aft* of the stub ‘line’.) **See following images A1 through A4**

A1 - Only a short stub remains of the *outer* strut of the outer Starboard A-Bracket.

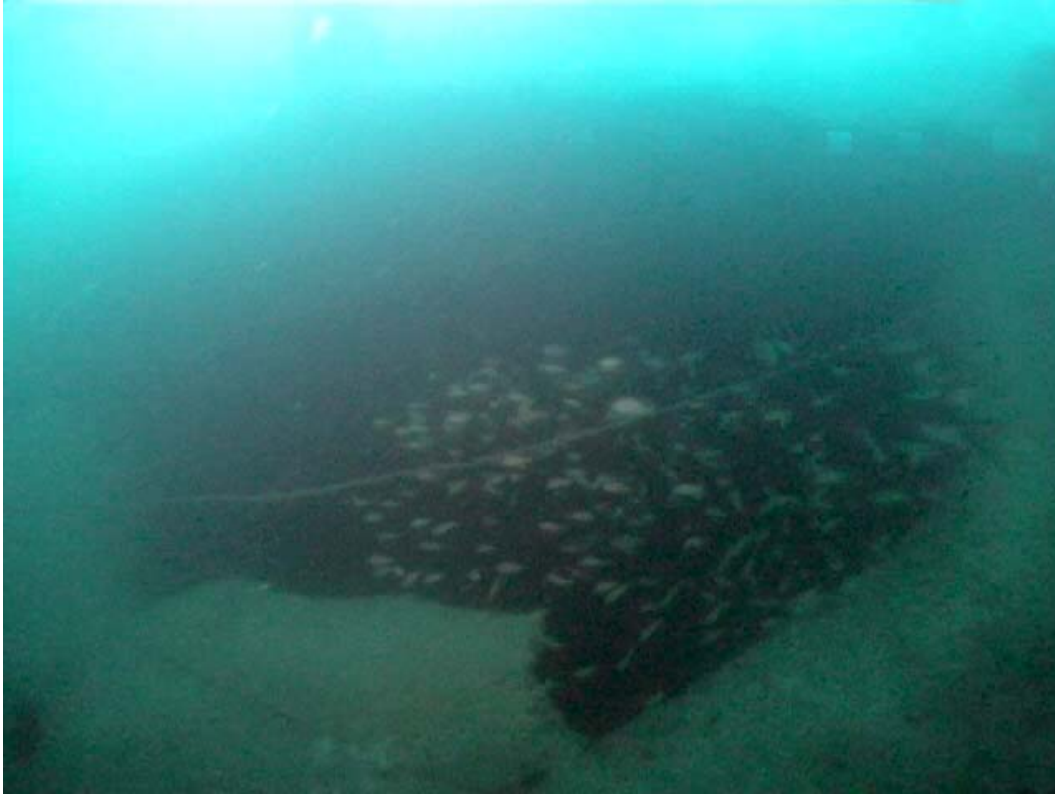
A3 - Aft edge of torpedo hole at right. A porthole is just visible lower left corner.

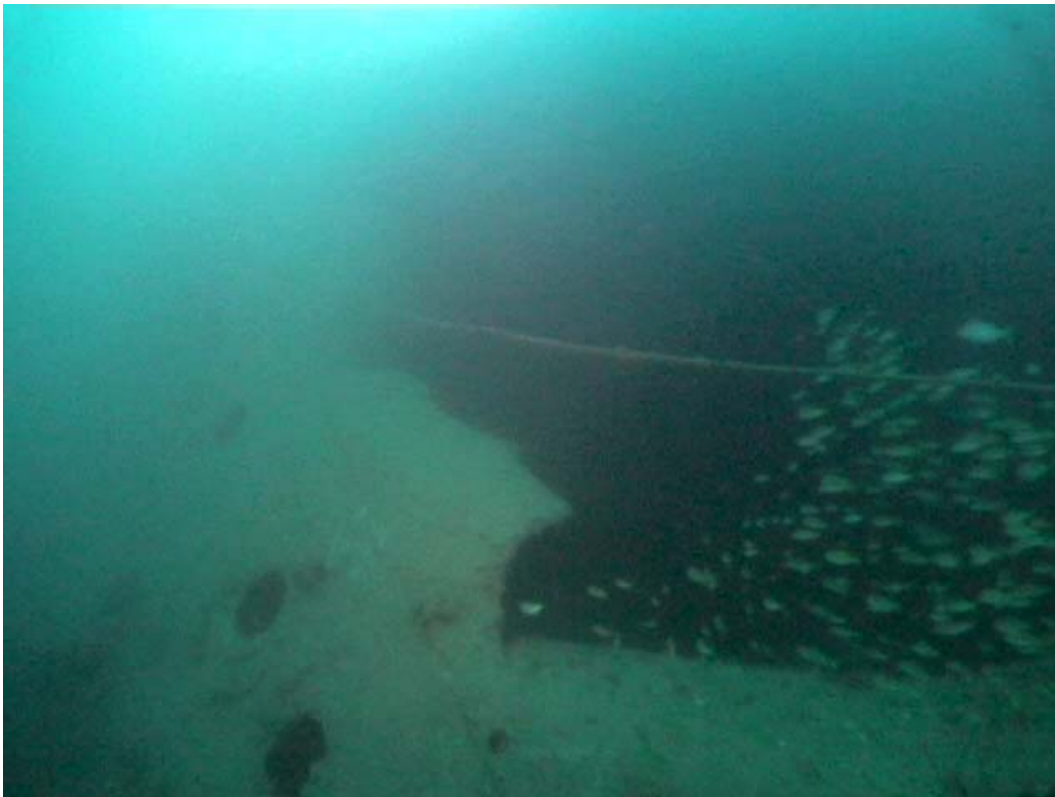
A4 - Center of torpedo hole. 'Lower' row of scuttles / portholes are clearly visible at left.

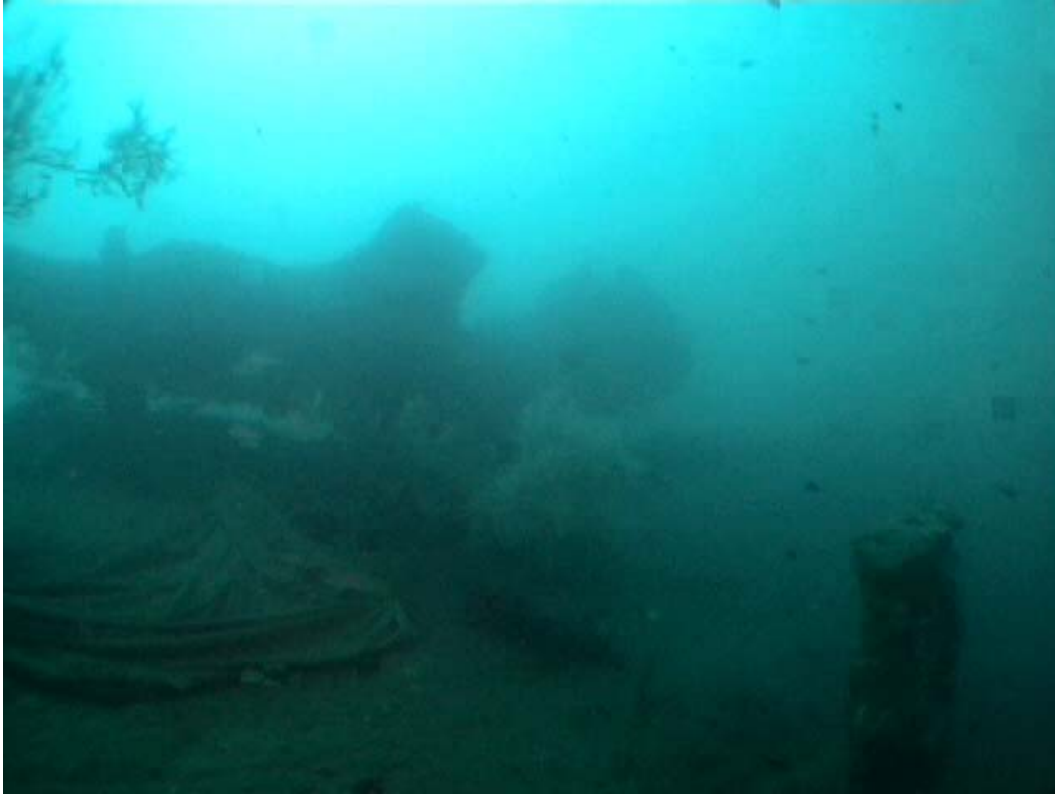
**B)** The propeller of the outer Starboard shaft is wedged firmly ‘over the top’ of the inner Starboard shaft, so much so that two of the blades are actually between the inner shaft and the Keel Plate. **See following images B1 through B4**

B1 - Stub described in caption A is lower right. A-Bracket and propeller upper center.

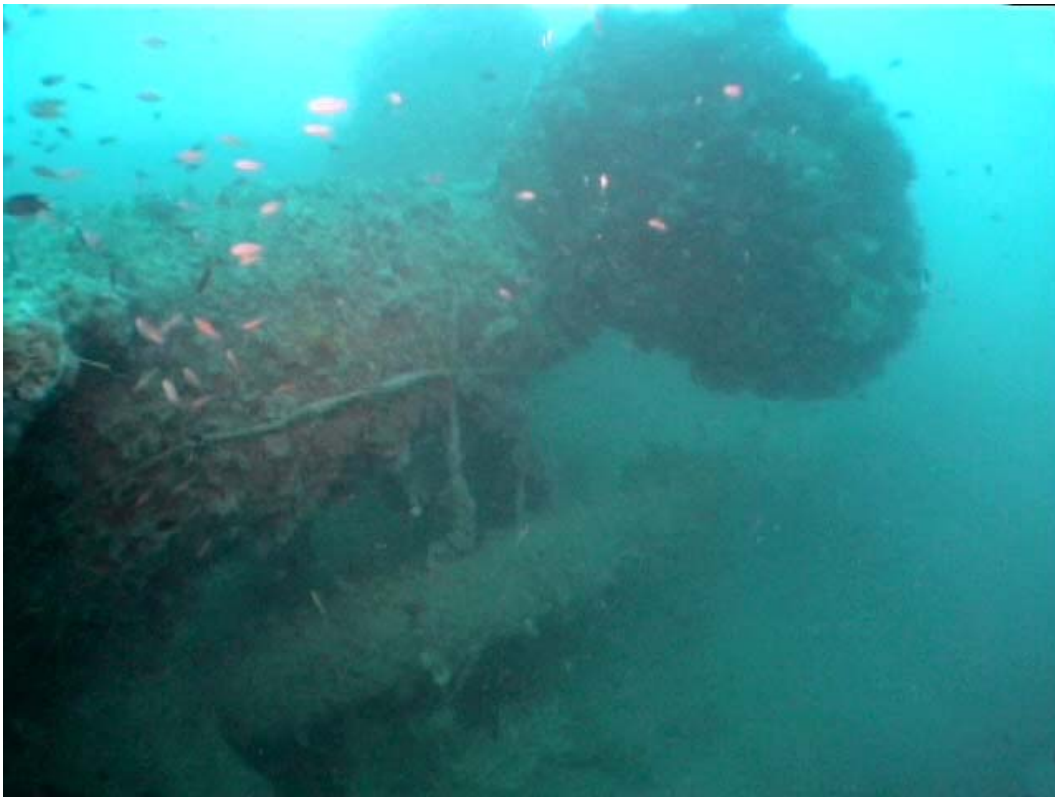
B2 - Outer Starboard propeller upper right. Inner Starboard propeller shaft lower center.

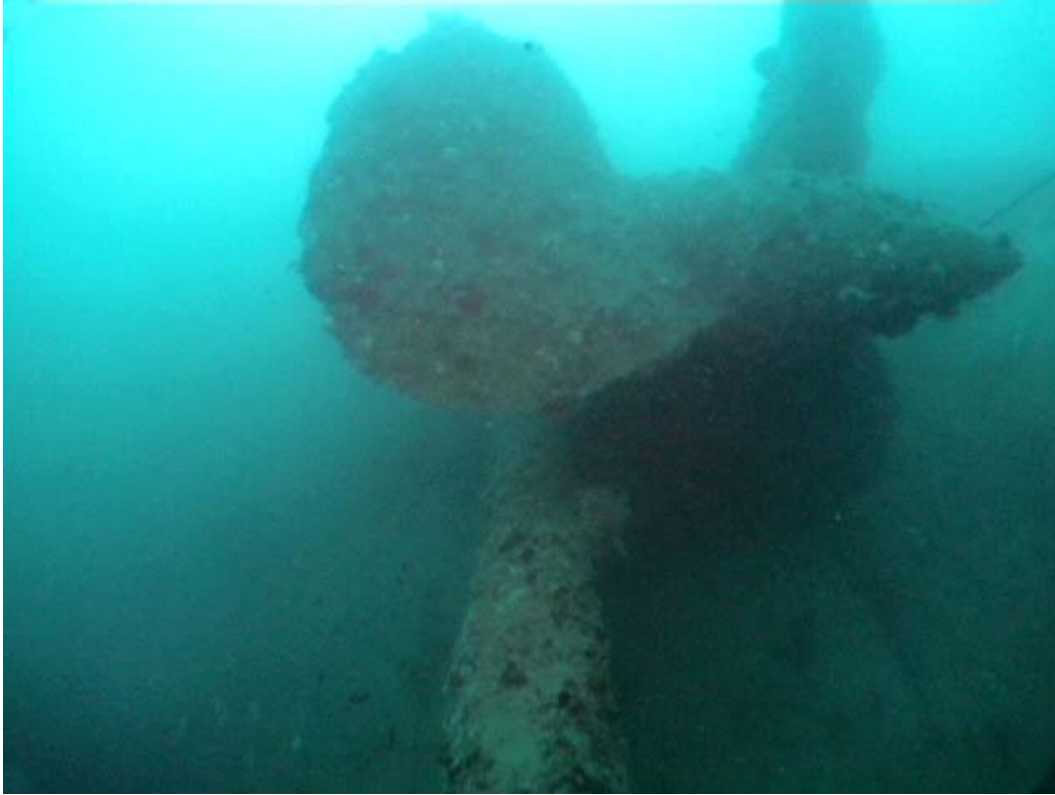
B3 – Inner Starboard propeller shaft lower center. Outer Starboard propeller upper right.

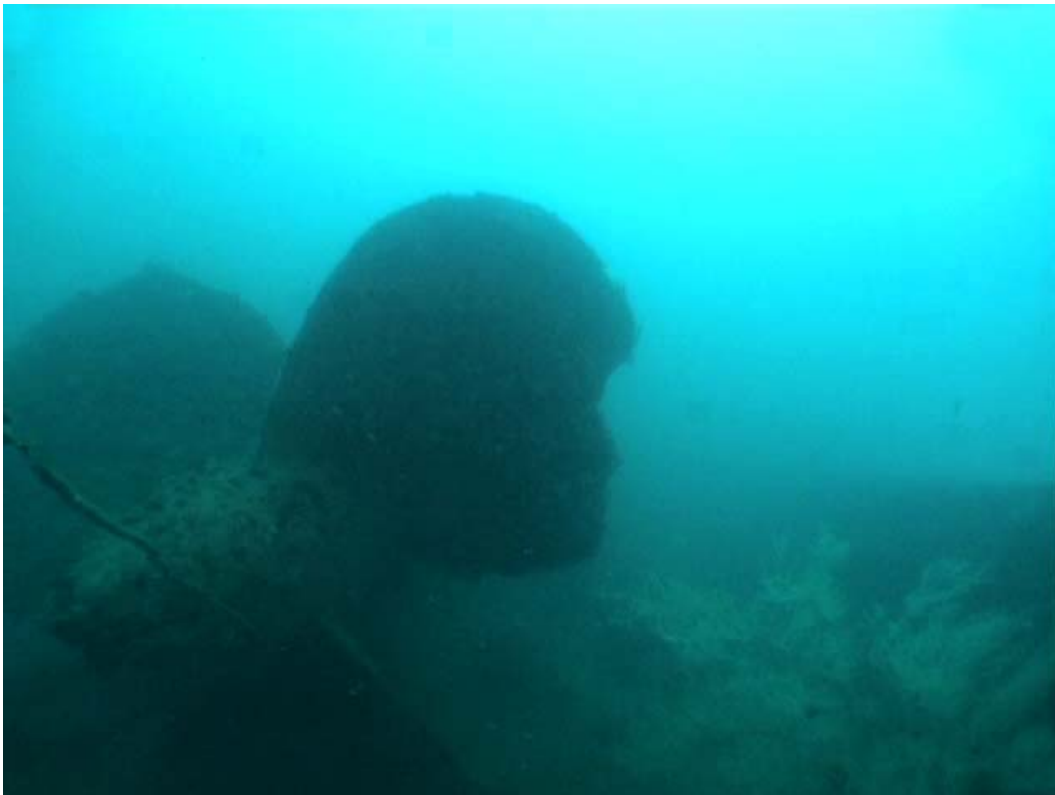
B4- Outer Stbd propeller left. Note disfigured blade. Keel Plate is dark area at right.

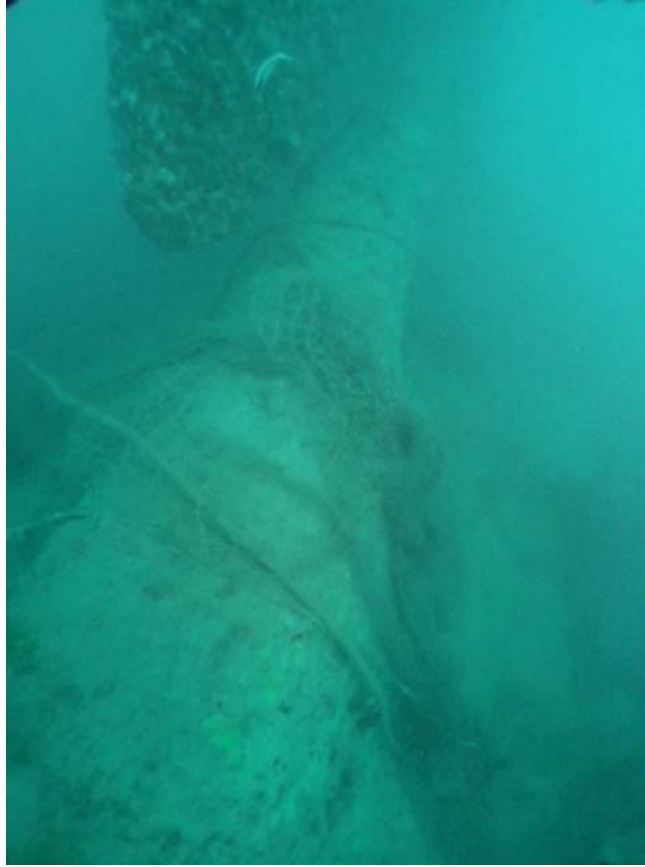
**C)** Rudder is angled to Port at approx 20 degrees. **See following images C1 and C2**

C1- Keel Plate of ship left center. Rudder angled off to Port upper left

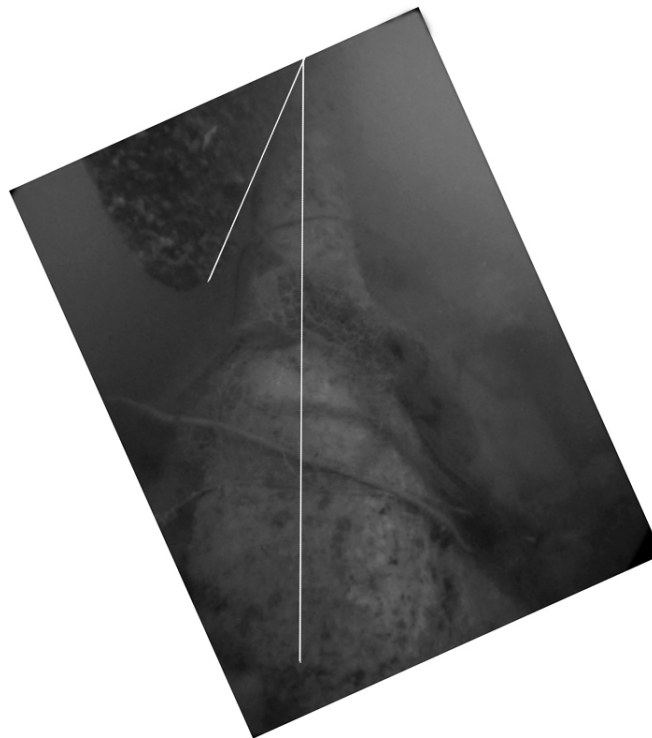
C2- Lines show approx 20 degrees angle of rudder to center-line (Keel Plate) of ship.

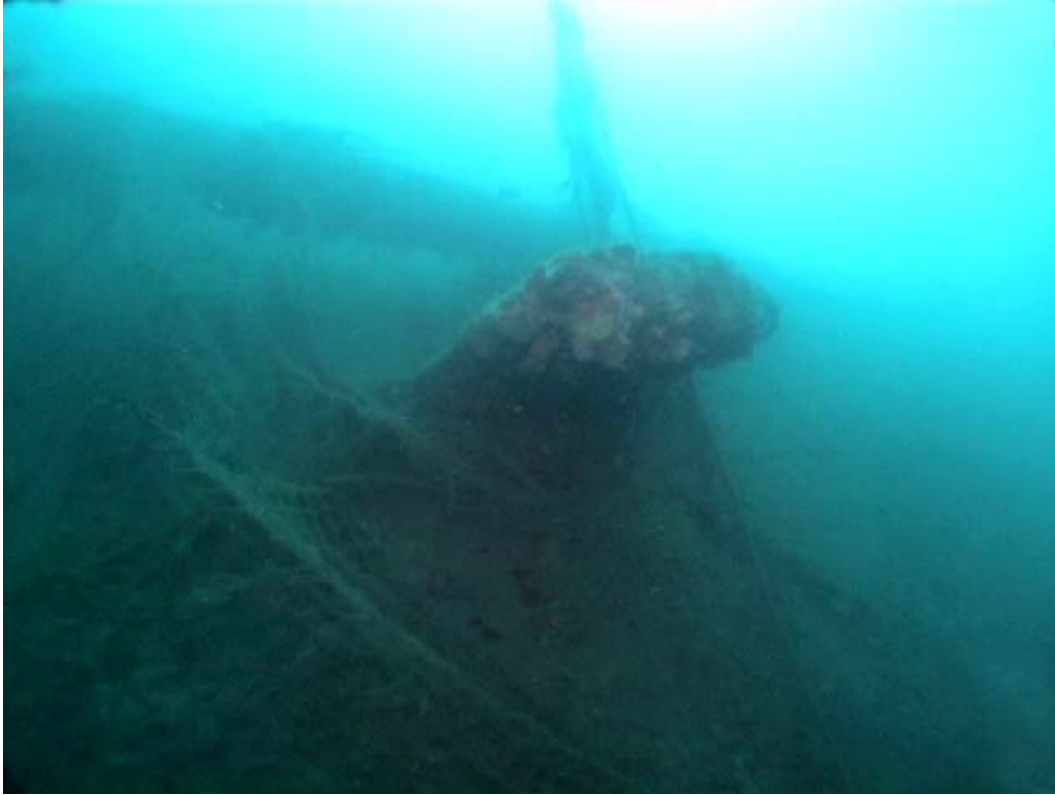
**D)** Only a small stub remains of the *INNER* strut of the Port outer shafts A-Bracket. **See following images D1 and D2.** (The outer strut appears to have sheared off clean at the hull.)

D1- Stub of *inner* strut of Port outer shaft A-Bracket. Inner Port propeller shaft upper left.

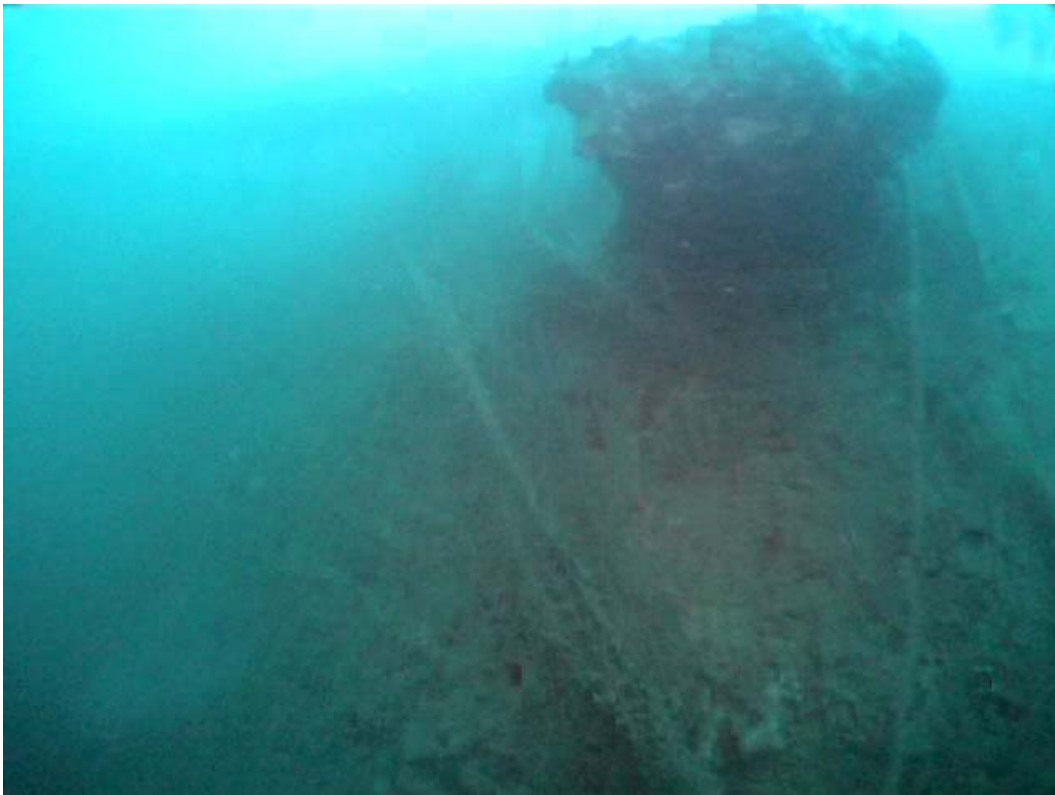
D2 - Only a short stub remains of the *inner* strut of the outer Port shaft A-Bracket.

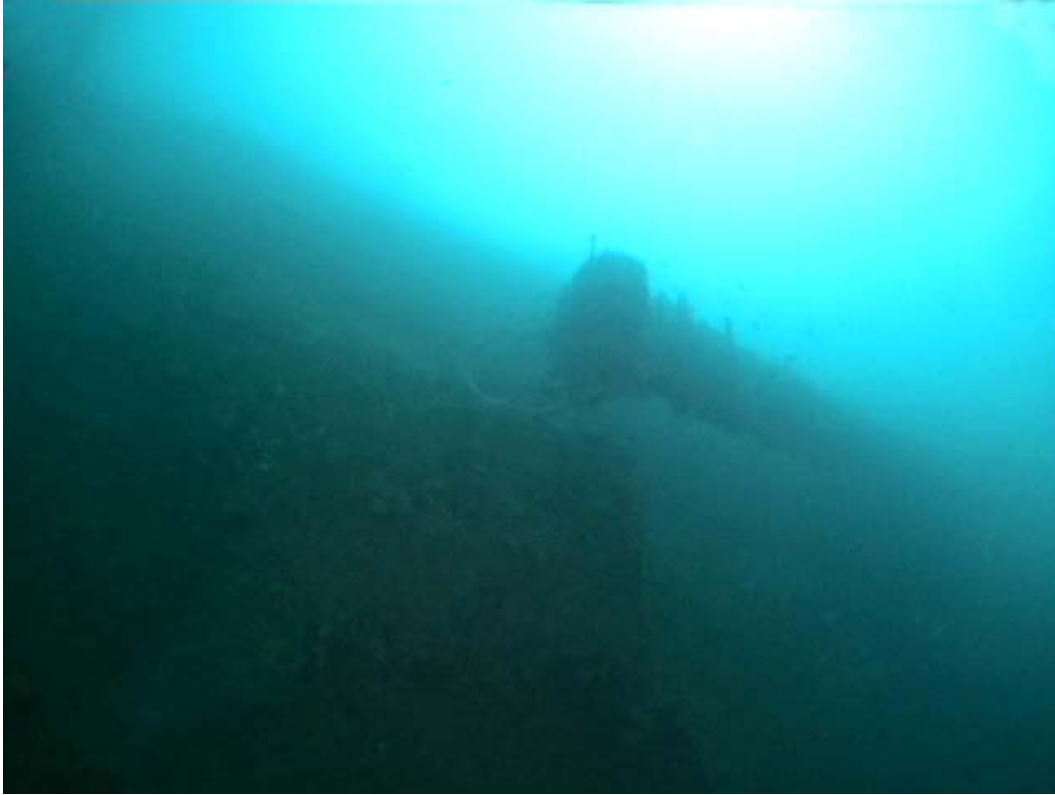
**E)** The aft ‘end’ of the exterior section of the Port outer shaft, with flange noticeable. **See following image E1** Distance measured from D to E = 5.3m/17.38ft. **See following image E2**

E1 - Upper center, the aft 'end' of the Port outer shaft with flange clearly visible on end.

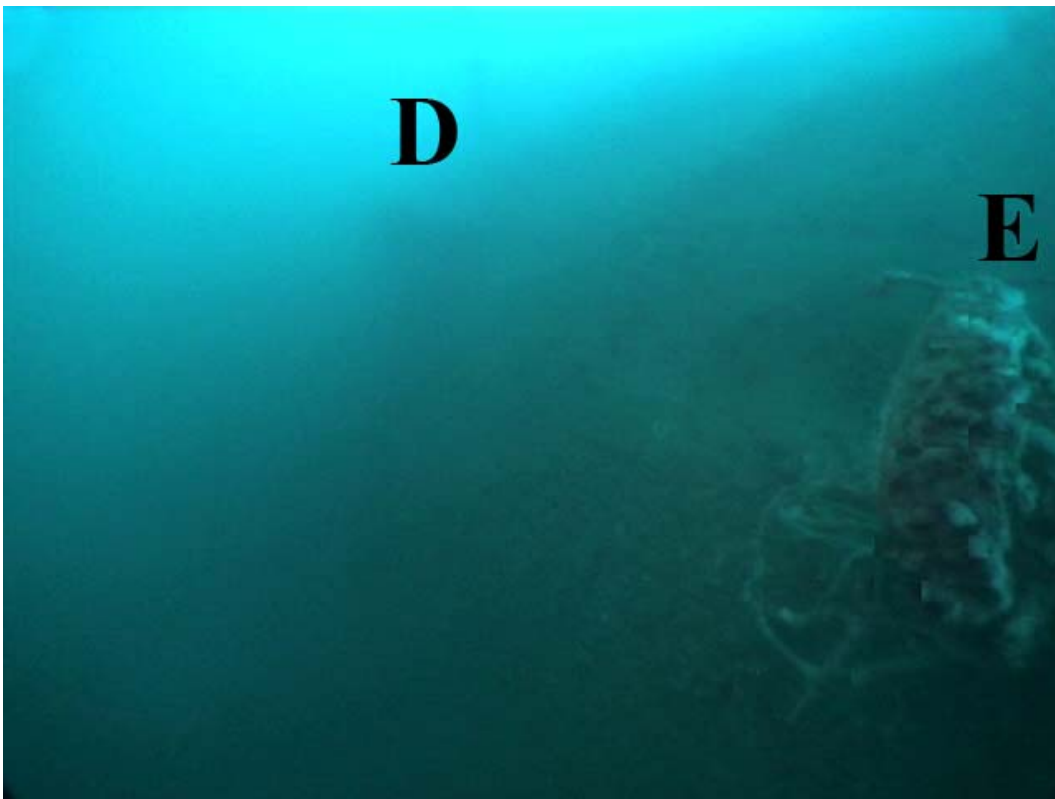
E2- Below E is the flange on end of shaft, while just visible below D is *inner* strut stub.

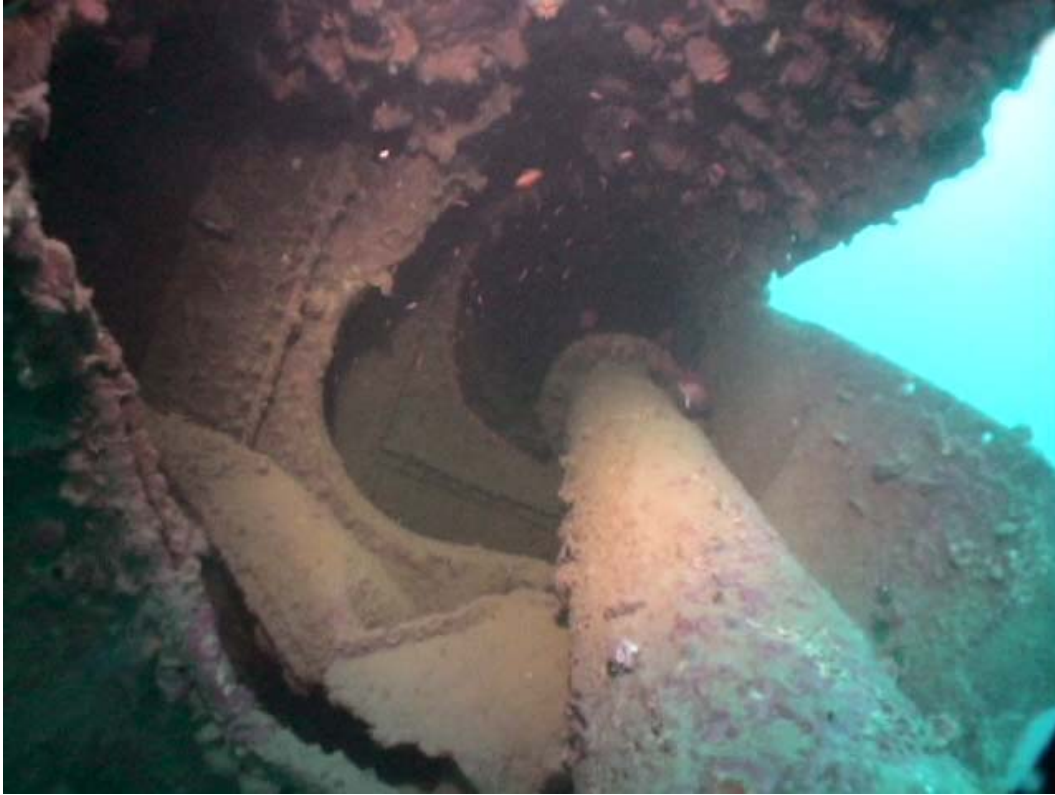
**F)** Two flanges, still firmly joined, link the protruding section of the shaft and the next section of shaft ‘inside’ the shaft tunnel. The after most of these two joined flanges can be seen just inside the ripped open stern tube entry to the shaft tunnel. **See following image F1.** Distance measured from E to center of flanges F = 10.9m/35.75ft. The position of where the stern tube exit gland would have been is believed to be at, approximately, the dotted line X4 on the schematic. **See following image F2 (NOTE: There are NO images from beyond this point.)**

F1 - Distorted web frames and the flange that joins the two 'outermost' lengths of shaft.

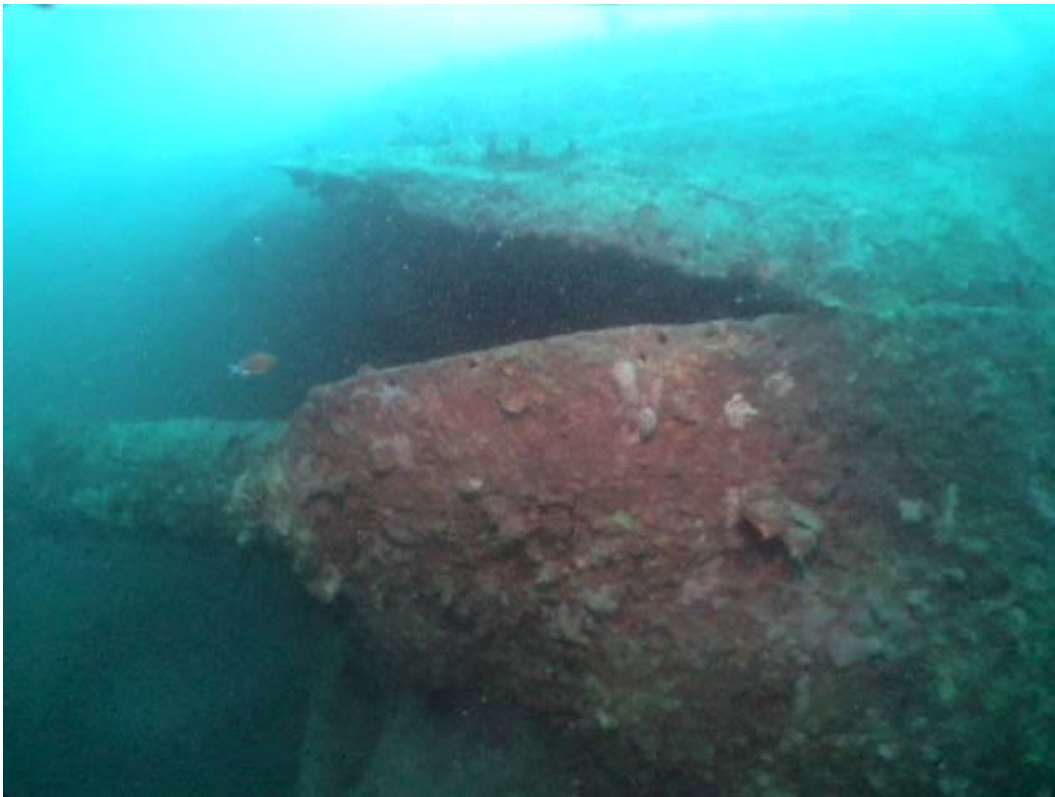
F2 - The 'split' at right in image F1 as seen from the outside. Shaft at far left center.

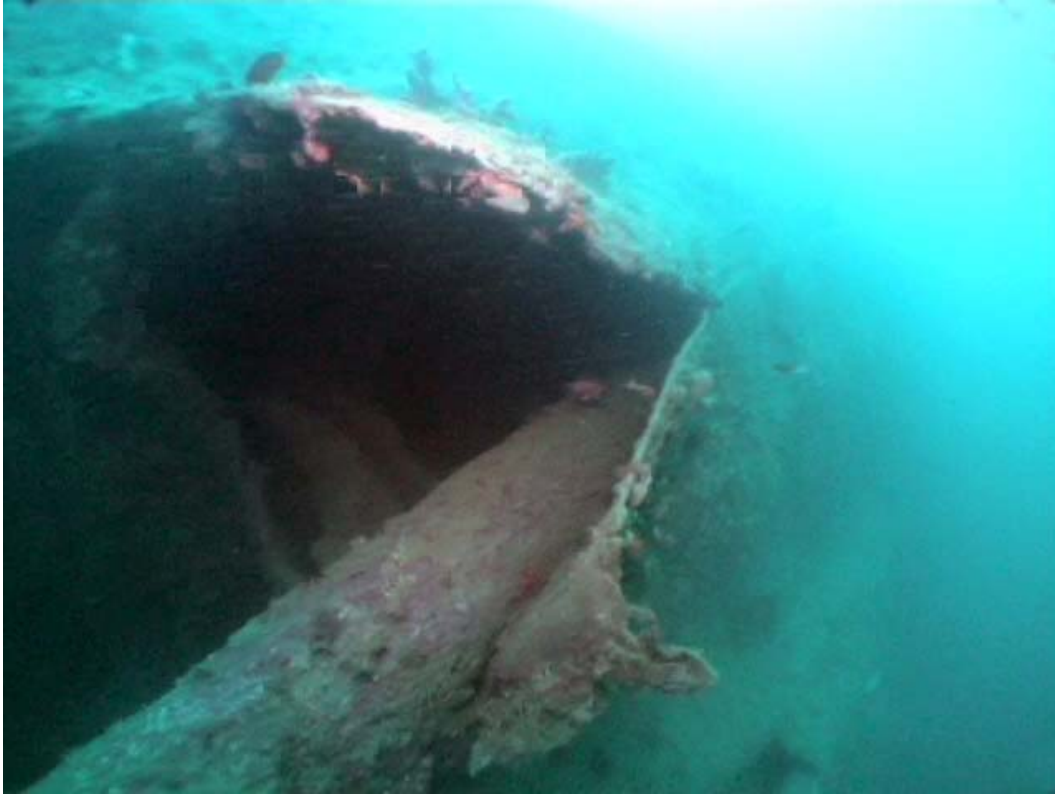
- X4)** The dotted line across the shaft next to X4 marks the approximate position of where the shaft exited the hull at the gland, but the gland / stern tube is no longer there and the general area surrounding is severely damaged from the torpedo explosion and the flailing shaft as it ripped away. **See following images X4/1 and X4/2.**

X4/1 - Massive deformation where outer *Port* shaft exits hull. Compare with image X1/2.

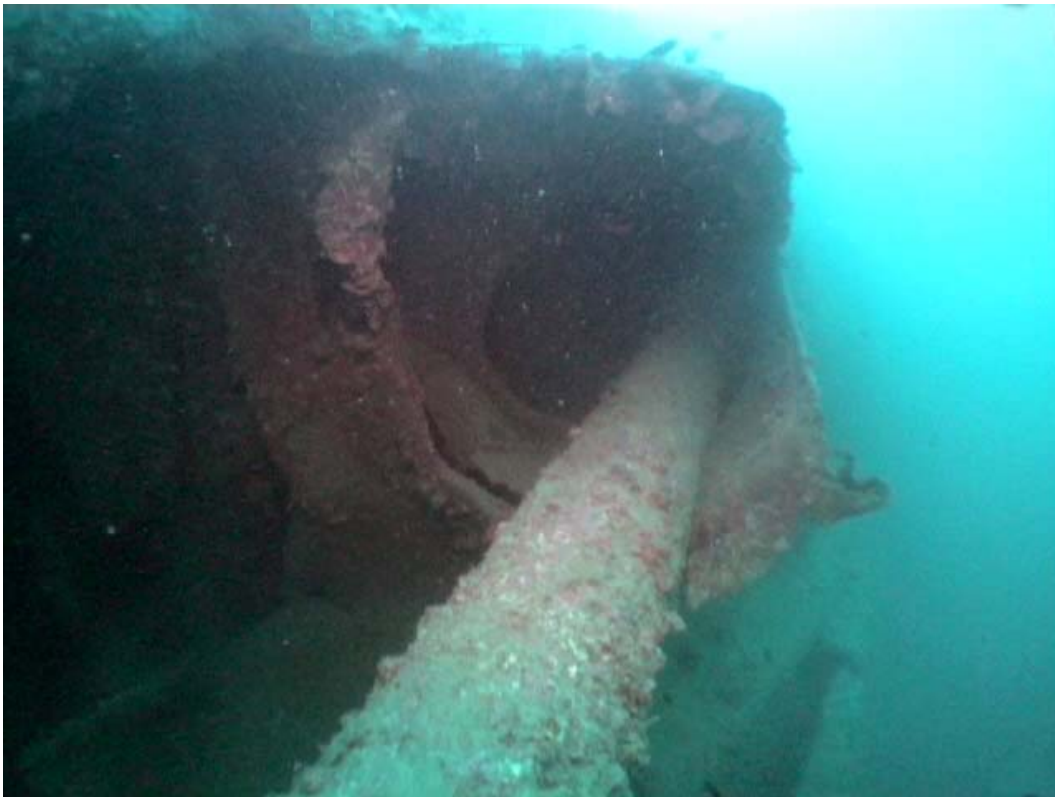
X4/2 - Looking forward along outer *Port* shaft to where stern tube gland 'should' be.

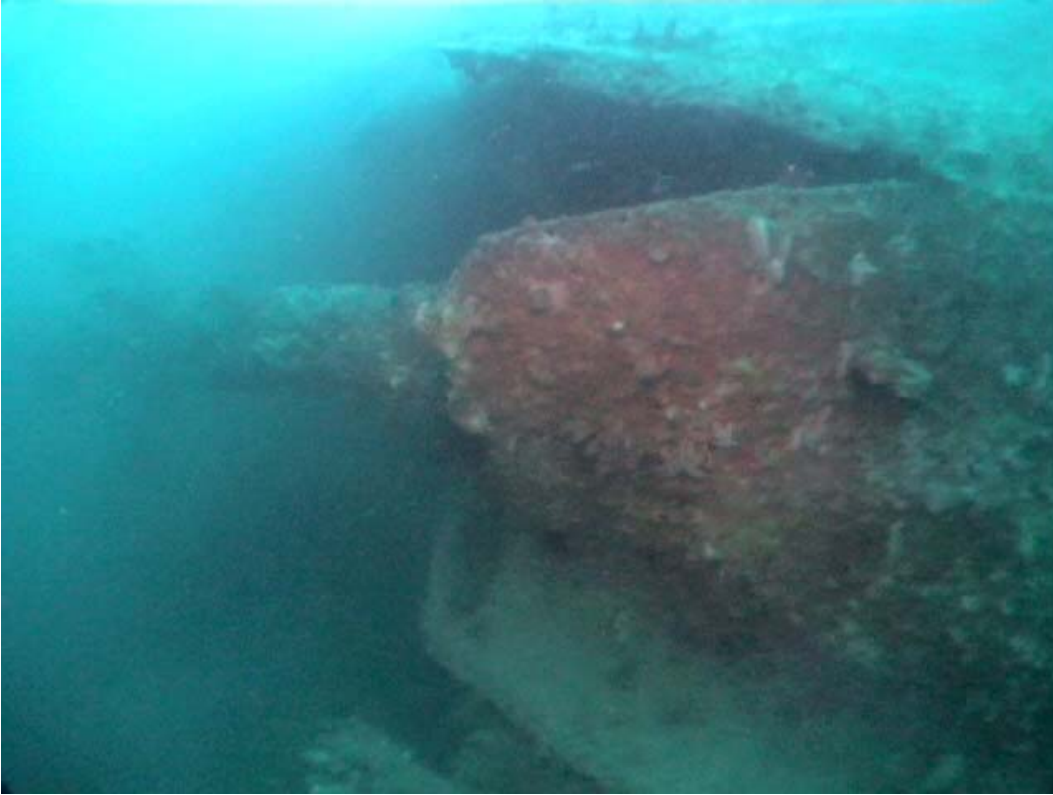
Where the gland once was, approximately, is now the forward edge of the port side torpedo hole, which is ‘centered’ somewhat further aft along and just above the shaft axis. **See following images X4/3 through X4/7.**

X4/3 - Torp hole to left, shaft center left. Forward edge of hole just below shaft exit point.

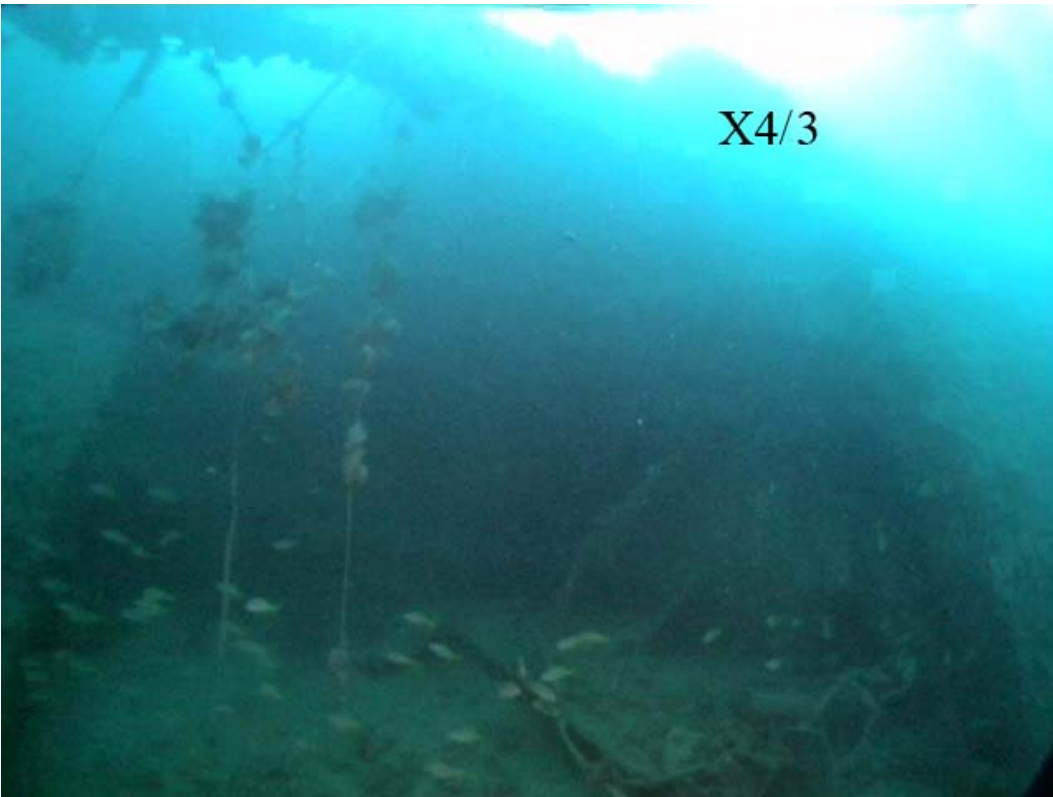
X4/4 - Torp 'hole'. Shaft upper left & center, exits ripped open hull at upper right (X4/3).

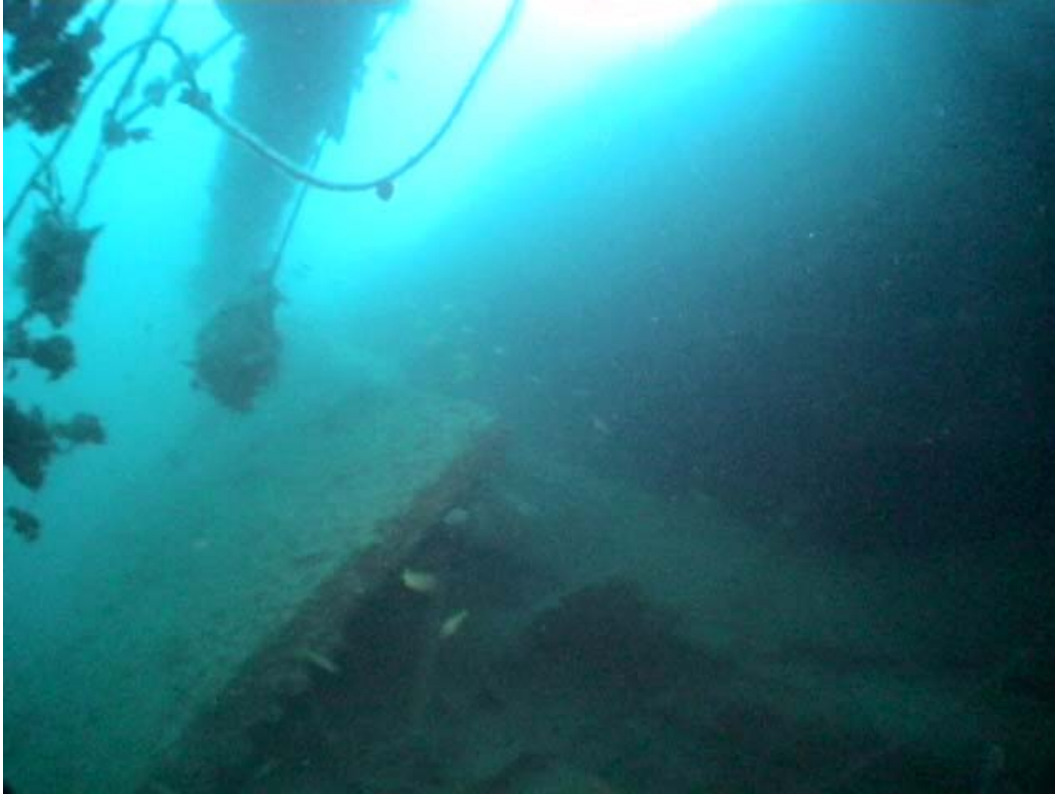
X4/5 - Looking aft from beneath outer shaft (upper left), interior of torp 'hole' at right.

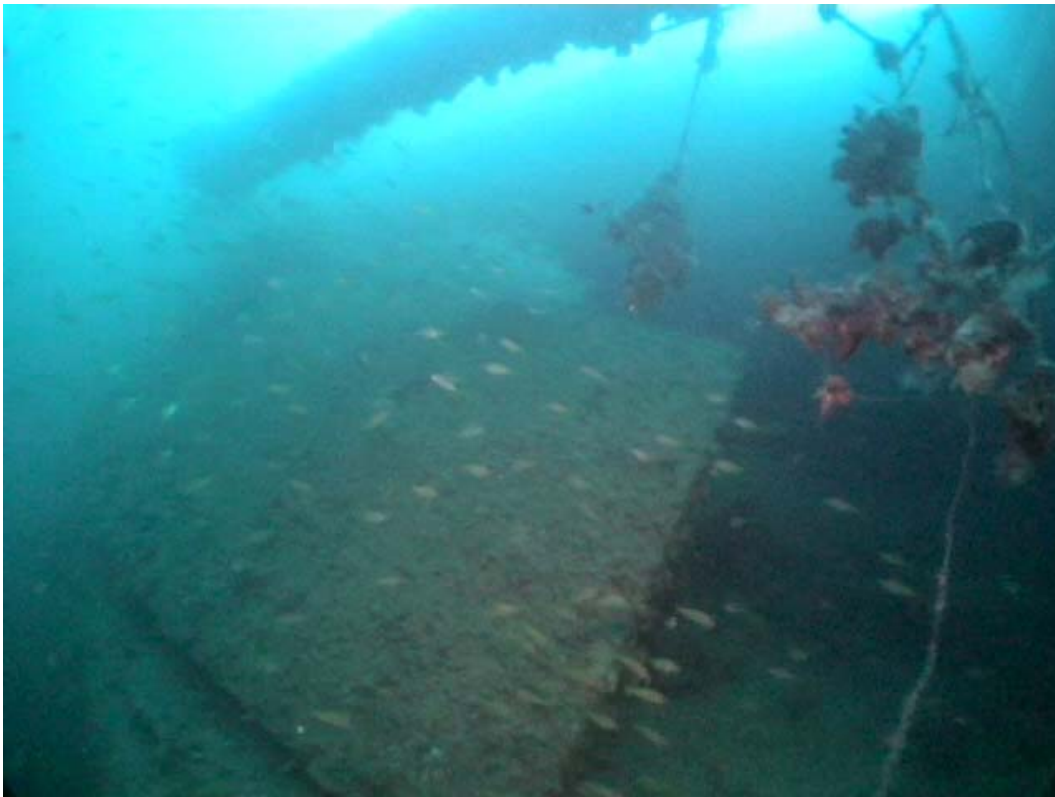
X4/6- Looking aft at a collapsed hull side plate. Torp hole to right, shaft upper left center.

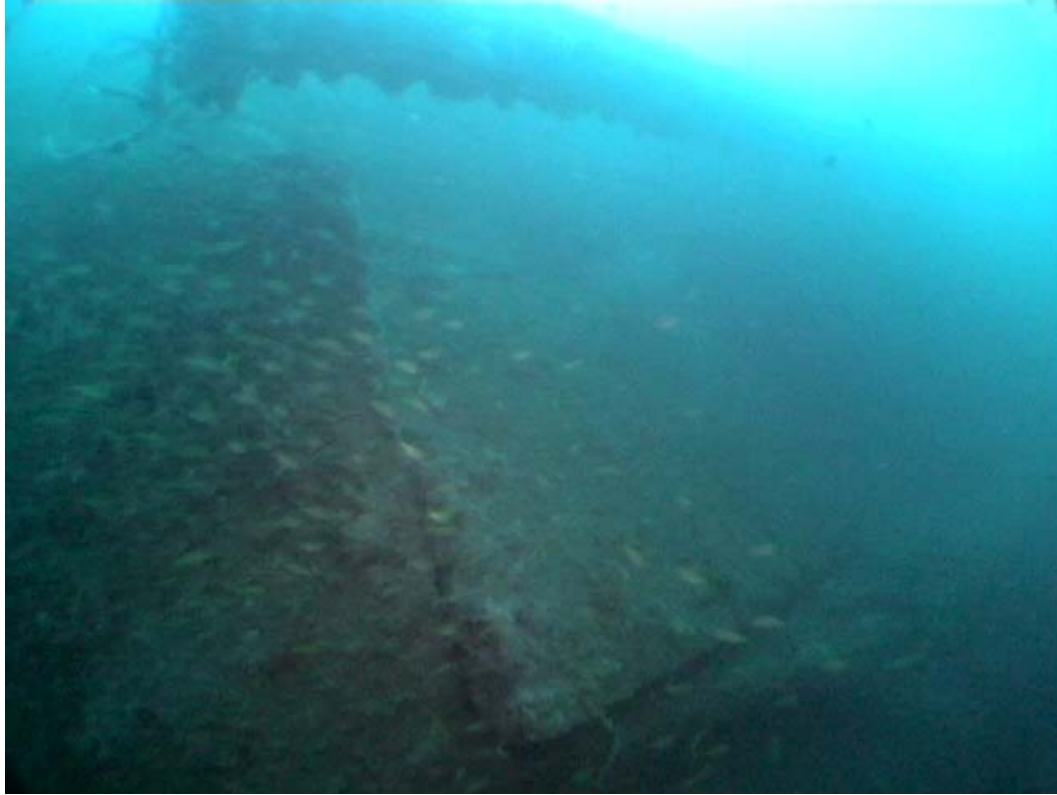
X4/7 - Aft edge of same collapsed hull plate as seen in X4/6 is just below flange on outer shaft end.

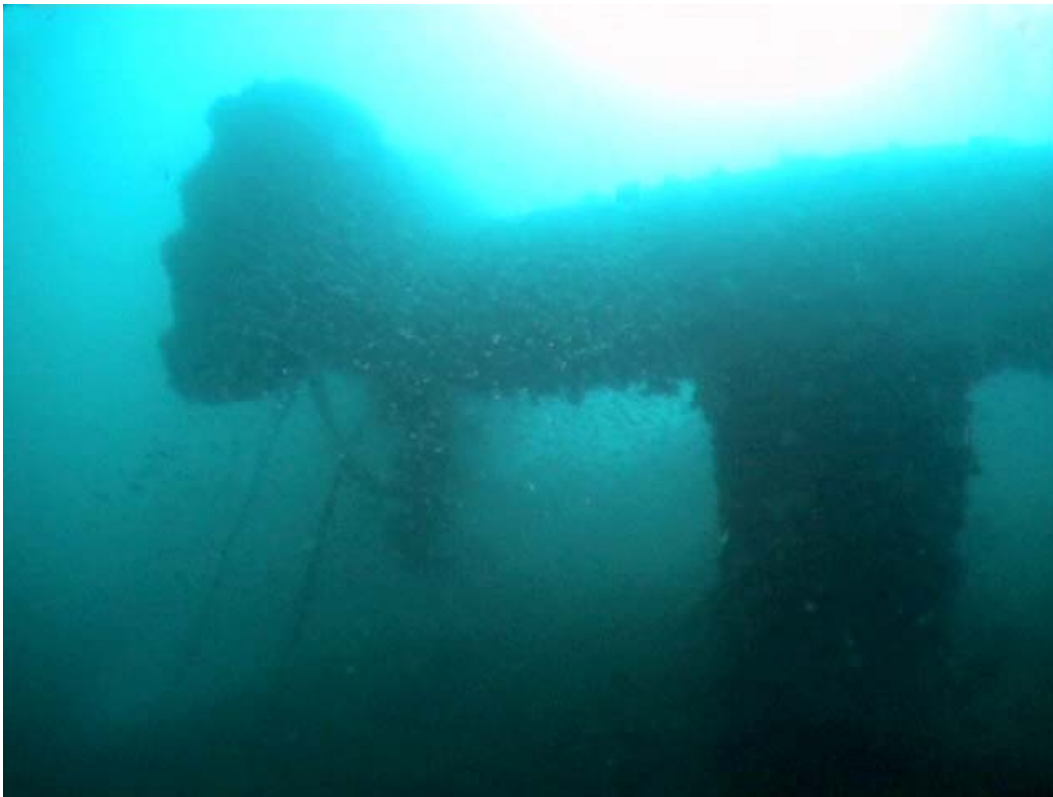
Chipped blade on *inner* Port propeller; right, outer strut of its intact supporting A-Bracket.
