EXPEDITION ‘JOB 74’

An overview of Expedition ‘Job 74’ which carried Explorers Club Flag #118 to the wrecks of HMS *Prince of Wales* and HMS *Repulse*, South China Sea, May 13th – May 25th 2007.

Report compiled and submitted by expedition member and flag applicant Kevin Denlay, Fellow International 1998. (Page 1 of 28)

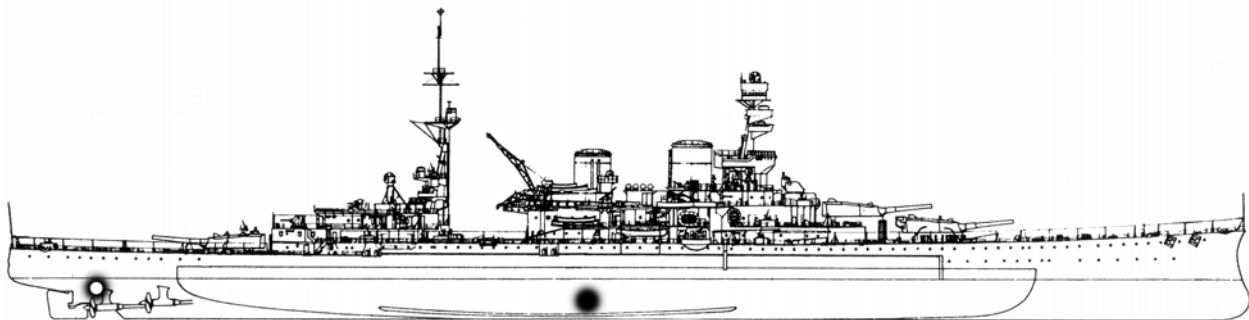
It should be noted however that the other, or fourth 'reported' torpedo hit to port towards the stern, supposedly abreast Y turret - an area where the seabed/sand has *not* built up against the hull to any great extent and hence which should have left any hole clearly visible - was simply *not* seen to be there.

Expedition 'Job 74' could confirm only two hits as shown, although as stated previously the two port side amidships hits *may* have been buried beneath the seabed at the time the expedition was conducted. However, the suspected hit abreast the rear turret is *not* there.
Black solid circle on hull = Confirmed starboard side torpedo hit.
Black outline circle on hull = Confirmed port side torpedo hit.

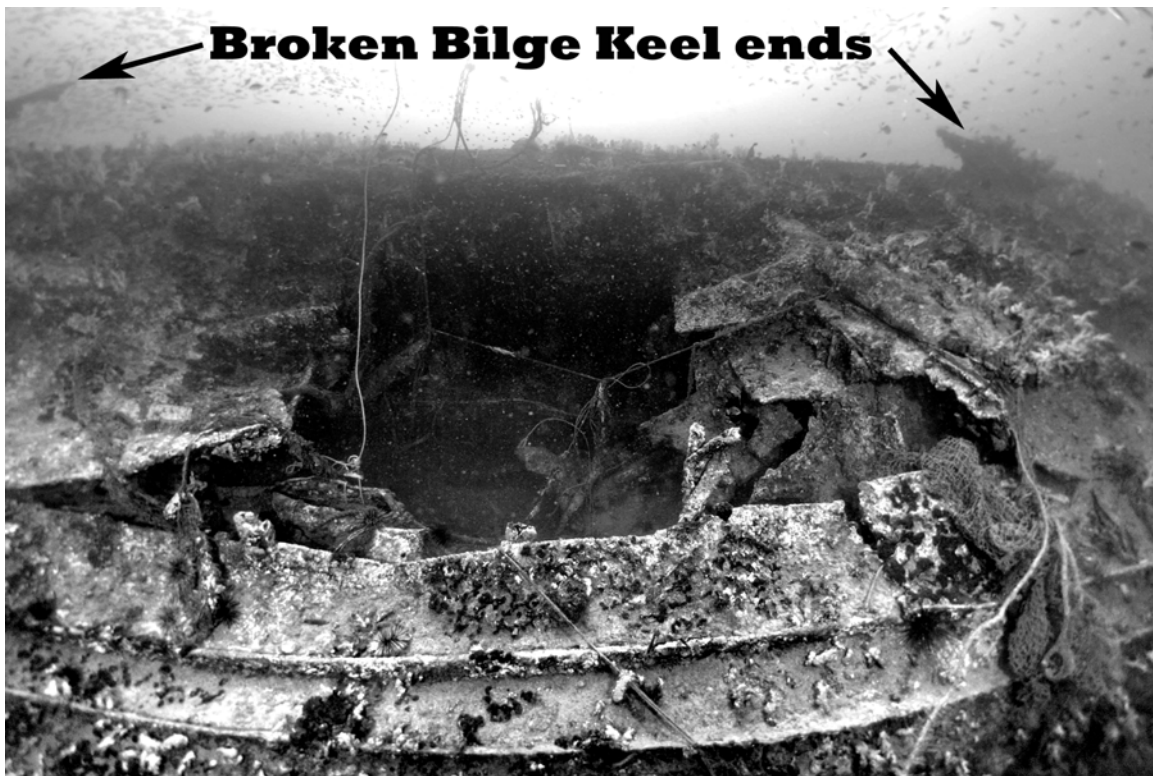
Photo is of the starboard amidships hit on *Repulse*, which is approx 4m high x 6m wide. Top left and right can just be seen the remains of the destroyed bilge keel. (NOTE; the distortion/curvature seen at the bottom of photo is from the use of a Fisheye - 180° - lens.)

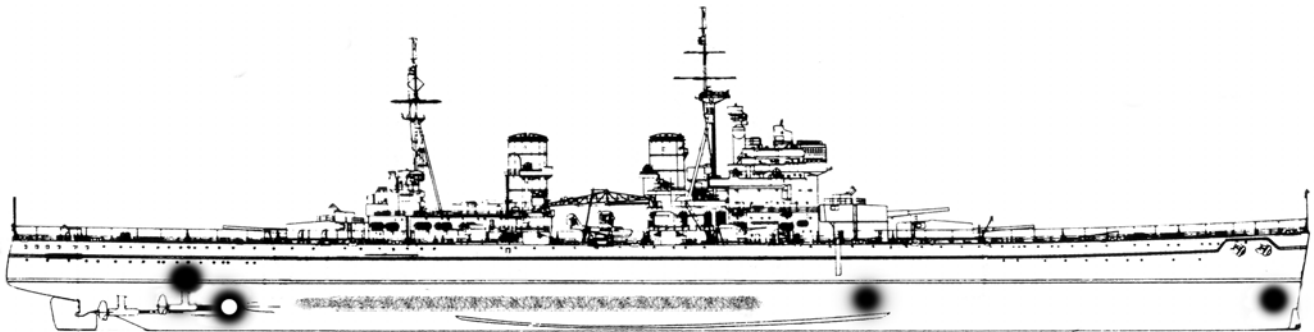
Video survey footage shot along the entire *starboard hull* therefore confirms only *three* large jagged penetration holes centered at; 1) The very bow itself - *Frame 8* - so close to the bow stem that the stem itself is broken/fractured and the hole actually penetrates right through the ship from starboard to port; 2) Beneath B turret - *Frame 109* - just forward of the bridge; 3) The stern - *Frame 296* - *above* and slightly abaft the outer strut of the outer propeller shaft A-Bracket, i.e. higher on the hull than *all* the other torpedo holes, indicating that the surrounding area aft was already well submerged when this torpedo hit. Video survey footage shot along the *port hull* confirms only *one* large jagged penetration hole - *Frame 284* - which is at the stern between the port outer propeller shaft A-Bracket and where the port outer propeller shaft exited the hull. The same video footage however shows *no* jagged penetration holes whatsoever - as specifically seen in the above four areas - *anywhere* else along the port or starboard hulls and specifically *not* in the area around the mainmast or rear funnel where torpedoes were thought to have hit the ship.

Expedition 'Job 74' could confirm only four hits, in the areas as shown above. If the hits reported beneath the mainmast and rear funnel actually struck the ship they have not penetrated the hull like the others have. However considerable indentation exists on both sides of the ship along the entire length of the shaded grey area - shown above - with longitudinal splitting in some parts in this area, right beneath/along the armour belt base.
 Black solid circles on hull = Confirmed starboard side torpedo hits.
 Black outline circle on hull = Confirmed port side torpedo hit.
 Torpedo hole *height* Stbd aft indicates just how far stern had already *settled* when hit!

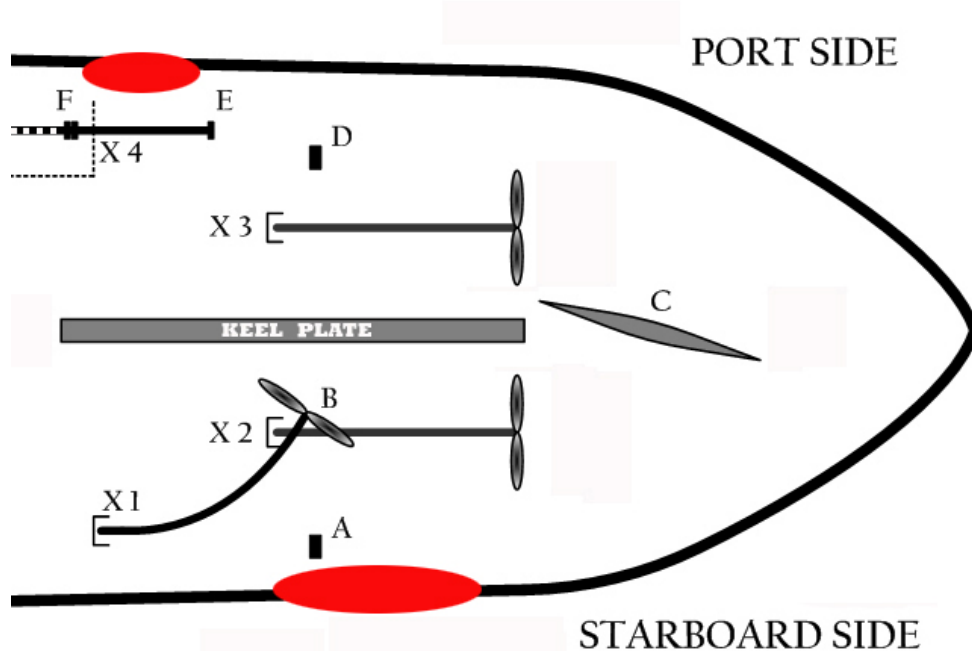
H.M.S. PRINCE OF WALES Upside-Down Stern Section - Propeller Shafts Details From Survey by Divers May 2007

- A) Remains of the *outer* strut of the outer Starboard shaft A-Bracket.
 - B) Outer Starboard propeller shaft is bent inboard and its propeller rests 'atop' the inner shaft just aft of where inner shaft exits the hull at the stern tube gland.

- C) Rudder is angled to port at approximately 20 degrees.
 - D) Remains of the *inner* strut of the outer Port shaft A-Bracket.
 - E) Flange on end of outer Port shaft (propeller, A-Bracket and shaft length missing).

- F) The flange that joins two lengths of shaft that can be seen when looking forward along the shaft inside the damaged stern tube receptacle.
- X1, X2, X3. Positions where shafts exit the hull at the stern tube gland.
X4. Where the Port shaft stern tube gland exit point is *thought* to have been. Severe damage to this area has made marking the exact position, in relation to the remaining shaft, difficult. Red elliptical areas on either side show position of torpedo hits/holes. Hole on Port is approximately 4 mts high by 6mts wide and was the first hit the ship took, while the hole on Starboard is approximately 4mts high by 11mts wide and was the fourth, or last, torpedo hit the ship took. (Time between hits, approx. 40 minutes.)

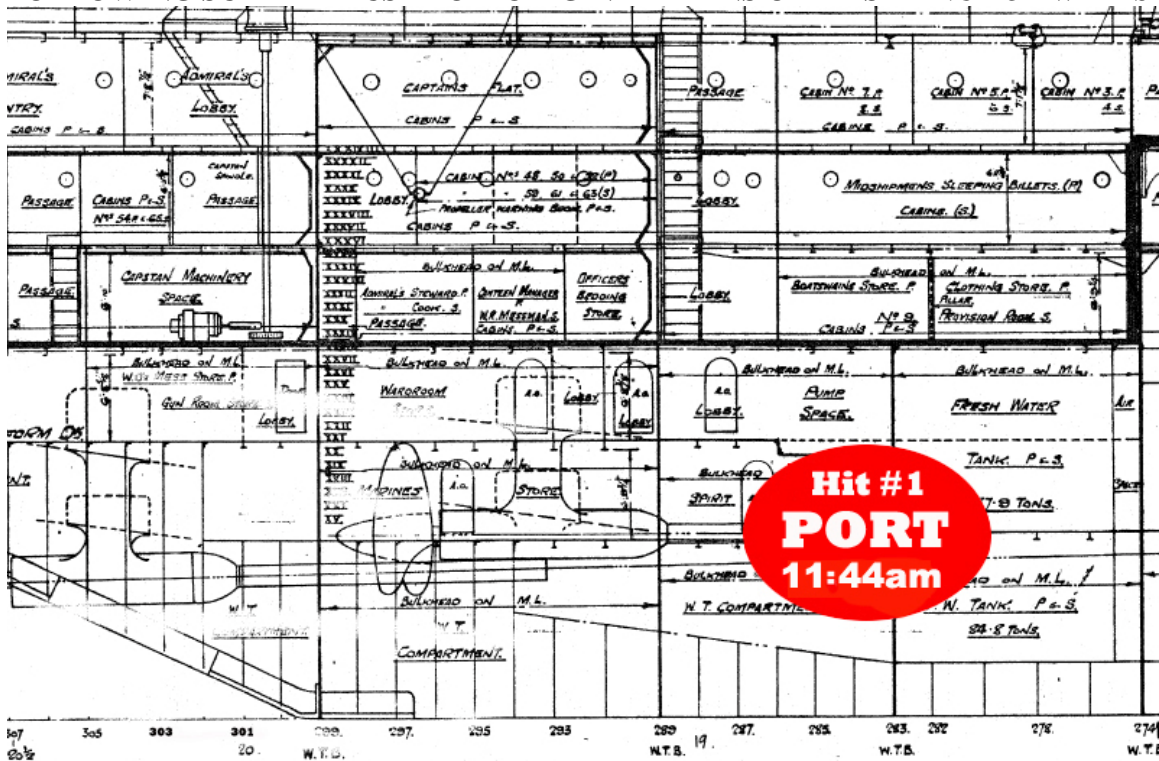
ABOVE: Port side hit aft centered at about Frame 284 is approx 4m high x 6m wide. Please note; this is a 'starboard side plan' but shows the PORT side hit position on hull.

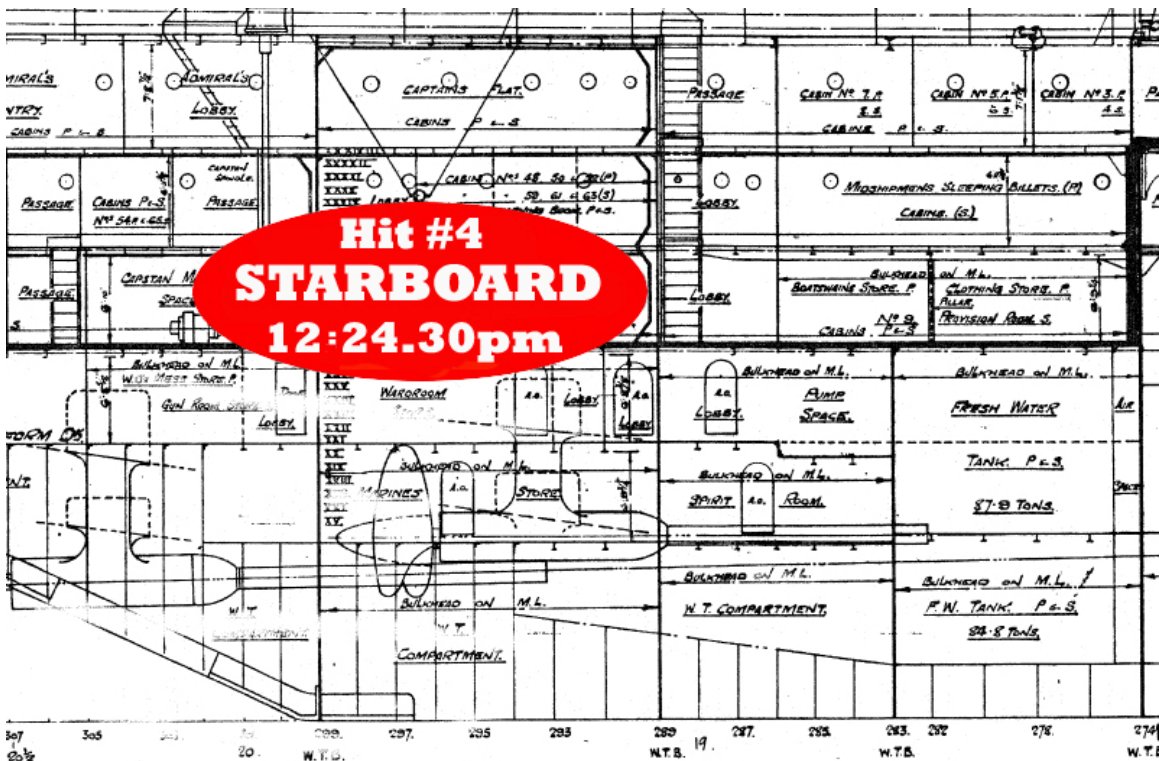
Starboard side hit aft centered at about Frame 296 is approx 4m high x 11m wide.

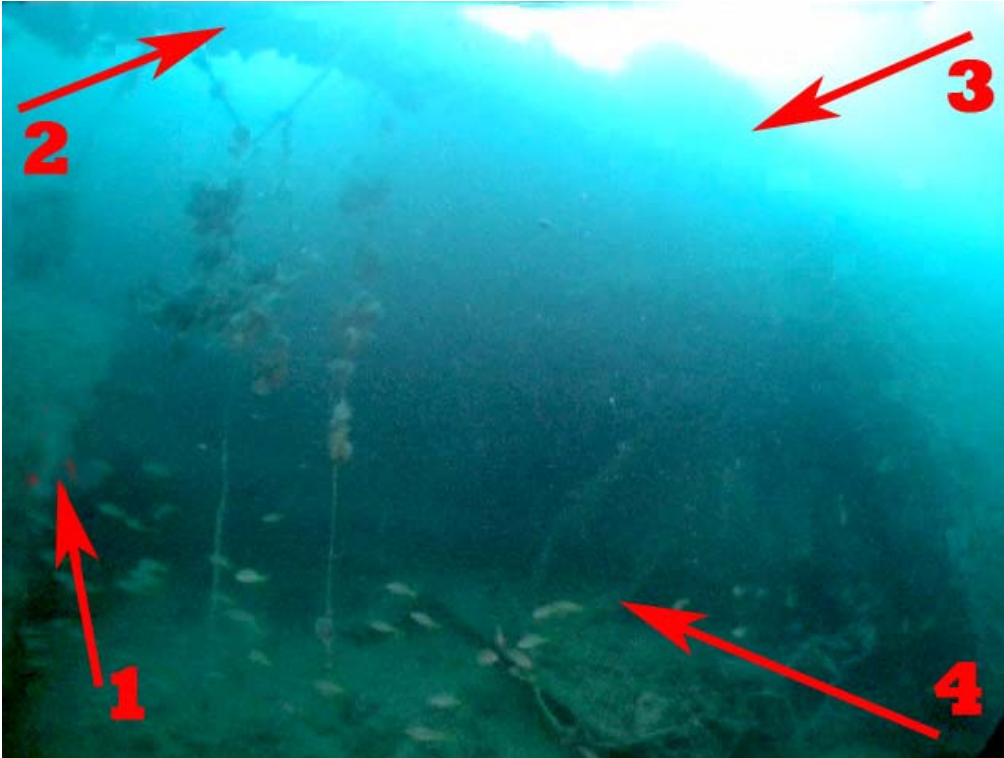
1) Edge of an inward collapsed hull plate. 2) Outer Port propeller shaft. 3) Location of split in hull where shaft exited stern tube. 4) Main opening of torpedo hole. Above 4 is forward edge of hole. Hole dimensions approx 4 meters high by 6 meters wide.

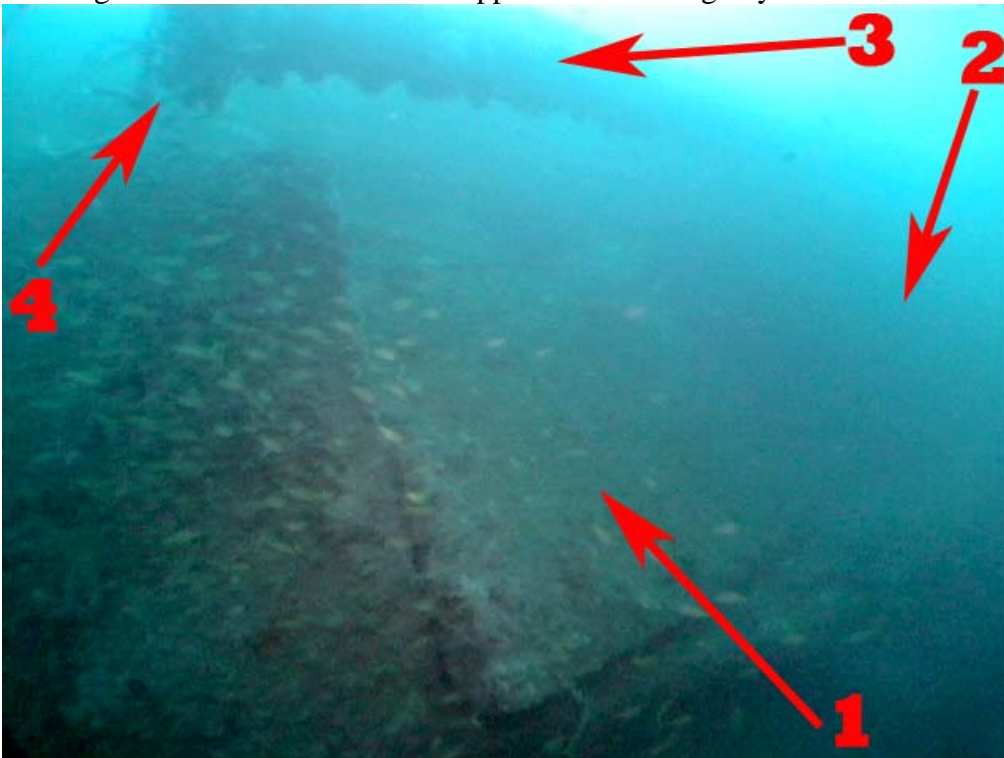
1) Aft end of same inward collapsed hull plate marked 1 in above image. 2) Main opening of hole. 3) Outer Port propeller shaft. 4) Flange on end of outer Port shaft.

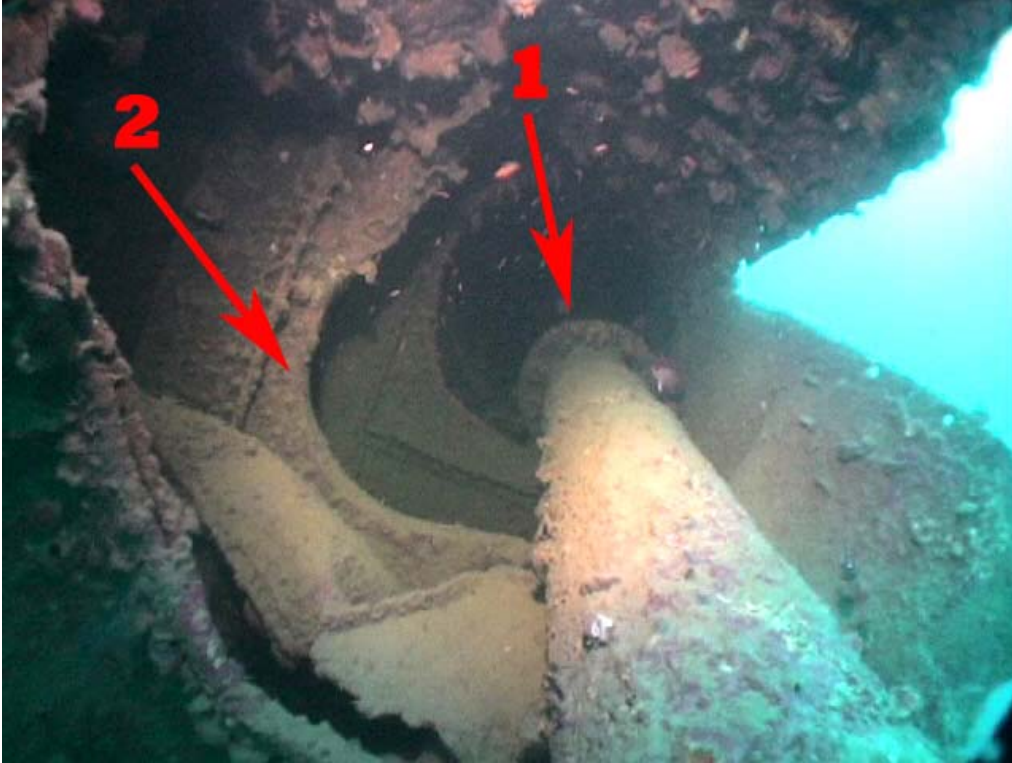
Looking forward from forward edge of torpedo hole into stern tube receptacle. 1) Flange that joins extruding length of shaft to an inner length. 2) Distorted/elongated web frames.

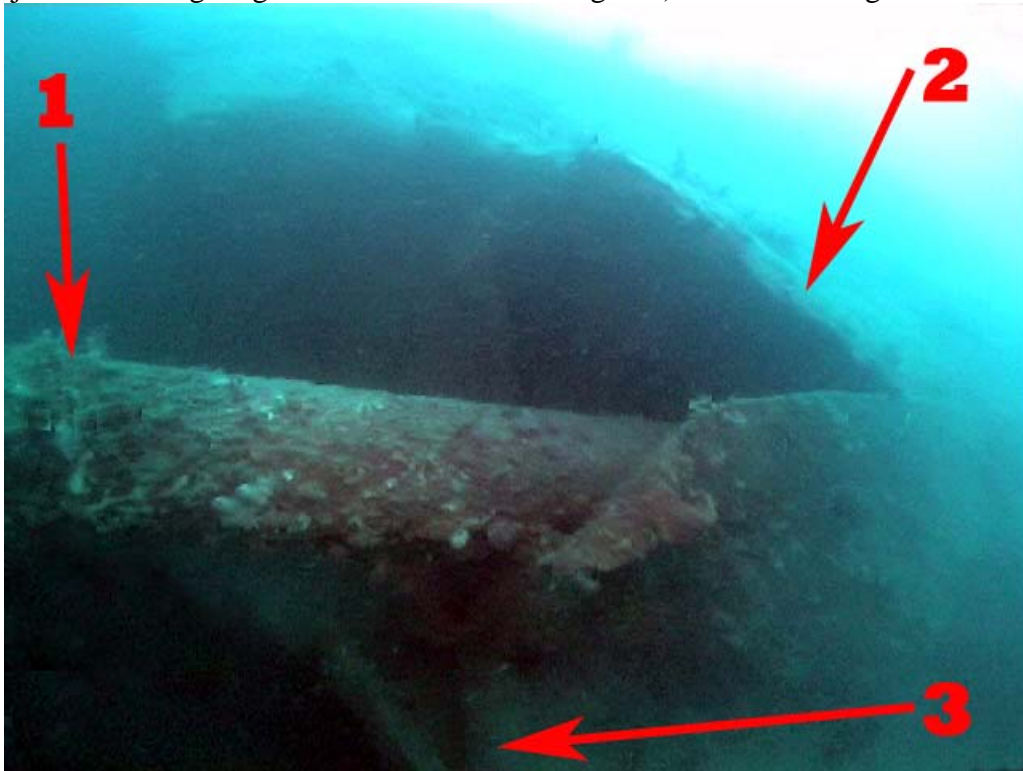
1) Outer Port propeller shaft. 2) Split in hull thought to be from shaft rotating out of center / flailing, etc., after the torpedo hit. 3) Forward edge of Port torpedo hole.

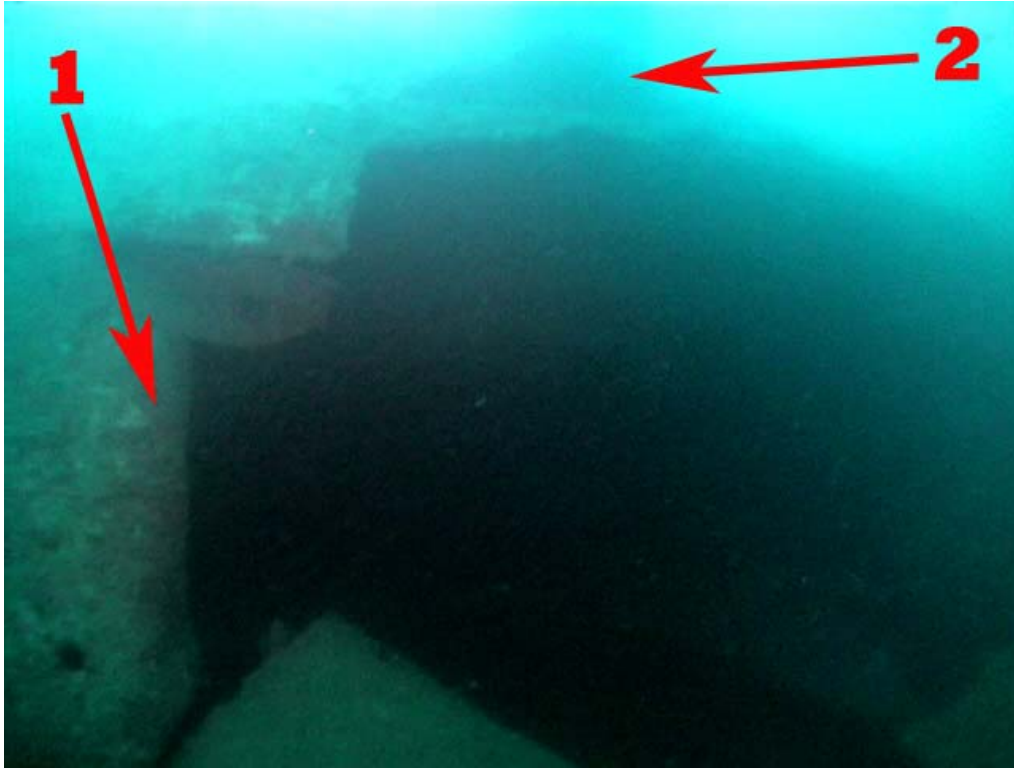
1) Forward edge of Starboard torpedo hole. 2) *Outer* strut stub from outer shaft A Bracket.

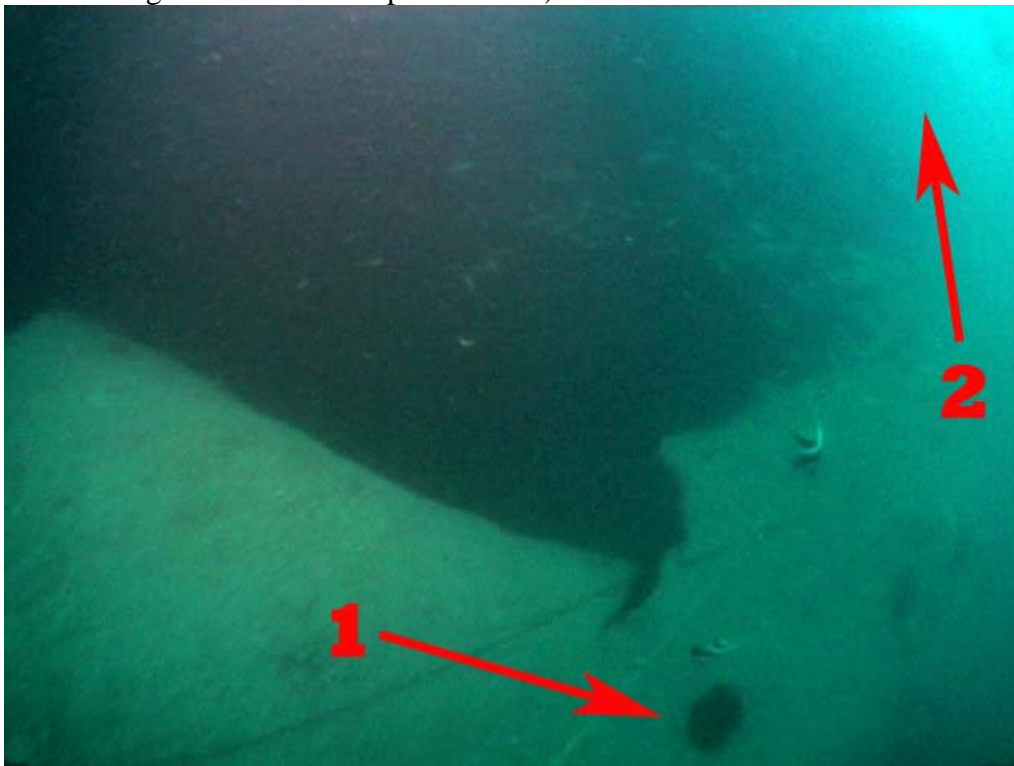
1) The height of hole in hull can be judged by how close it comes to the row of scuttles / portholes. This was by far the highest location of any of the hits and infers just how far the stern had settled in the forty minute interval between Port and Starboard aft hits. 2) Aft edge of torpedo hole. Dimensions are approximately 4 meters high by 11 meters wide.

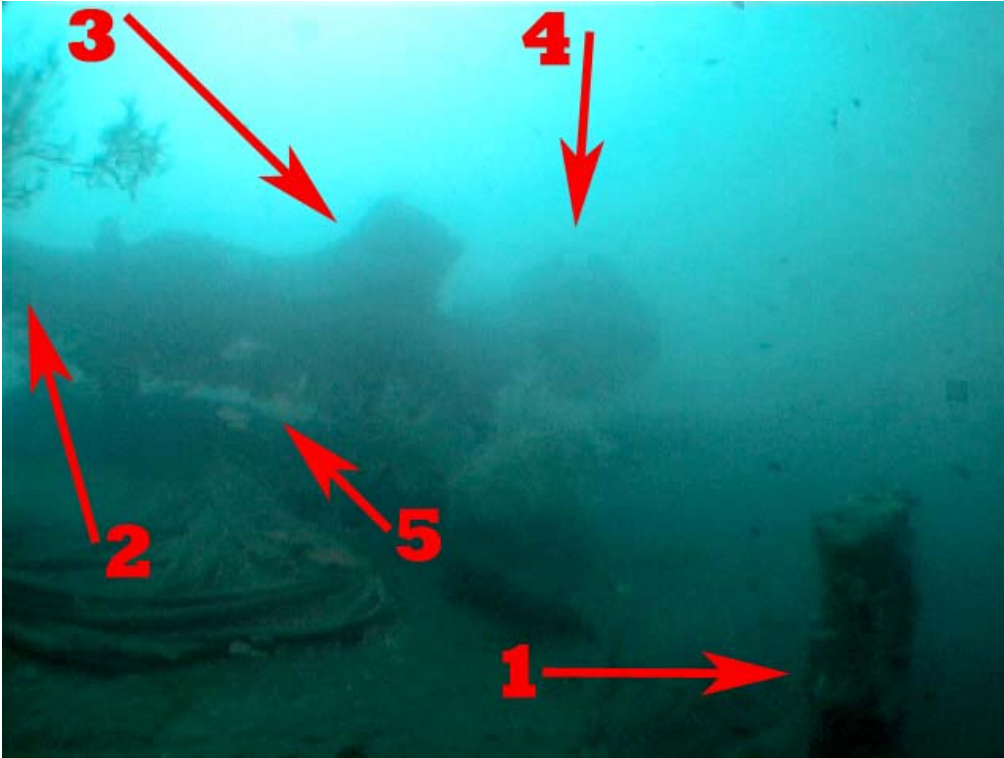
- 1) Only a short stub remains of the *outer* strut of the *outer* Starboard shaft A-Bracket. 2) Outer propeller shaft. 3) Remains of outer strut of outer A-Bracket that was joined to *1*. 4) Outer Starboard propeller (blade). 5) Inner Starboard propeller shaft where it exits gland.

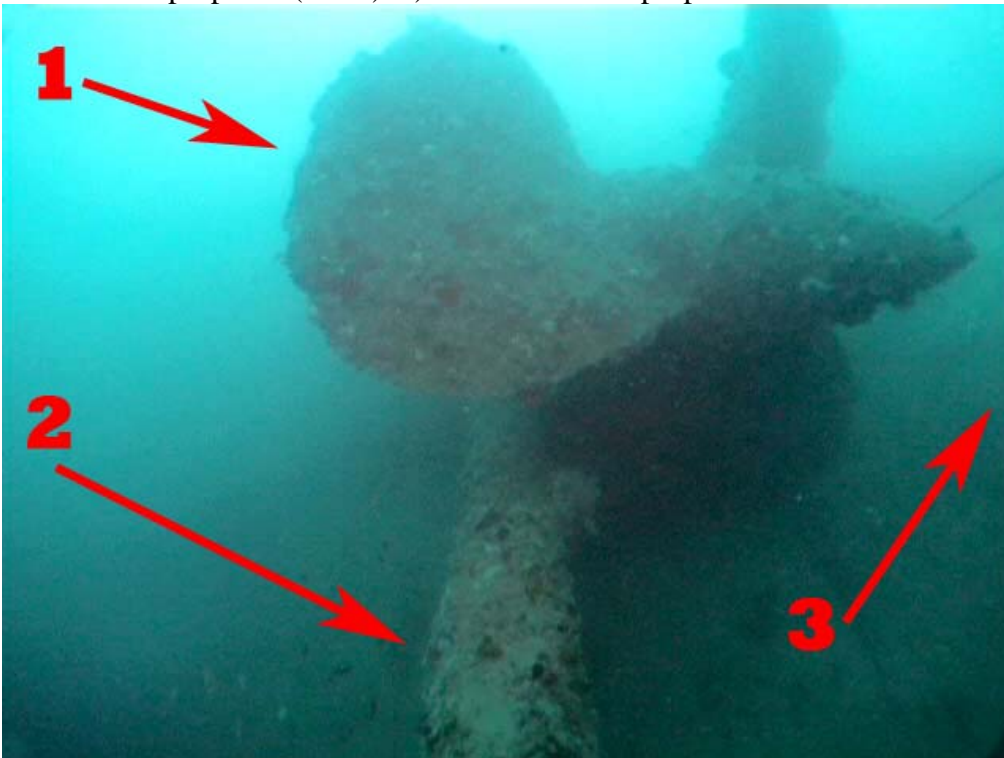
- 1) Outer Starboard Propeller. 2) Inner Starboard propeller shaft. 3) Center Keel Plate.

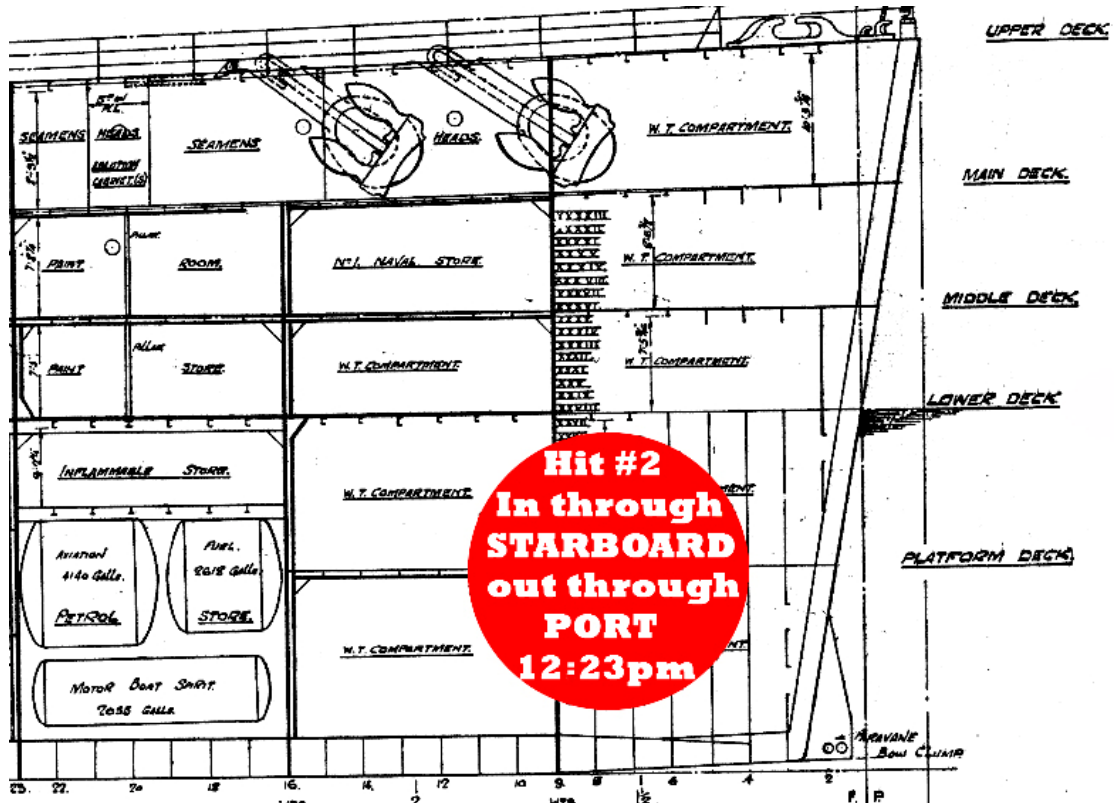
Starboard side bow hit is centered about Frame 8 and is approx 7m in diameter.

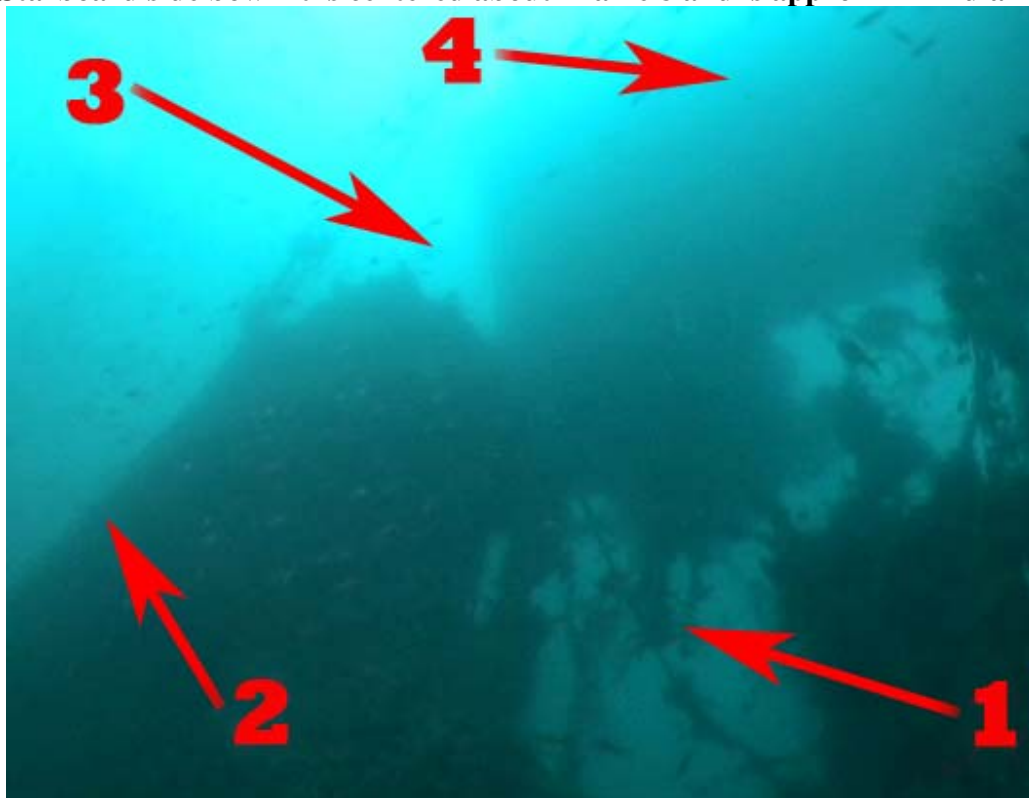
1) Forward portion of torpedo hole viewed from Starboard. 2) Bow stem. 3) Break in bow stem-post. 4) Bow stem below break (*below* when ship was upright that is).

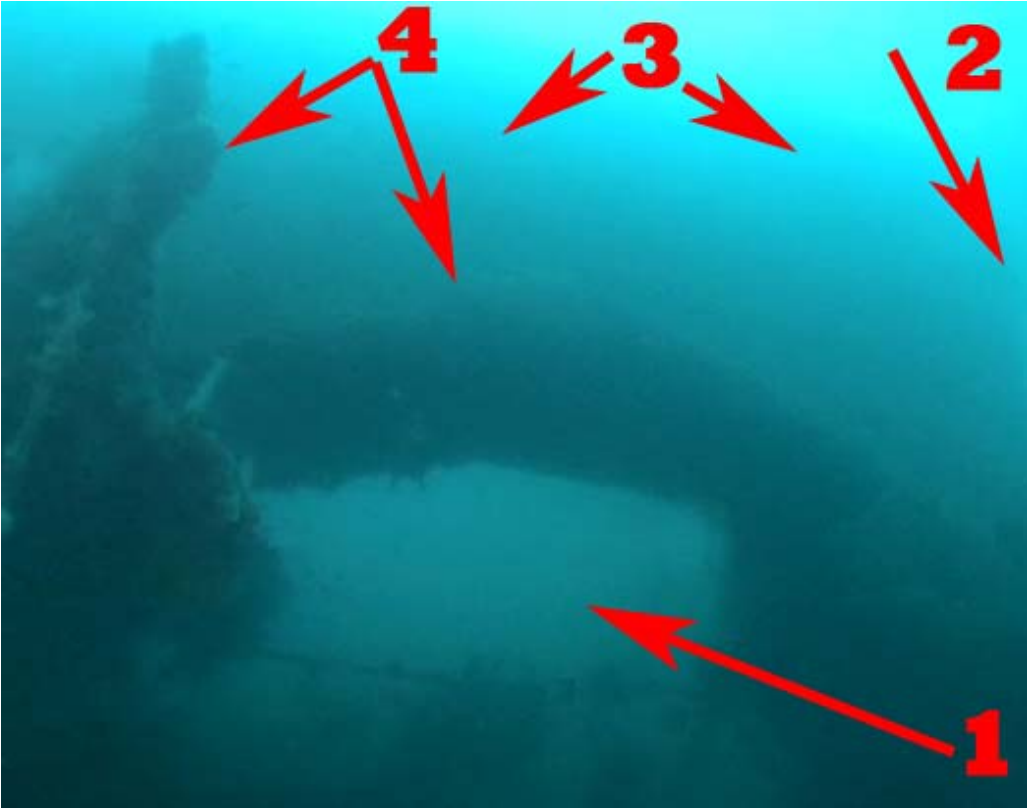
1) Torpedo hole viewed from Port side. 2) Bow stem. 3) Center Keel – bottom - of ship. 4) Hull plates bent noticeably out to Port from force of Starboard hit.

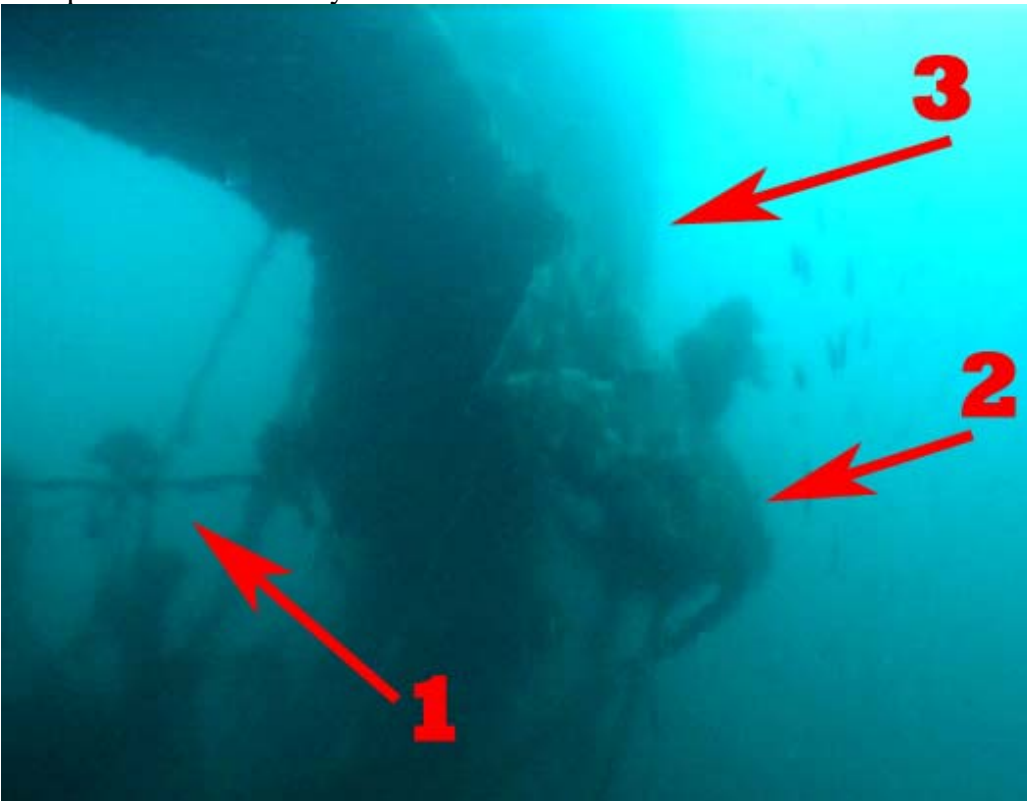
1) Torpedo hole. 2) Hull plate at forward edge of hole bent out to Port. 3) Bow stem.

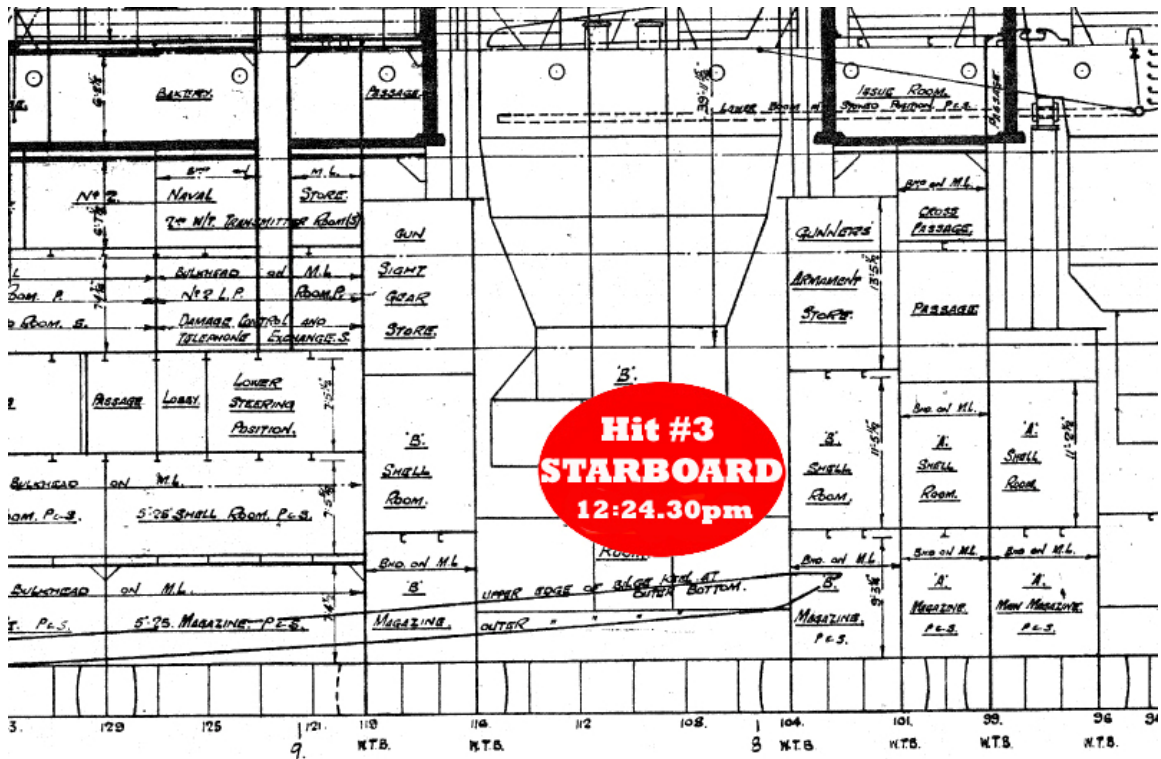
Starboard side hit forward is just forward of the Bridge and outboard of B Turret, centered about Frame 109 and approximately 4m high x 6m wide.

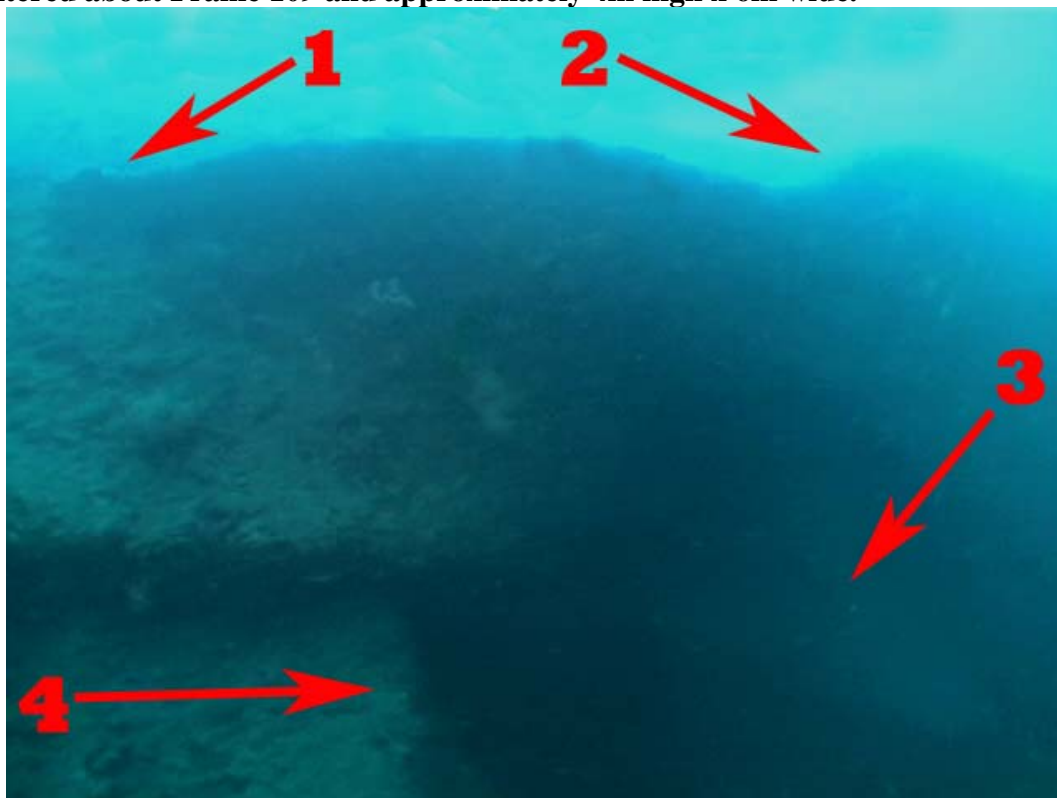
1) Forward end of Starboard Bilge Keel. 2) Buckle in Bilge Keel above torpedo hole. 3) Upper portion of torpedo hole. 4) Forward edge of torpedo hole.

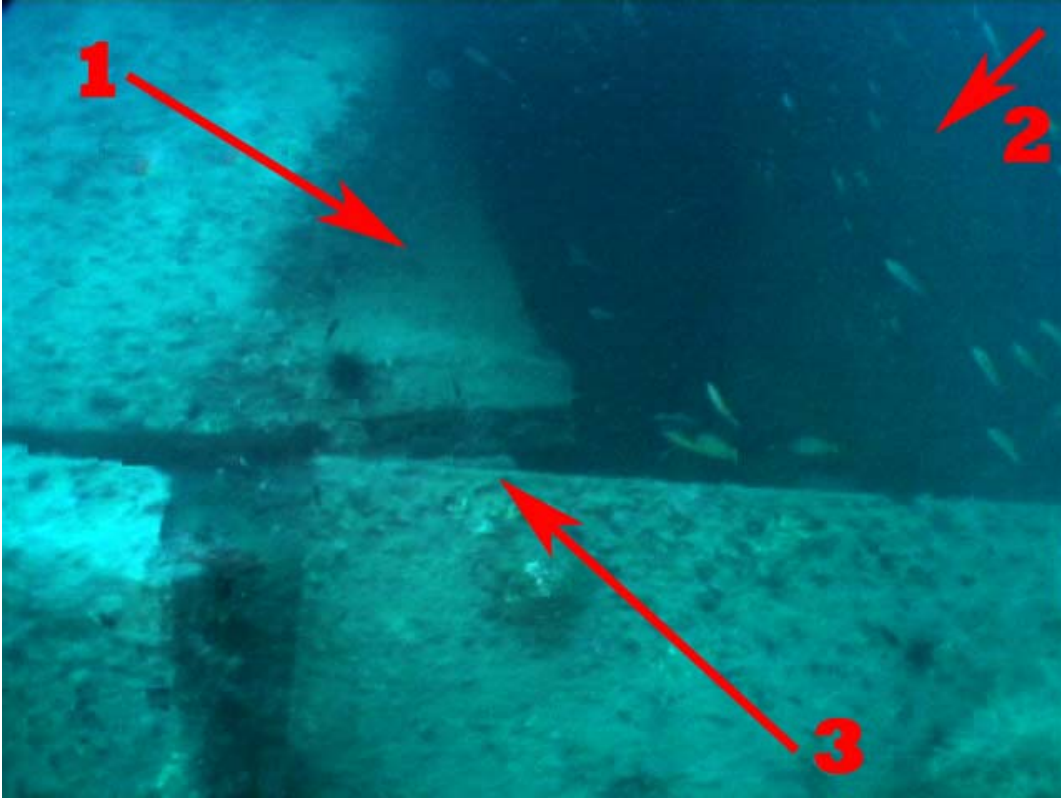
1) Bent in plate, lower forward edge of torpedo hole. 2) Lower portion of hole. 3) Bottom edge of Armour Belt plate.

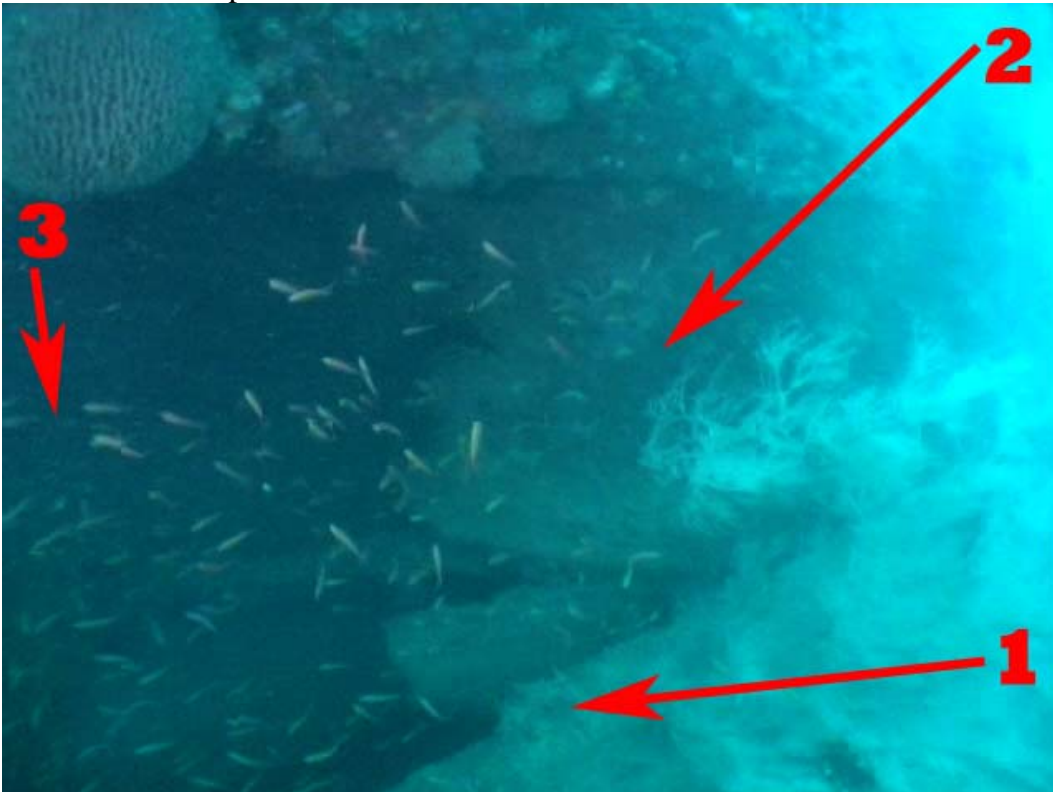
1) Bottom edge, Armour Belt. 2) Bent in hull plates, aft edge of hole. 3) Torpedo hole.

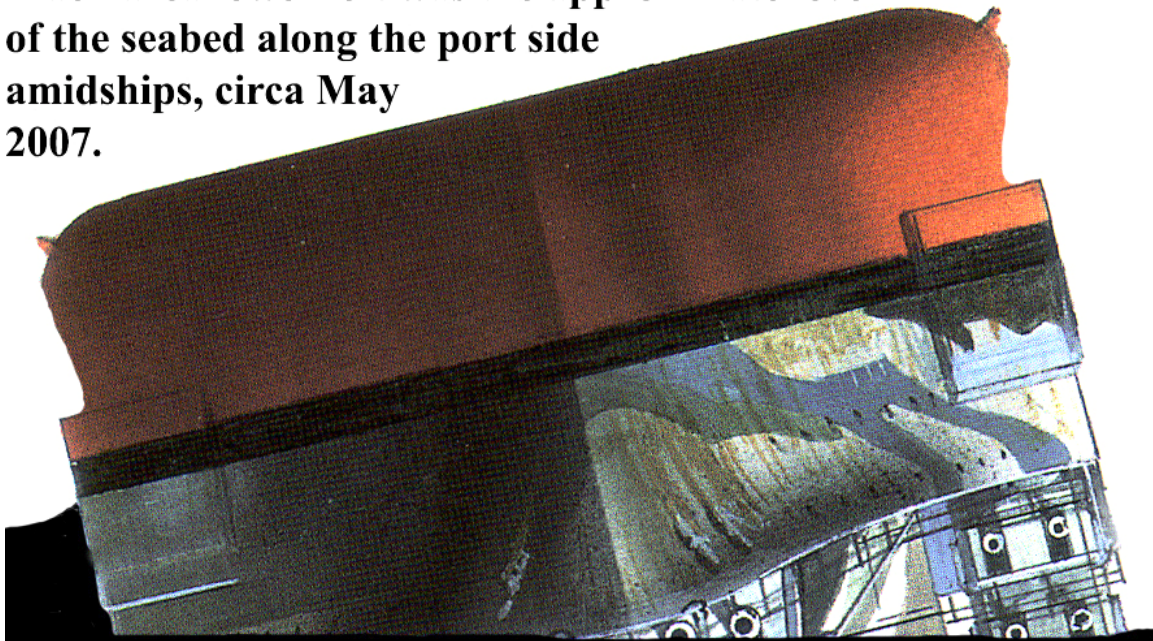
Black area lower left was the approximate level of the seabed along the port side amidships, circa May 2007.

WRECK OF *PRINCE OF WALES* LAYS ON AN ANGLE OF APPROX. 15° TO PORT. Concave indentations in hull below armour belt are shaped as above throughout the areas as described in paragraph at bottom of page 9. This damage, and more information on the stern damage, is discussed - and shown in more detail - in two separate reports accessed at bottom of linked page; http://www.pacificwrecks.com/ships/hms/prince_of_wales.html

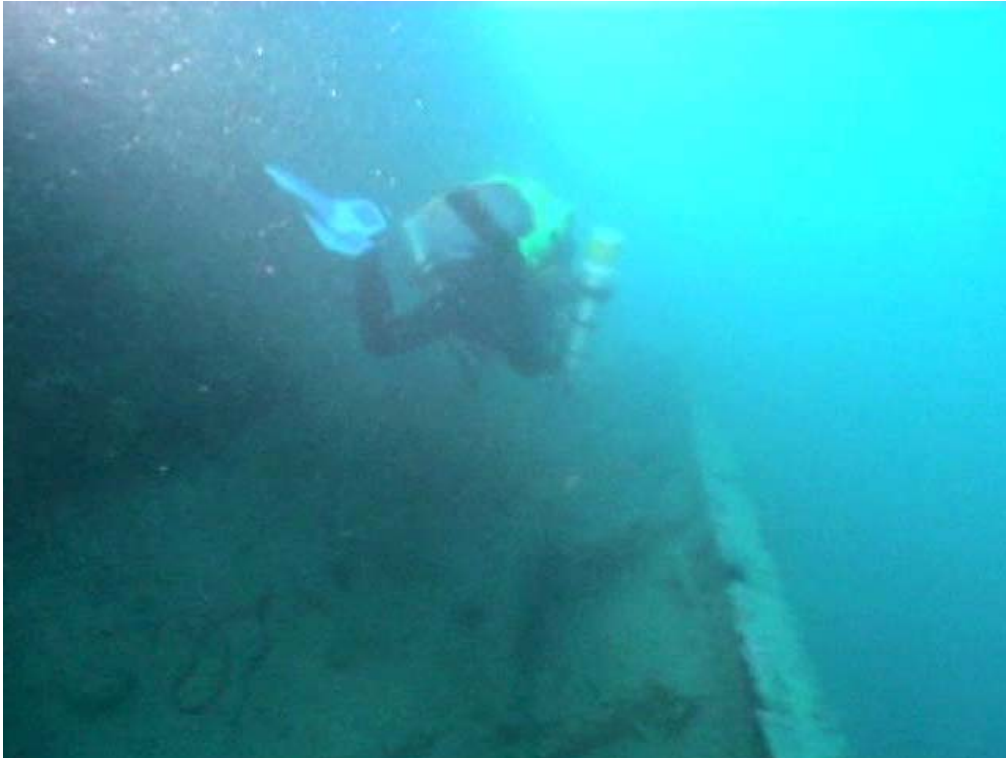
Diver swimming aft along hull indentation (on Starboard side) at about the widest point.

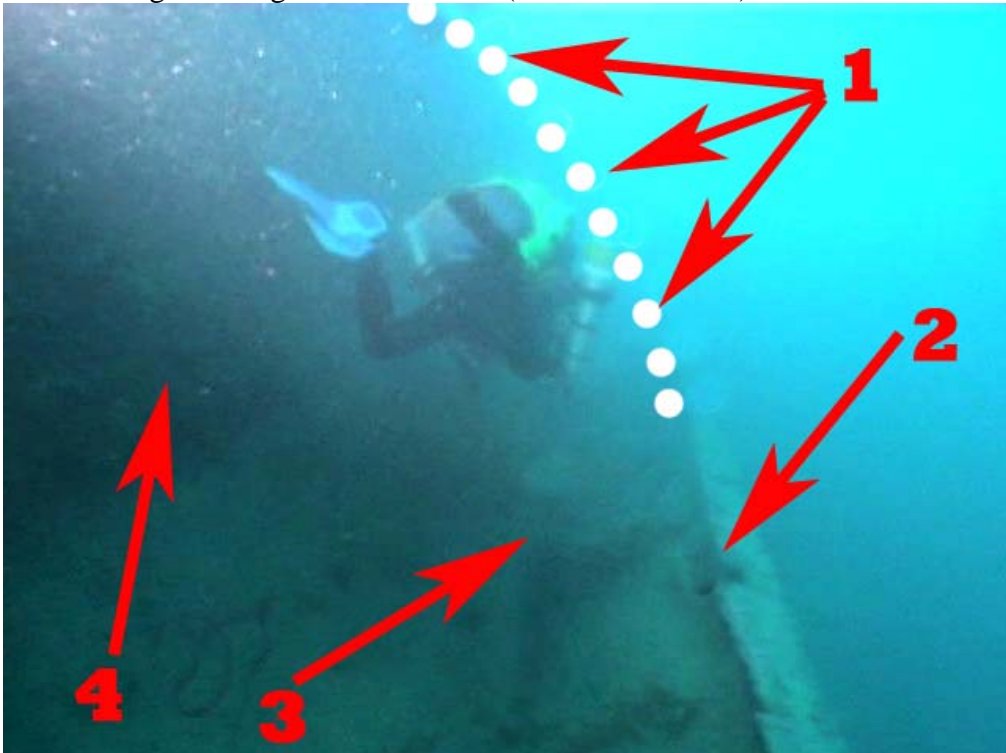
1) White dots follow a line that hull curvature *should* take, i.e. convex. 2) Bottom edge of Armour Belt plate. 3) Edge of lower hull plate (running fore and aft) that has *pulled away* from Armour Belt. 4) Lower hull plates below Armour Belt now concave; they should be convex. This deformation stretches for 65 meters on Starboard hull & 70 meters on Port.
