DEATH OF A BATTLESHIP THE LOSS OF HMS *PRINCE OF WALES* December 10, 1941

A Marine Forensics Analysis of the Sinking

Garzke - Dulin - Denlay

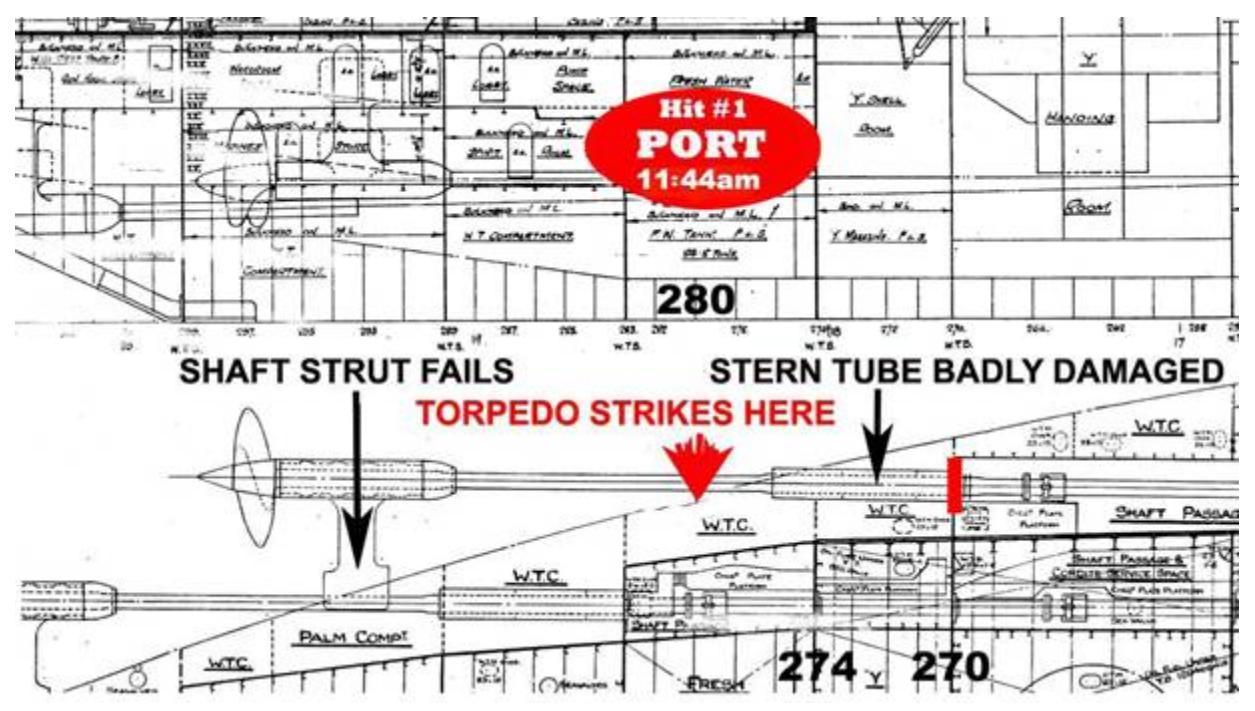
Figure 1 – Location of the First Torpedo Hit

The outboard port shaft strut arms were weakened by the force of the explosion and a ragged hole was torn in the hull plating approximately four meters high and six meters wide just abaft the stern tube, and the shaft itself was damaged. The stern tube was also damaged (See Figure 1), but its degree of damage is not known, nor will it be until that missing section of shafting and the associated stern tube structure is found for further examination. The outer port propeller continued to rotate at high speed and, turning out of center, started to wobble and vibrate, putting additional stress on the weakened strut. (The 2007 survey has shown that the weakened inboard strut arm of the strut eventually failed by breaking in half, while the outboard strut arm broke off cleanly at the hull. See Figure 4c). LT Wildish was unaware of this serious damage to his shafting and propeller. As communications in the ship had been disrupted, his actions were dictated by what was happening within his space. (As we will see later, this disruption of the ship's internal communication system – caused by the loss of electrical power as a result of the torpedo hit – would soon have serious repercussions for both damage control and for the ship's fighting ability.) He did experience a terrific shock response with the ship whipping around like a springboard, and that event was also noted in the testimony of other survivors. This caused some rivet failures in connections of structure around "Y" turret, as the massive weight of this structure was not as easily excited as lighter local structure around it. This would be a contributory cause to later progressive flooding in this area of the ship (Appendix D).

The upper *profile view* shows where the first torpedo hit to port at about Frame 280, based on measurements made by the Expedition 'Job 74' diving team. The lower *plan view* shows the stern tube and the aft end of the outer shaft alley for the shafting from "B" Engine Room (upper shaft in plan view). The torpedo struck just abaft the stern tube, which in turn became disassembled from the shafting after the failure of the shaft strut. The explosion would have wrecked the structure of the nearest bulkhead (Frame 274) in the stern tube area and most likely caused serious damage to the bulkhead that closed off the aft end of the shaft alley (Frame 270 - red line). When the shaft began to rotate out of center it further damaged that bulkhead (Frame 270) and later demolished it when the shafting came apart.

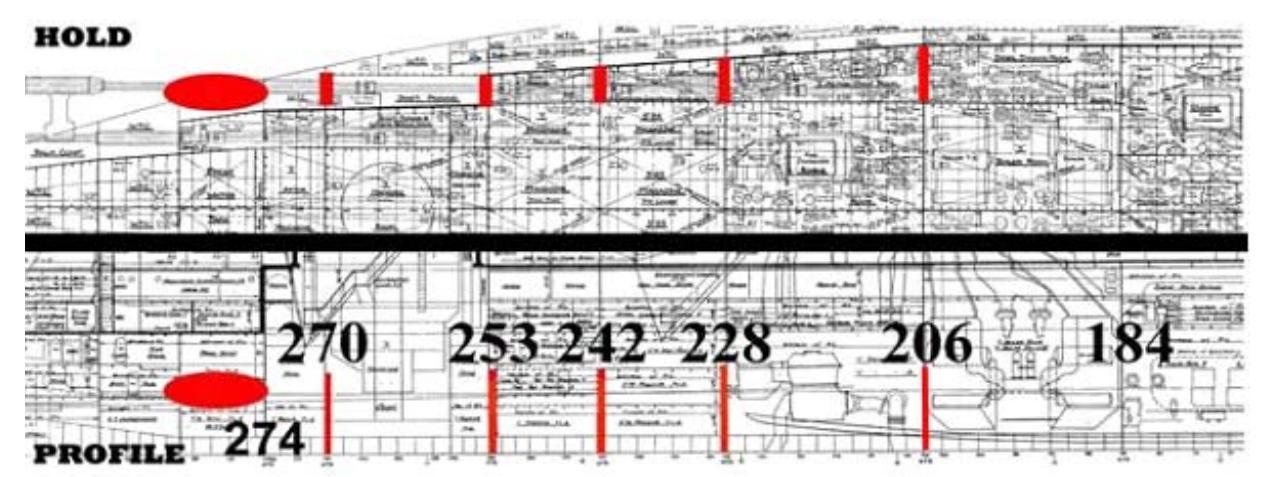
Figure 3 – Arrangement of Port Outboard Shaft Tunnel

Using Expedition 'Job 74' survey measurements, we can now accurately show where the torpedo in the first attack struck *Prince of Wales* (red ellipse). The red lines mark the position of the transverse bulkheads along the shaft tunnel affected by the shaft initially running out of center and then eventually disintegrating (Frames 270, 253, 242, 228 and 206). The bulkhead at Frame 184 remains intact but its gland (which cannot be viewed because of the Thrust Block Enclosure) must have failed to remain watertight as Lt Wildish reported that water flooded through it into B Engine Room.

A survivor from the Diesel Dynamo Room had even reported that its aft bulkhead (Frame 206) had "caved in", but this has been found to be slightly in error. The shaft rotating out of center had destroyed the bulkhead stuffing gland. When inspected in 2008 and photographed in 2009 by a survey diver, the bulkhead itself was found to be relatively intact, but the gland the shaft passes through was wrecked, with the surrounding structure misshapen and elongated. When LT Wildish restarted the turbine in the ahead position, the shaft, rotating out of center, started to come loose from its remaining pedestals and bearing covers which subsequently led to the failure of the bolts connecting the 17.5-inch line shaft flanges. This situation then caused the line shaft to come apart (Figure 6) which resulted in varying degrees of destruction to the previously damaged shaft tunnel bulkheads at Frames 270, 253, 242, 228, and 206 (see Figures 3 and 11).

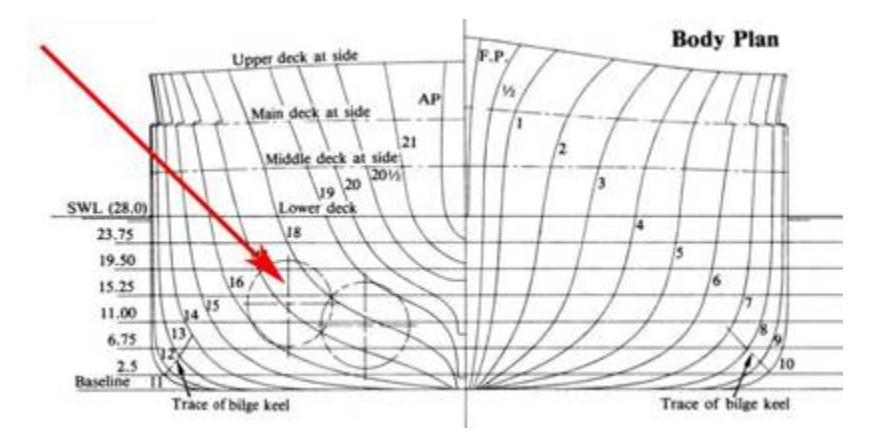
Figure 4b – Location of the Port Torpedo Hit

The red arrow above points to the approximate location of the port torpedo hit, just where the outer propeller shaft exited the hull. Note how the hull curves under where the torpedo struck the hull. This may account for why no column of water was seen to be 'thrown upwards' by this hit, as did occur with all the other hits.

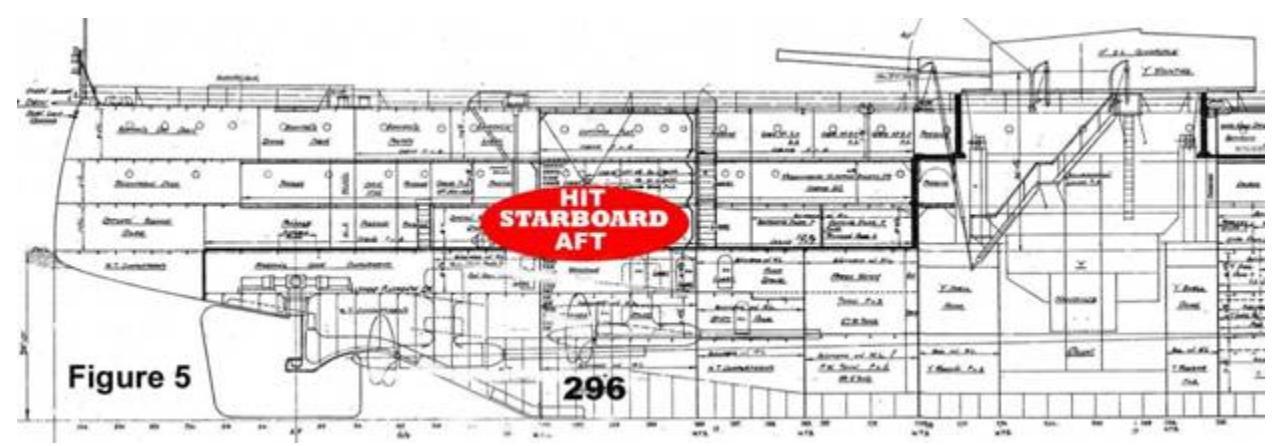
Figure 5 – Location of Torpedo Hit on Starboard Side Aft

The most devastating hit from the torpedo attack on the starboard side occurred abaft of "Y" Turret, leaving a hole approximately eleven meters long and four meters high in the hull (Figure 5) and immediately jamming the starboard outer shaft. The result was that the turbines in "A" Engine Room driving this outer shaft came to a complete and abrupt halt. Only the inner starboard shaft was now in operation. In 1966 and again in 2007, divers examining the wreckage found the outer shaft (44.5cm dia.) was bent inboard to the extent that its propeller was wedged over the inner shaft. The fact that the outer shaft was bent inboard and the propeller is wedged over the inner shaft and between the keel plate meant that the outboard shaft strut failed, and on inspection in May 2007 the outer strut arm of the outer strut was seen to have snapped in half.

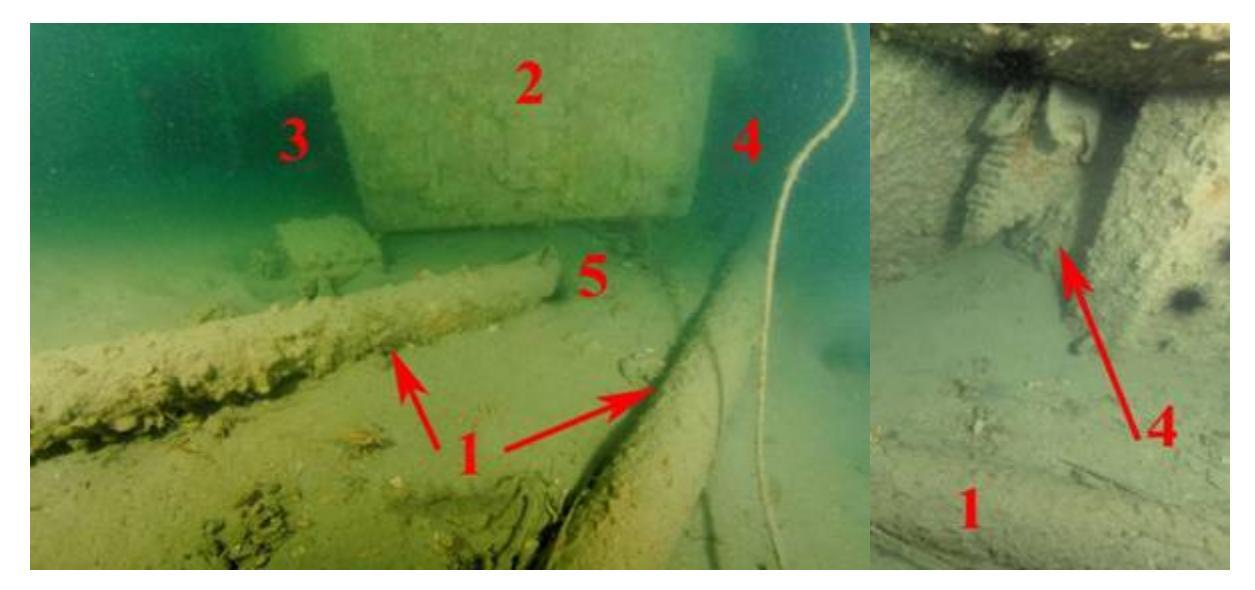
Left. The guns of S2 turret (2) have been torn out of their mounting apertures (3 & 4), caused no doubt as the guns, near maximum elevation (see image page 24), struck the seabed with the weight of the ship settling on top of them. Both gun tubes (1) lay on the seabed with torn jagged ends (5) where they ripped from the mounting. **Right**. A close up of the turret aperture (4) where one of the barrels (1) tore out from.

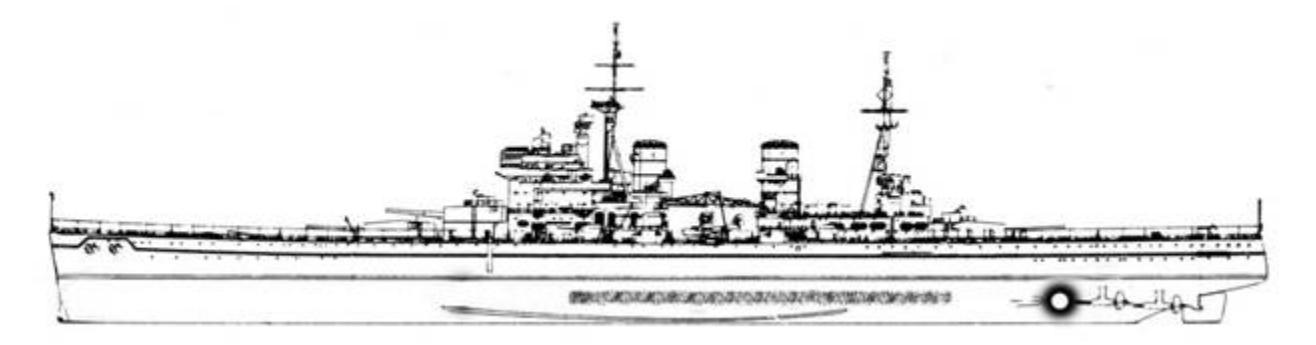
Figure 9 – Location of the Port Side Torpedo Hit

On the port side aft there is a single torpedo hole approximately 4 meters high and 6 meters long extending aft from just forward of where the outer shaft exited the stern tube gland (this hole is centered at approximately Frame 280, Figure 1):

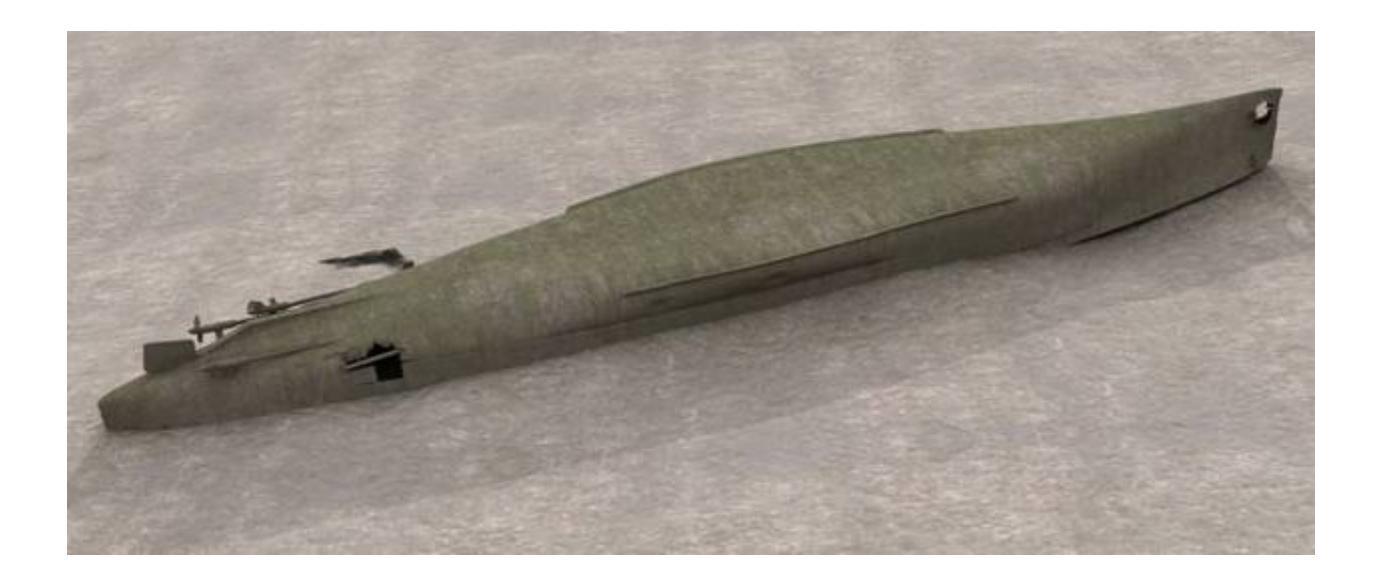
- a) The blades of the propeller for the port inner shaft are missing large pieces of their edges, indicating that they were struck by debris from the initial torpedo explosion or by either the outer propeller or other debris when it broke away.
- b) The port outer shaft has come apart at the flange about 8 meters forward from the opening in the stern tube where the shaft emerges (Flange 'A', Figure 11). The receptacle for the stern tube has been ripped open large enough for a diver to enter forward along the shaft, and has a rip or tear on the outboard side which extends forward about two meters. The damaged web frames in the stern tube receptacle are now clearly visible, as is the one remaining intact flange (Flange 'B', Figure 11).

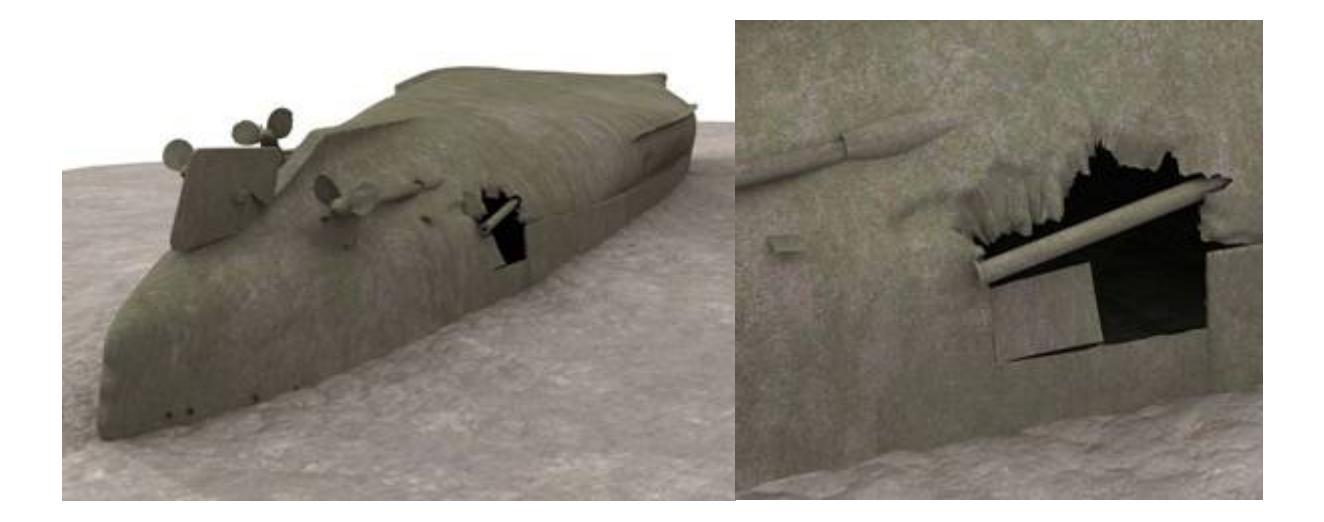
- c) There is a plate of armor collapsed inwards at the forward edge of the hole. Another plate just aft stands somewhat vertical, and appears precariously balanced. The hull forward and aft of this hole is significantly damaged and distorted for approximately 2 meters in either direction.
- d) The September 2009 excursion up the port shaft alley revealed the damage caused by the shaft rotating out of center, which was caused by torpedo damage to the stern tube, propeller shaft, and strut. The holes in transverse bulkheads at Frames 206, 228, 242, and 253 are huge, some 4-6 feet in diameter. Several hatches were discovered opened either from the intense water pressure or left opened by escaping crew. In the latter case, if the hatch had been quickly dogged and not firmly closed, the water pressure would have sprung them open.

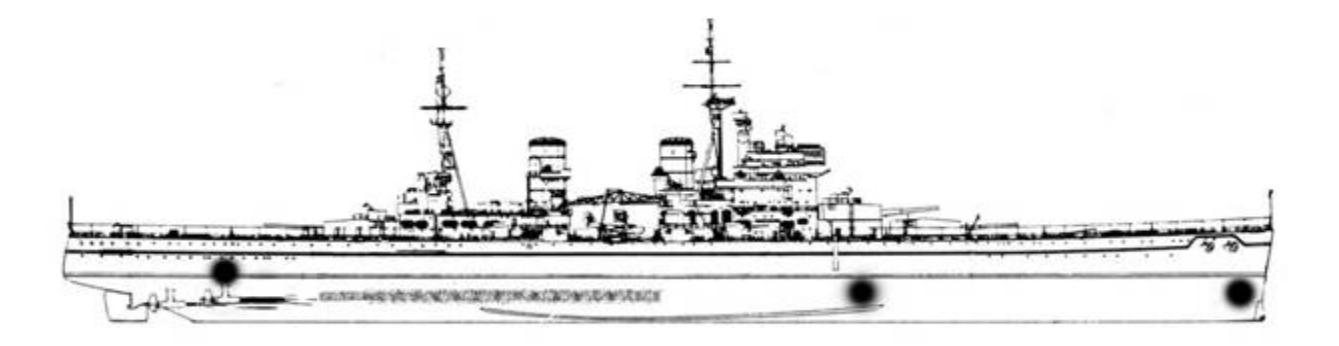
Figure 10 – Location of Three Torpedo Hits on the Starboard Side

Of the three starboard hits the after-most one was the most serious (*the after-most hole is centered at approximately Frame 296, Figure 5*), the forward two being somewhat superfluous in the cause of her demise.

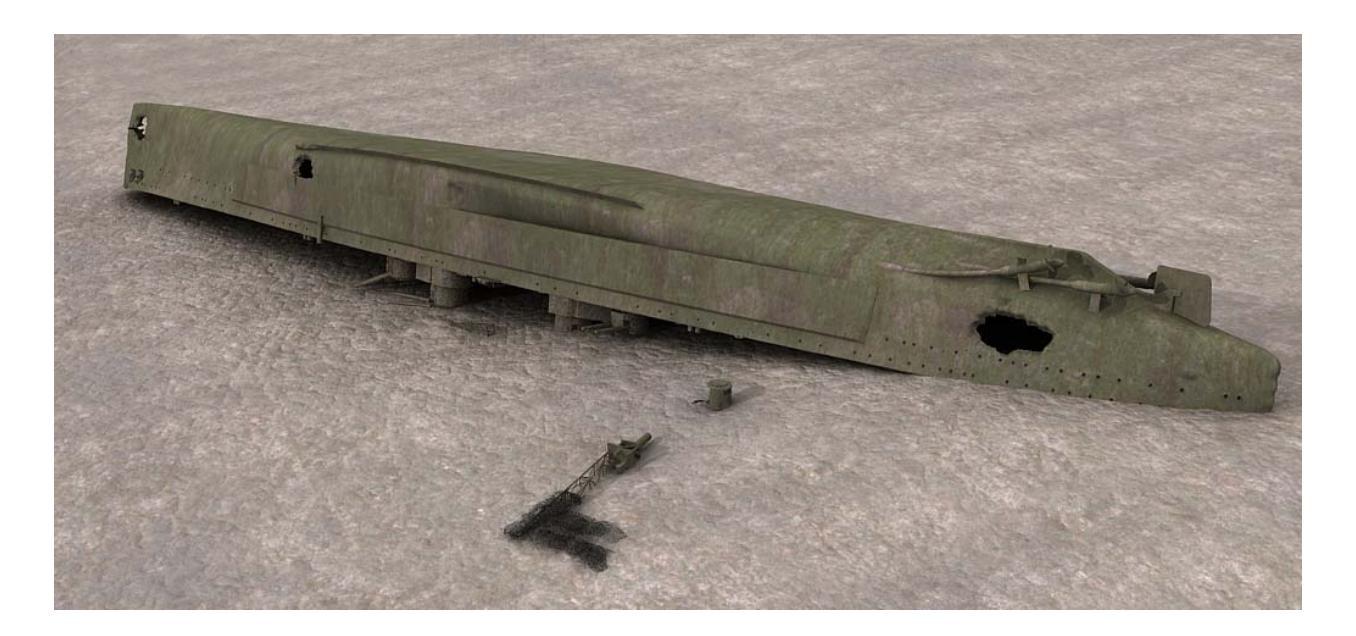
- c) The torpedo damage extends into the ship, with decks visible inside the hole.
- d) There are rips and tears in the surrounding plates and supporting structure that have been pushed in fore and aft of the hole for about two meters in either direction.

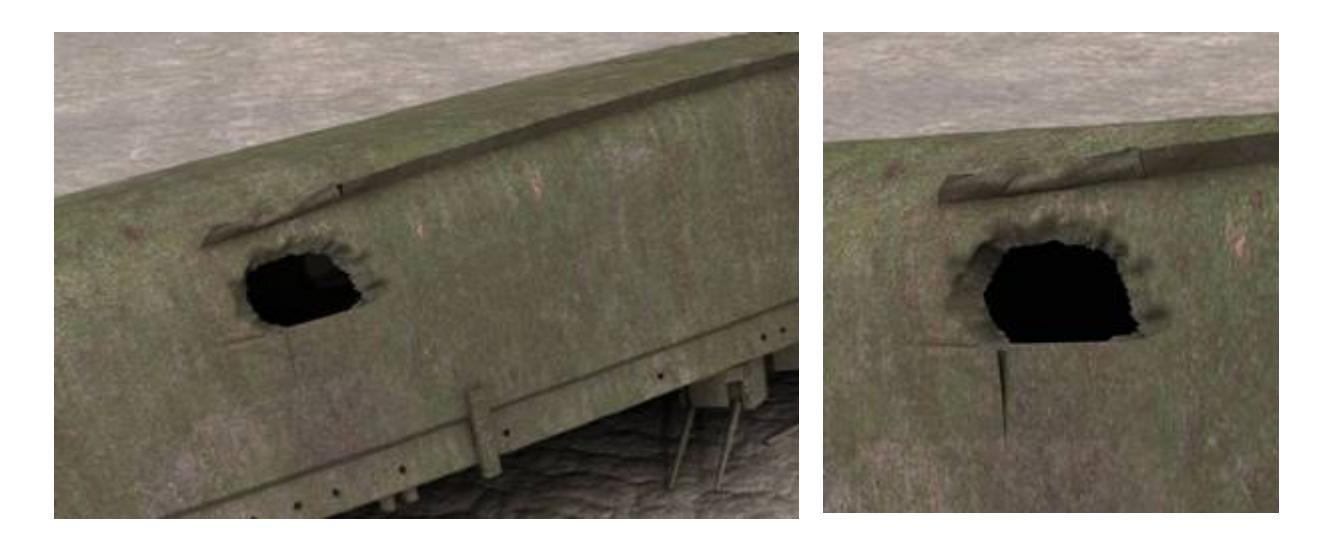
- a) The torpedo hole is approximately 4 meters high by 6 meters wide.
- b) The hit was made in way of the torpedo defense system and there appears to be no significant breach in the inboard bulkhead of the air/fuel/air sandwich layer.
- c) It also appears that the torpedo exploded just below the lower edge of the main side belt which helped to contain it and aided in venting the blast effects.
- d) There is a hole in the Middle Deck over the defense system into the Seamen's Mess area, reported to have been caused by a degaussing generator being blown up through the deckhead.

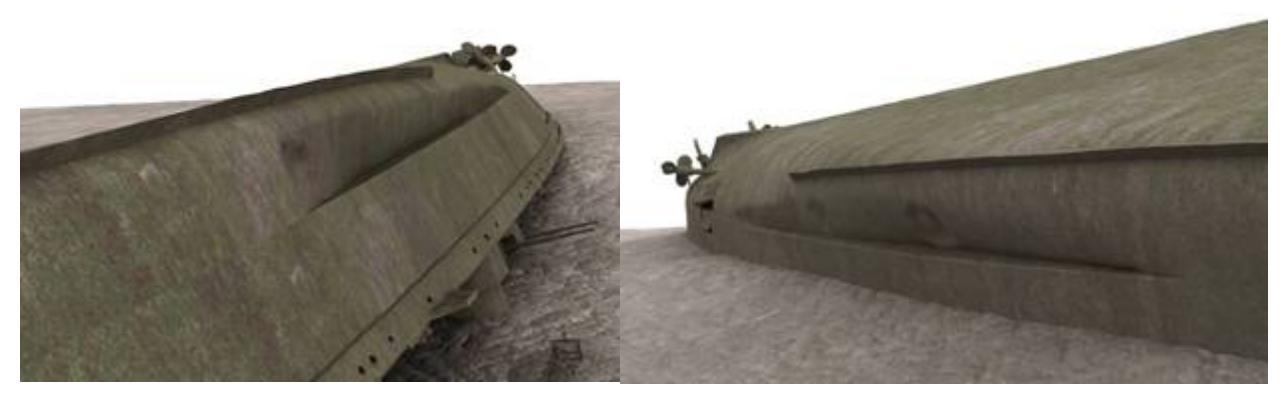
Left. Starboard side hull indentation (also see Figures 7 and 10). **Right.** Port side hull indentation (also see Figures 7 and 9).

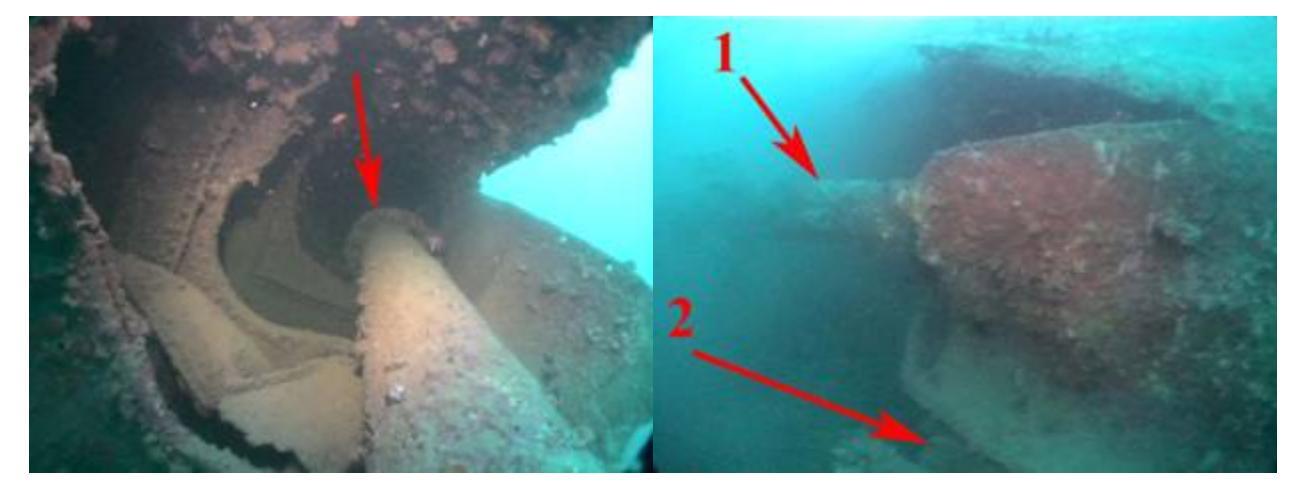
Left. Looking forward along the section of shaft that protrudes from the damaged stern tube receptacle. Note the deformed web frames that supported the stern tube and the intact flange (Flange B, lower plan position, Figure 11) that the diver maneuvered around to gain access to the shaft tunnel proper. **Right**. Viewed from 'outside' the shaft can be seen hanging down 'unsupported' (1) and a split along the hull at the base of the armour belt (2), caused by the effects of the torpedo explosion, can also be seen.

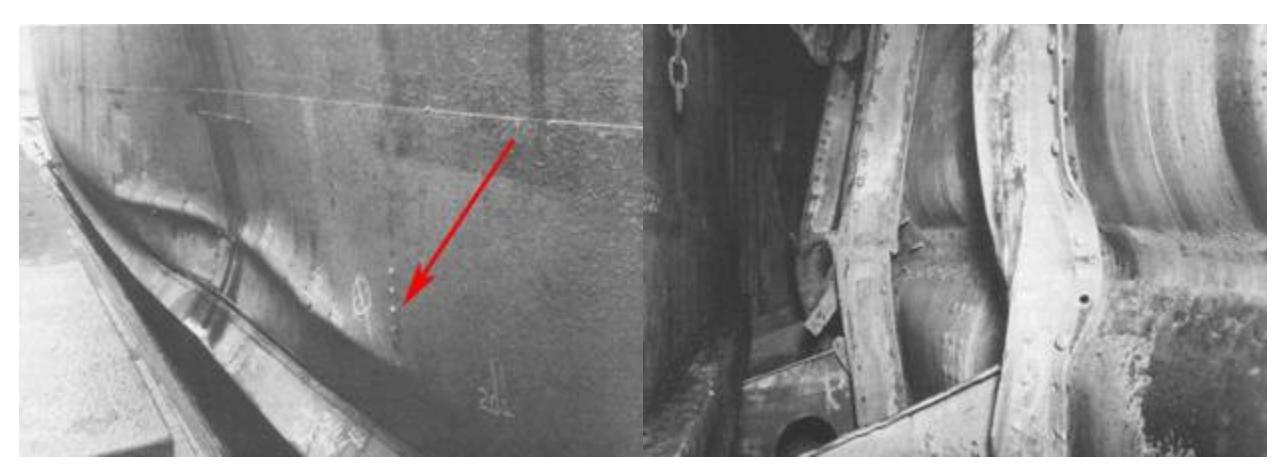
These two photos show the (German) bomb damage sustained to the port side of *Prince of Wales* while fitting out at Cammell Laird Shipyard in 1940. **Left**. Dished in hull plating stretched from Frame 184 to Frame 206 – note the plugs in the way of popped rivets (red arrow). This damage bears a direct resemblance to what has been discovered in both hull sides on the wreck. **Right**. The internal deformation in the area of the damage shown at left and is typical of a compartment of the side protection system.

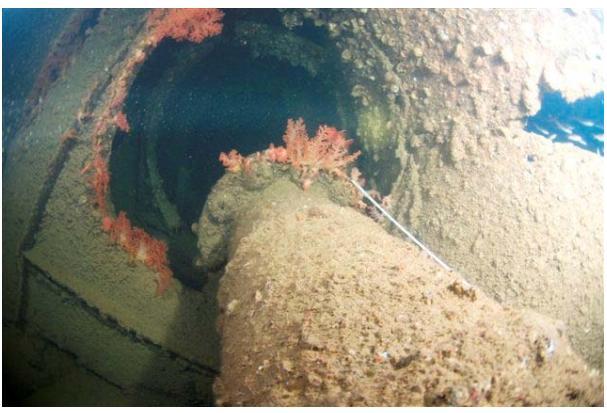
Flange B, now just inside hull where stern tube should be, is the only remaining intact flange on entire shaft.

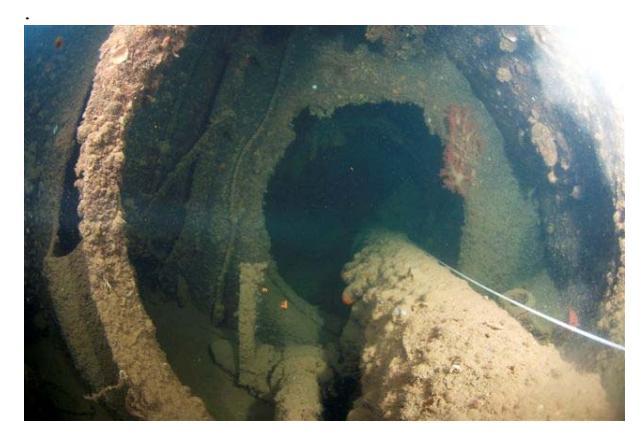
Looking forward at destroyed bulkhead at Frame 270. White 'line' right is the survey measuring tape.

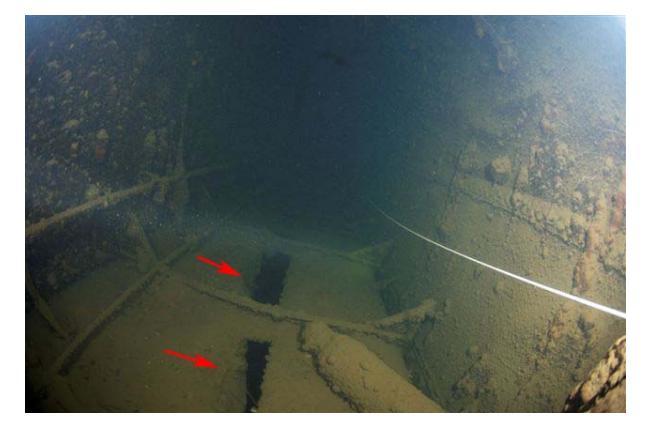
Flange C just out of picture lower right corner; start of large gap between C/C1. Note gaps in deckhead (arrows).

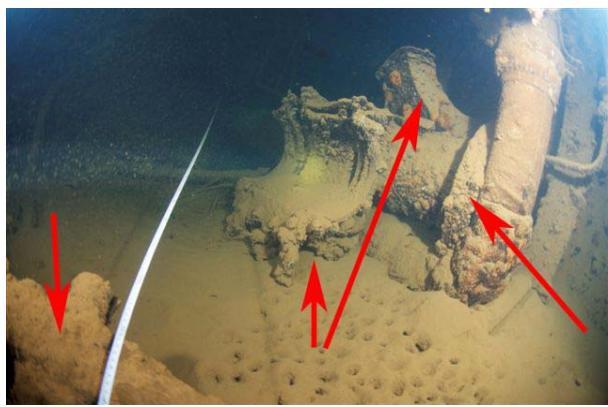
Flange D, left arrow: Remains of Plummer Block, centre two arrows: Flange D1, right arrow.

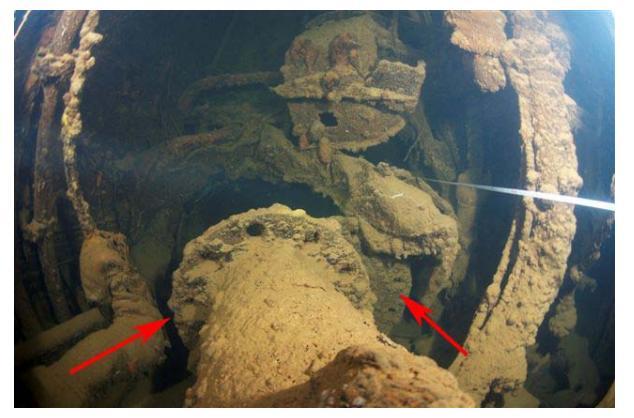
Flange E, left arrow: Flange E1, right arrow. Bulkhead at Frame 206 in background.

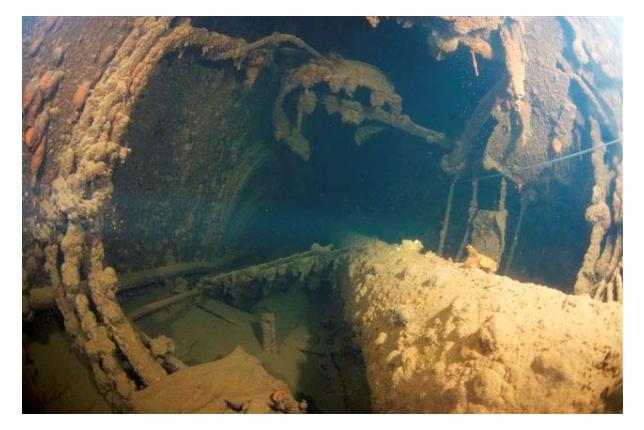
Photo taken immediately after survey diver maneuvered through elongated bulkhead gland at Frame 206

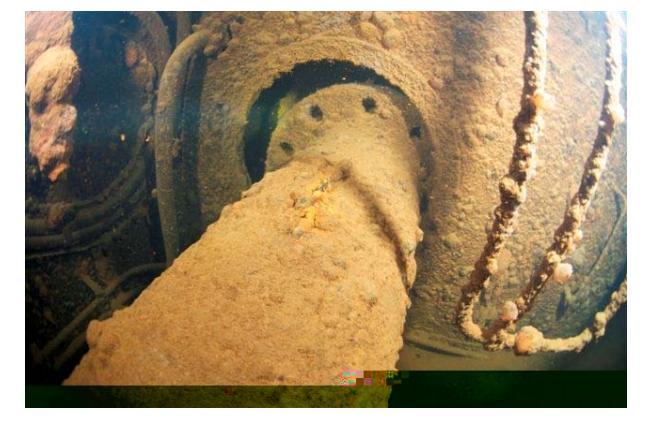
Shafting leading to dislocated Flange F inside Thrust Block enclosure
