DEATH OF A BATTLESHIP THE LOSS OF HMS *PRINCE OF WALES* December 10, 1941

A Marine Forensics Analysis of the Sinking

Garzke - Dulin - Denlay

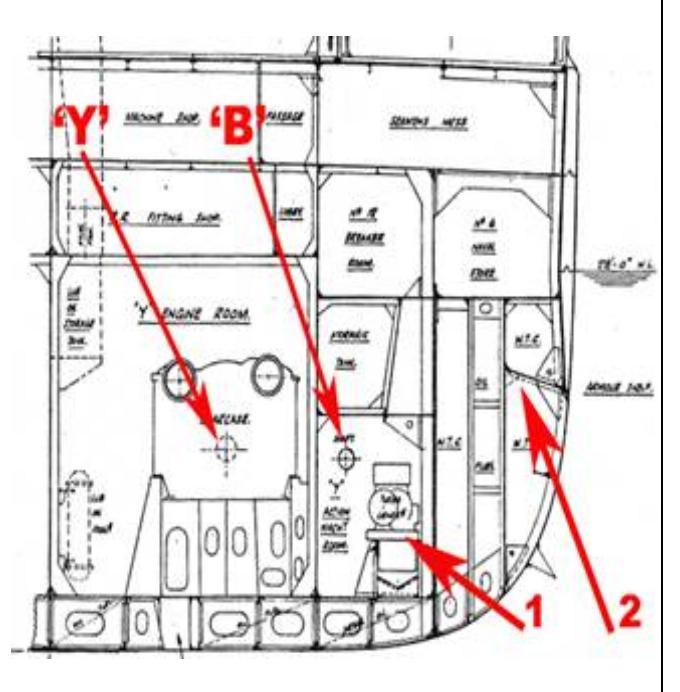
Figure 2 – Transverse Section

This is a transverse section of the ship through "Y" Action Machinery Room looking aft. "Y" Action Machinery Room was part of a long outer shaft alley from "B" Engine Room to the stern tube. Note the positions of "Y" and "B" Engine Room shafts and that the "B" shaft is centered only about 1.25-meters beneath the deckhead of 'Y' Action Machinery Room; as this will be referred to later in the paper. A section of line shaft was also reported to have fallen on the steam dynamo (1) seen against the torpedo bulkhead. Note also the shelf connection (2) that supports the lower portion of the side armor belt and its attachment to the inner bulkhead without proper backing structure.

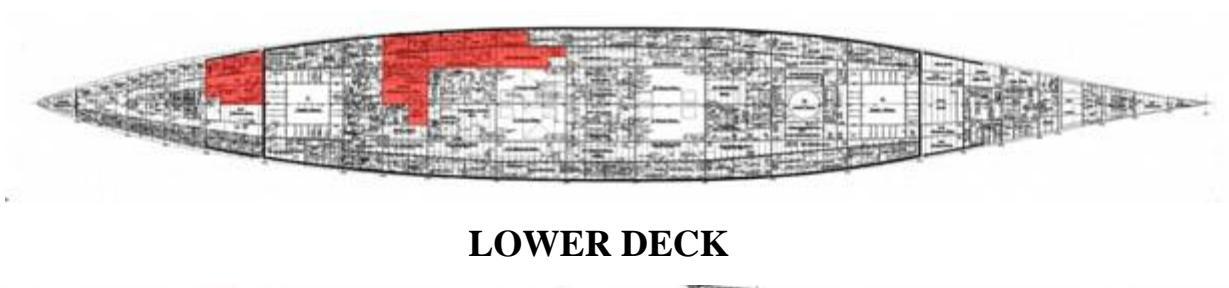
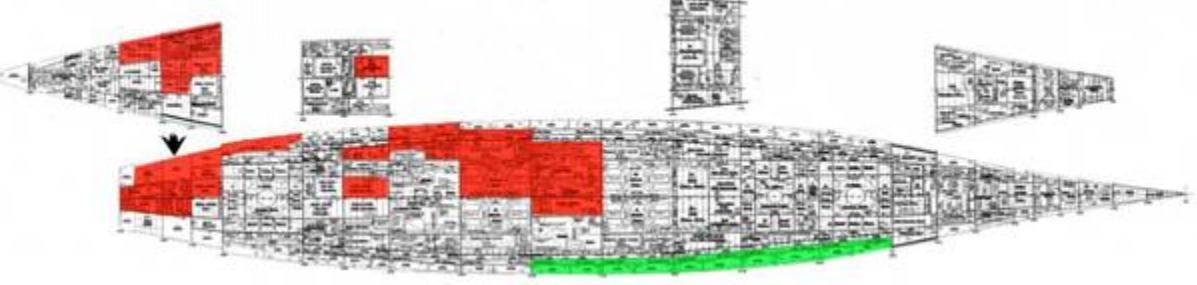
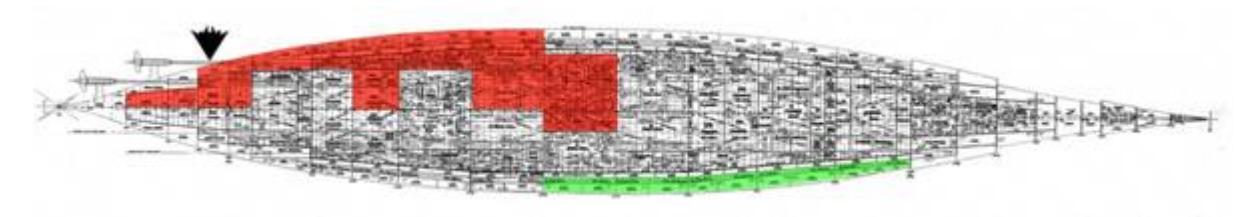
Figure 4 – Flooding Diagrams after First Torpedo Hit

The black arrow head denotes where the first torpedo struck. The red areas in the above lower-level diagrams (Hold, Platforms, and Lower Deck) of *Prince of Wales* denote the areas in the ship that were flooded after the first torpedo strike. The green area is the section of the starboard Side Protection System that was intentionally flooded to try to correct the list and trim after the massive influx of water to port.

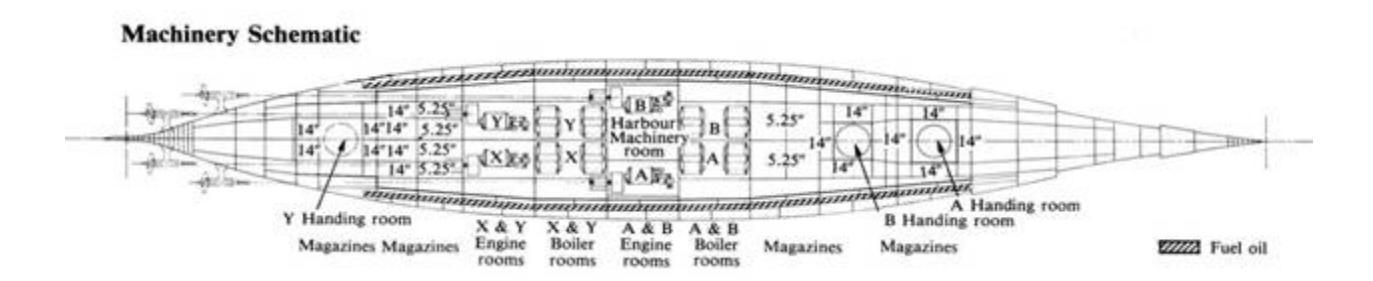
Figure 4a – Machinery and Magazine Arrangements Schematic

The above schematic shows the layout of Boiler Room and Engine Room machinery spaces and the various Magazines for the 5.25-inch and 14-inch guns in relation to one another. Also note how the center section of the "triple layered" Side Protection System was filled with Fuel Oil.

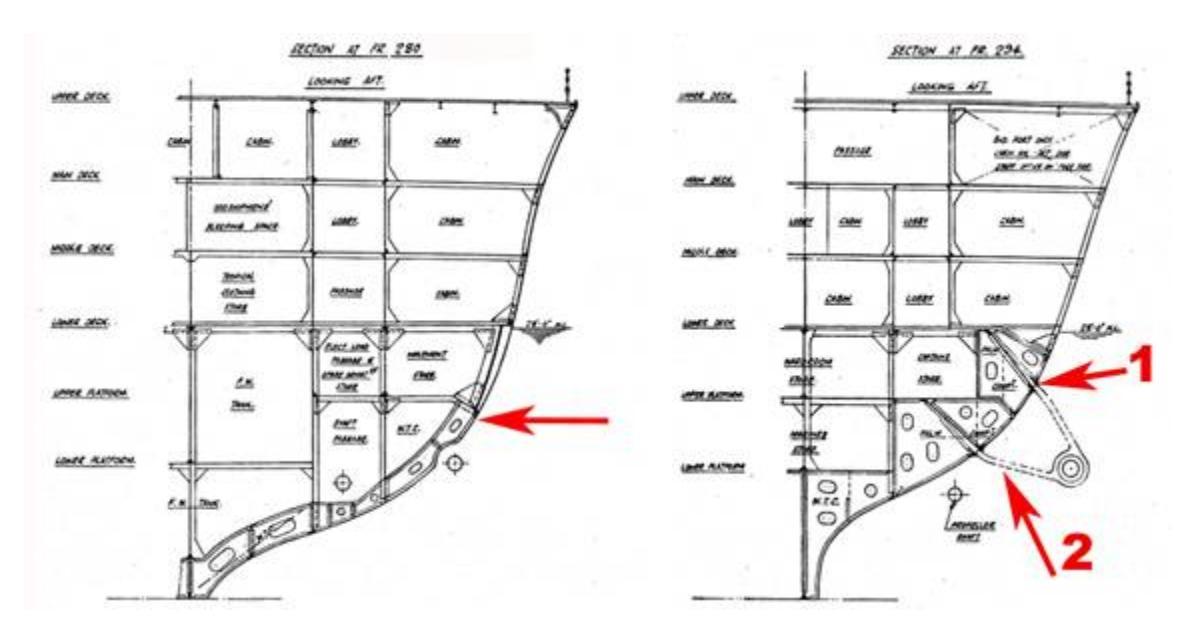
Figure 4c – Cross Sections of Port Hull in Way of Torpedo Hit

Cross sections of port hull at Frames 280 and 294, *looking aft*. Left. The torpedo struck at about Frame 280 just above the outer port propeller shaft (red arrow). **Right.** Frame 294. The outer strut arm (1) of the outer strut eventually broke off flush with the hull while the inner strut arm (2) broke in half. (Note: The later hit above the starboard outer strut broke its arms in the opposite manner, i.e. the outer strut arm broke in half, while the inner strut arm broke off flush with the hull.)

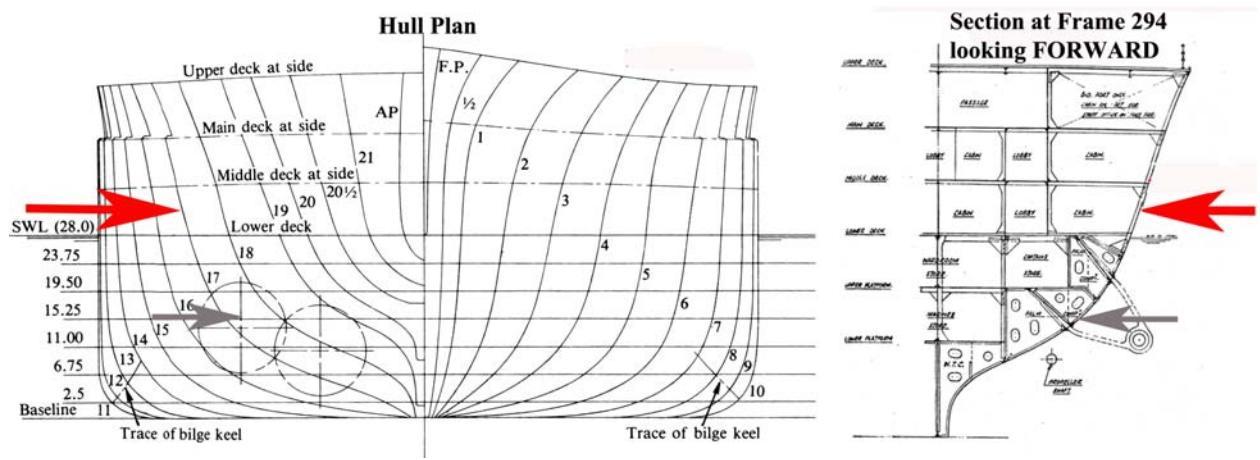
Figure 5a – Height of the Torpedo Hit on Starboard Side Aft

Prior to these three hits to starboard it was thought by some that there was at least a chance the ship could be saved; however we now know from examining the photos of the extensive damage seen right throughout the port outer shaft tunnel (Challen 2009), that this was almost certainly not the case. As can be deduced by how high 'up' the starboard hull-side (Figures 5, 5a and 10) the after-most torpedo impacted *Prince of Wales*, her stern had to have

already settled perilously low for this torpedo to have struck as high (on the hull) as it did. This was the result (of the flooding) from the single torpedo hit well aft on the port side that had resulted in a "mobility kill"; it not only wrecked the effectiveness of *Prince of Wales* as a combatant, it had also effectively sealed her doom through progressive flooding.

The RED arrows above points to the approximate location of the STARBOARD aft torpedo hit. For comparison the smaller GREY arrows points to where the first torpedo hit on the PORT side aft. Note how much higher on the hull the starboard torpedo impacted, which gives an indication of just how far the stern had settled in the thirty five minute interim between the port and starboard aft hits.

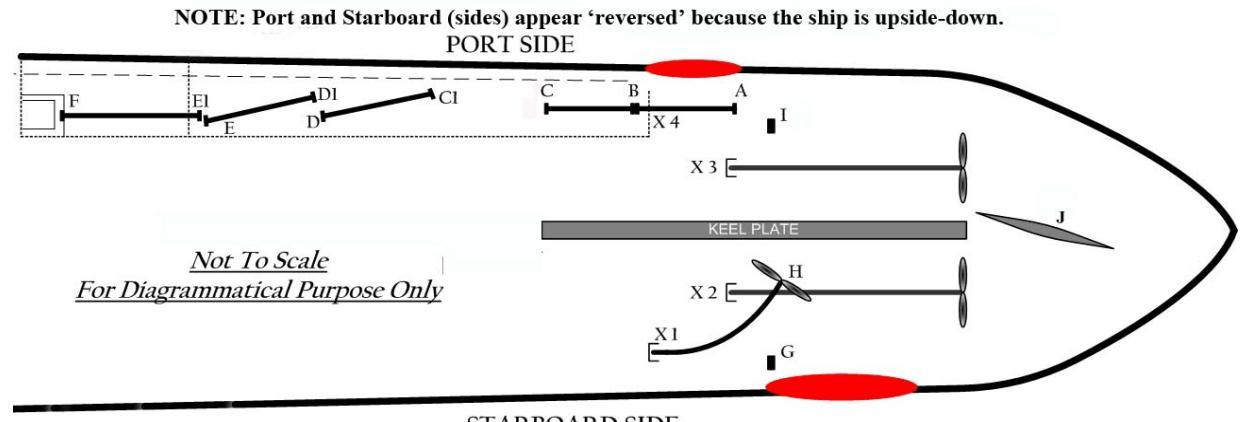
Figure 6 – Illustration of Propeller Shafts inc. Interior of Port Outer Shaft Tunnel

The three torpedo hits on the starboard side nevertheless seriously added to *Prince of Wales* woes, especially the after-most hit, as it negated all the damage-control efforts to complete a flooding boundary in the stern. The flooding they caused did, however, help reduce the list to port from nine degrees (as it was before the three starboard hits) to three degrees. The draft of the ship now increased significantly though, leading to further uncontrollable progressive flooding. With the both outer shafts damaged and the port inner shaft not operational, the ship's speed was cut to 8 knots. (See Figure 6 for the status of shafting as surveyed in 2007, 2008 and 2009.)

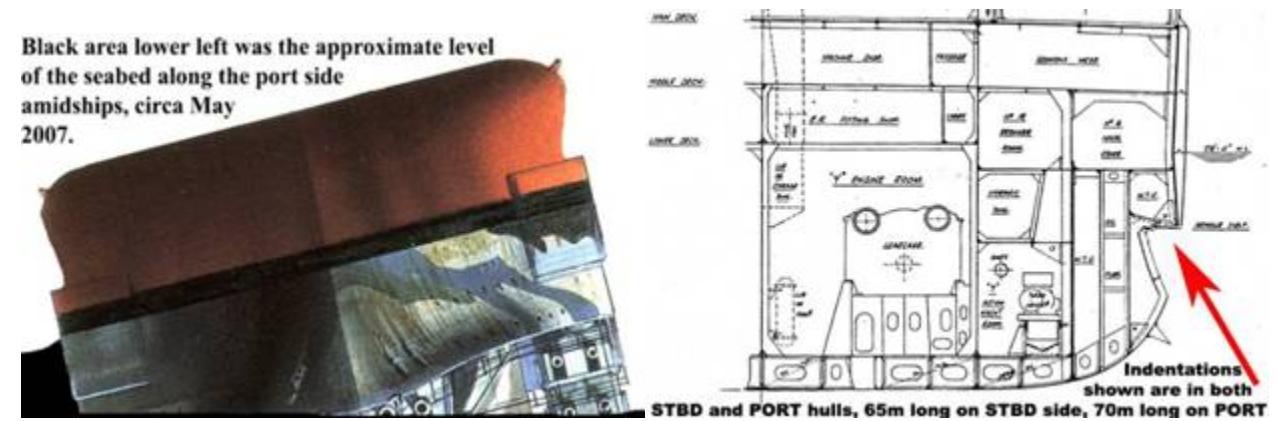
Figure 7 – Prince of Wales at Rest on the Seabed

The 2007 survey also discovered that there was significant longitudinal indentation of the hull plating for 65 meters along the hull on the starboard side of the ship and for 70 meters along the port side hull as well. (Figure 7) This leads to the conclusion that non-contact explosions, either from 'near-miss' bombs or torpedoes, caused considerable indentation on both sides of the ship and flooding of the outer voids through failed riveted seams; as these indentations could not result from the 'implosion phenomenon' as most of these areas were already flooded prior to sinking. Some of the indentations closely resemble the damage that *Prince of Wales* sustained from a near miss 250-kilogram bomb that exploded ten feet (three meters) from the ship's port

Prince of Wales rests upside-down at a depth of 68-meters and is tilted over on an angle of between 15 and 20 degrees to her port side, with the starboard deck edge about 5.5-meters up off the seabed at its highest point amidships. The Expedition 'Job 74' diving team found a 65-meter long concave indentation on the starboard hull and a 70-meter long concave indentation on the port hull just below the side armour belt during their survey of the hull in May 2007 (see also Figures 9 and 10). As shown in the above diagrams the indentations are very concave just below the armour belt, the concavity gradually decreasing down from the armor belt to a point just above the bilge keel. There is also a distinct 'knuckling' of the hull in several places along both port and starboard indentation areas, and very noticeable longitudinal splitting of seams along almost their entire length. (The original survey reports of said hull damage can be

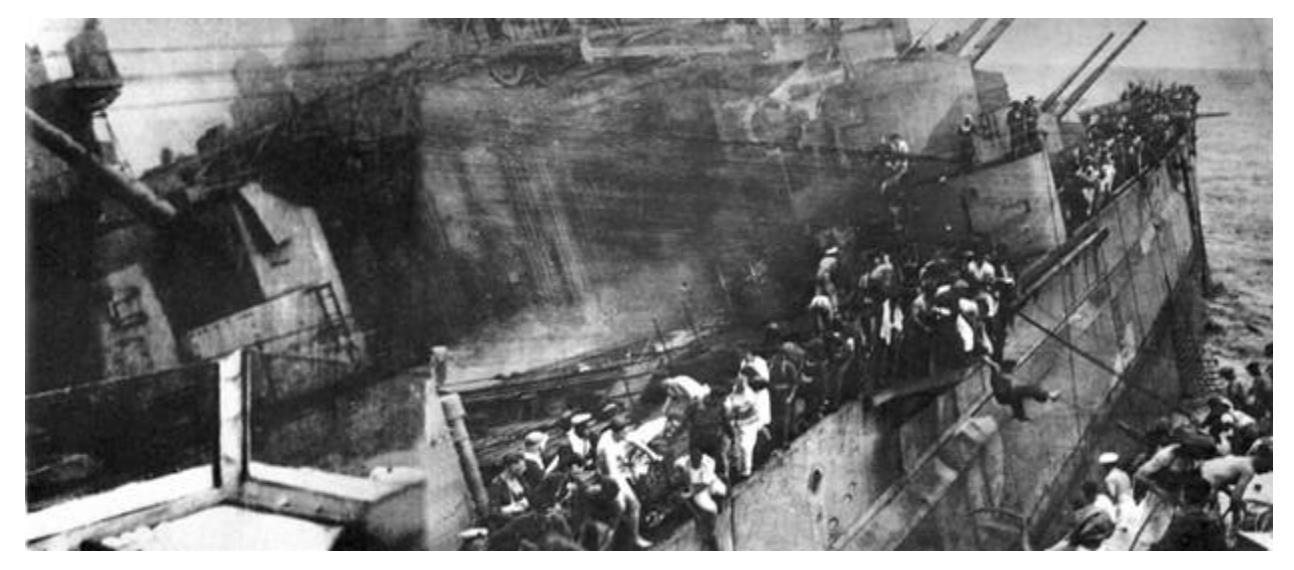
This image is a composite by the author of two photos taken from the destroyer *Express* that came alongside the starboard side to evacuate personnel off *Prince of Wales*. When the battleship capsized, her starboard bilge keel came up underneath the destroyer, causing *Express* to take a very large roll to starboard. Note the high elevation of S1 and S2's 5.25-inch guns (far right) that had fired at the Japanese bombers during the attack at 1244. (Interestingly, the barrels of S2 were found to have snapped off on impact with the sea bed after the ship capsized (see photo page 27), while the barrels of S3 (far left) were not visible during Expedition 'Job 74, having either snapped off and/or were buried under the seabed.)

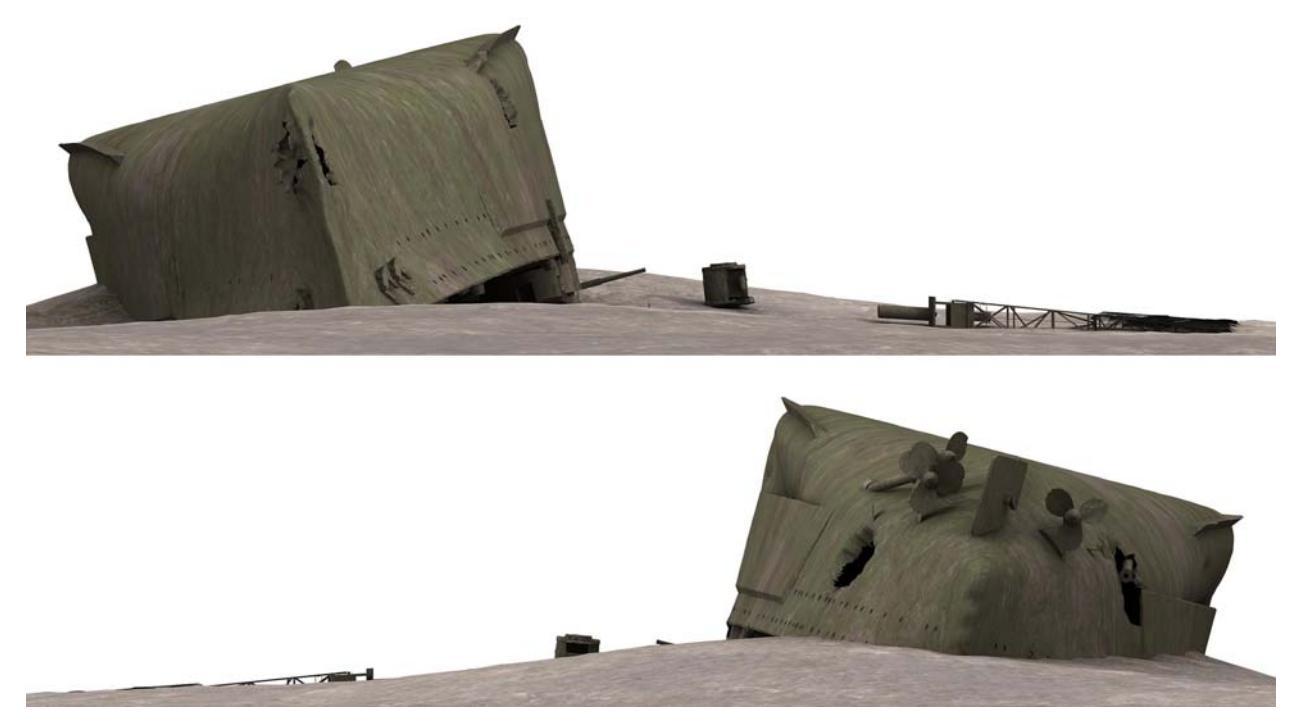
Prince of Wales rests at an average depth to the seabed of 68 meters on soft sand in the South China Sea. She is almost completely inverted with her port side imbedded in the seabed at an angle of about 15 to 20 degrees from the horizontal²⁴.

Above. Two views of what the wreck site looks like if viewed from ahead (top) and astern (bottom).

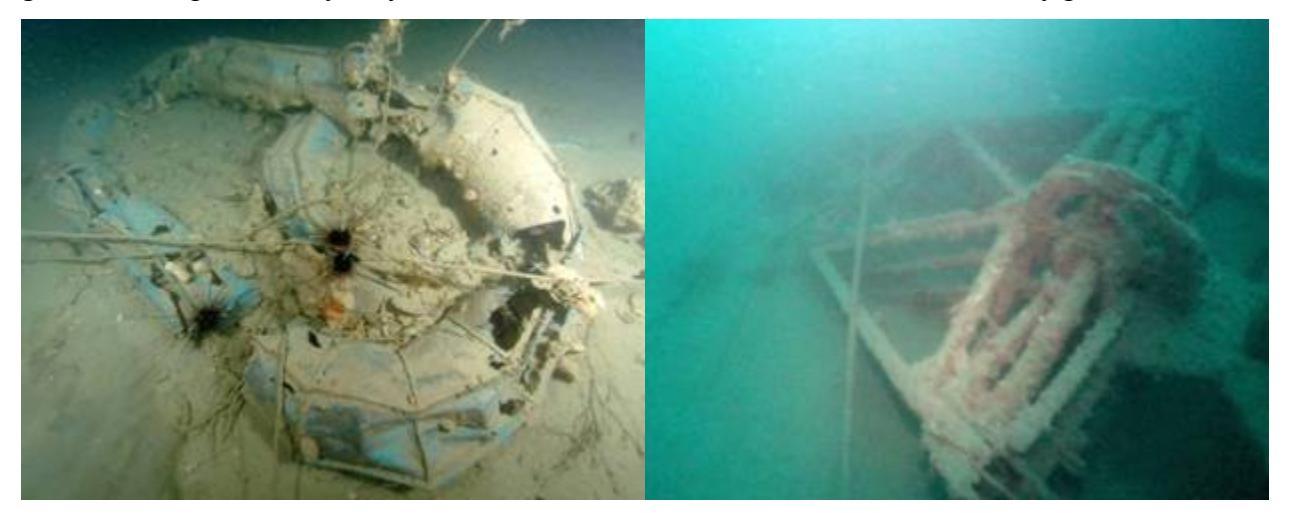
Left. The remains of a Carley float on the seabed near S2 turret. **Right**. A section of the *starboard* aircraft / boat crane lays on the seabed next to the wreck abreast the catapult deck.

The catapult area is 'open' approximately halfway across towards the port side (about a meter or more past the starboard turntable) to where sand has built up over time preventing further exploration in that direction. Several Carley floats (life rafts) can be seen on the seabed beneath the starboard deck near S2 turret, and a small section of a crane lies just outboard from the edge of the wreck in this area also.

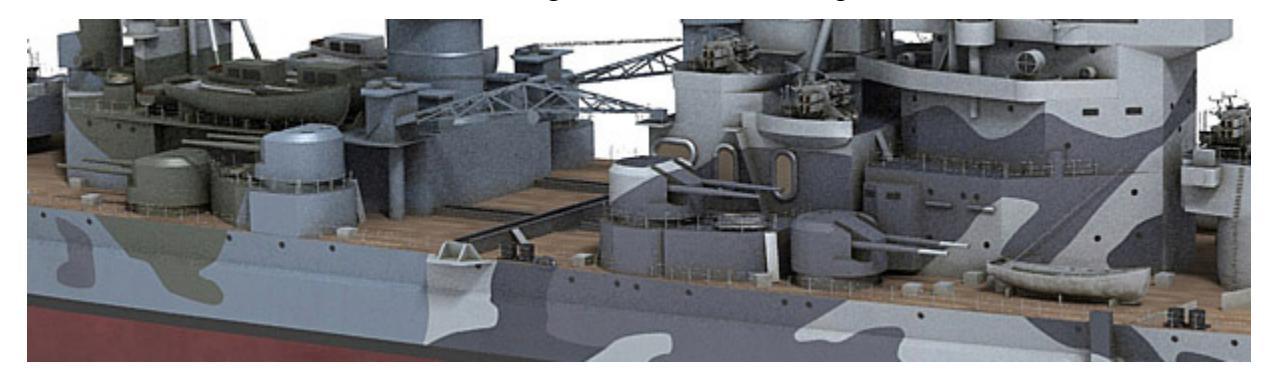
Turret S2 is partially buried in the sand with its casemate and most of the mounting exposed. However, when the ship struck the seabed, the guns broke away from the mounting and now lay beside it on the seabed. This turret is trained forward, pointing off the starboard bow. Turret S1 is well clear of the sand with its guns intact and is also pointed off the starboard bow.

The four starboard 5.25" guns that can be seen on the wreck, right to left, S1, S2, S3, S4.

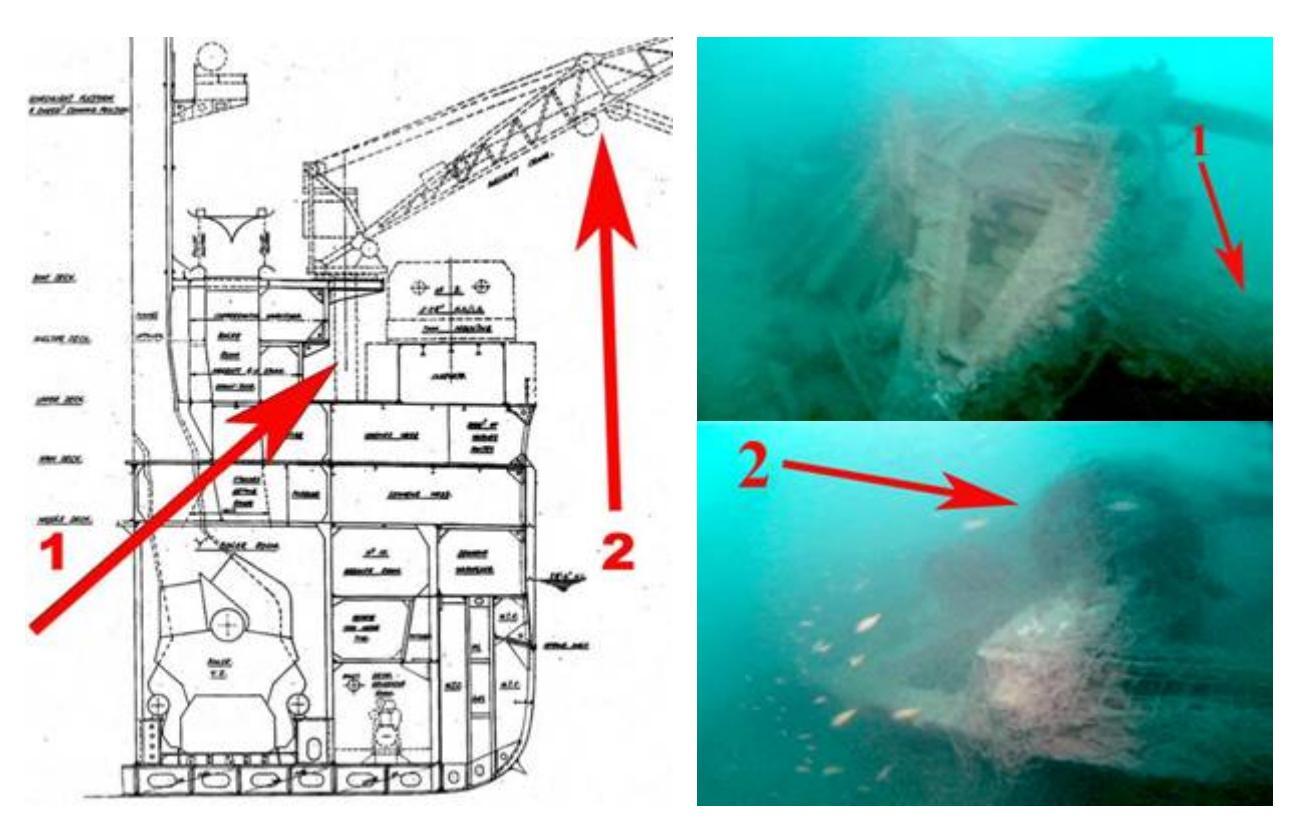
Figure 8 – Bomb Damage to the Port Aircraft/Boat Crane

There is a substantial debris field off the starboard side of the ship aft that is believed not to have been previously noted or explored in any detail. This debris field was explored out from the level of "Y" Turret to approximately 60 meters from the starboard side of the wreck. A major segment of what we believe is the port aircraft / boat crane lies in this field, pointing directly out to starboard and heavily encased in fish trawler netting. The tubular 'strut' on which the crane base rotated (Figure 8) is visible sitting up off the seabed and is only about 10 meters or so from the starboard hull. It is known that one 500-kilogram bomb hit near the port crane and exploded below the deck in way of the catapult – in an area called the Cinema Flat – causing a bulging in the deck structure above and weakening the crane foundation.

One of the seven 500-kilogram bombs released by the Japanese bombers struck on the catapult deck in the vicinity of the port aircraft / boat crane. What is believed to be the remains of this crane lays off the starboard side of the wreck with the tubular base support (1) and pulley wheels (2) clearly visible. Arrows 1 and 2 in the images at the right (which are from video taken at the wreck site) correspond to the same 'items' that Arrows 1 and 2 point to in the schematic.

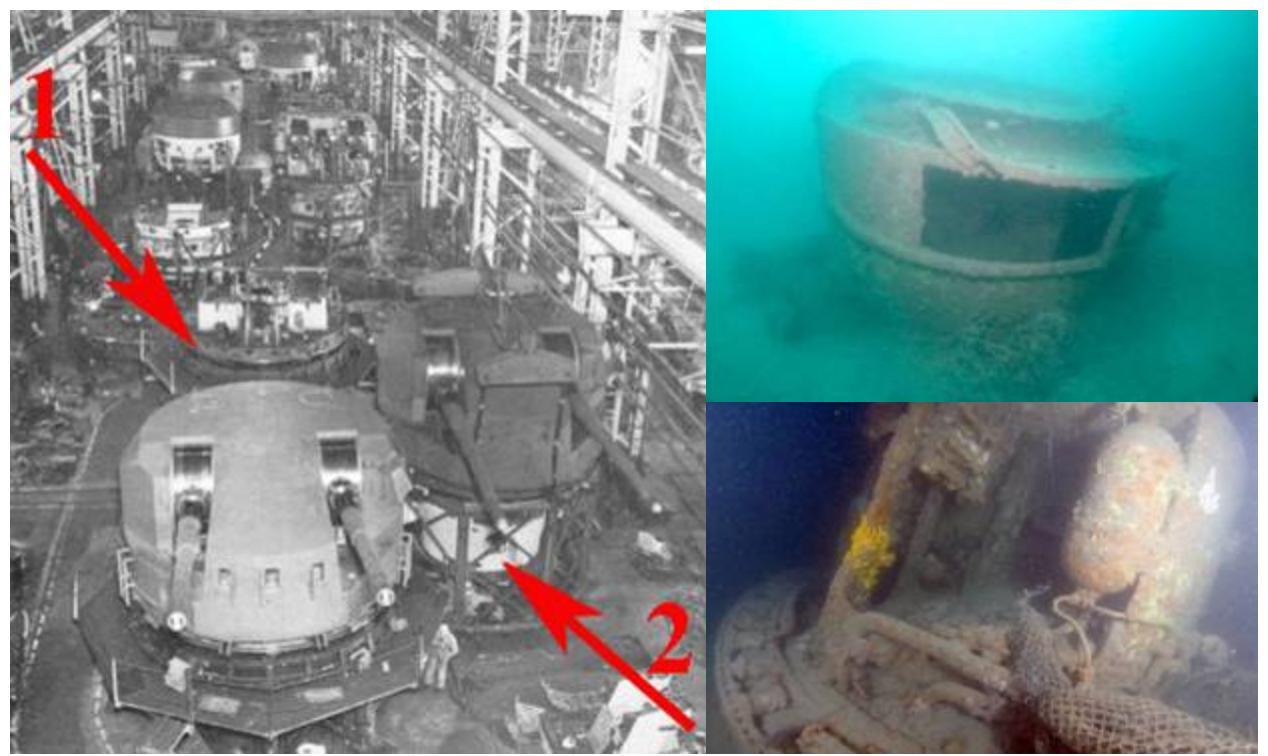
Between the starboard hull and the displaced cranes' location on the seabed is what appears to be one of the port 5.25-inch turrets inverted in the sand (most likely P3) with its rotating ring and working chamber clearly exposed; although the gun chamber itself is completely buried under the sea floor. The only explanation for this structure being there on the seabed is that it must have 'fallen out' from its deck location when the ship capsized. We now know that the foundation for this turret was damaged by the 500-kilogram bomb hit, which in turn allowed it - and the adjacent crane - to fall off during the capsizing process. (Note the statement of P3 Gunners Mate McIvor - page 33 - that the force of the nearby bomb explosion *"lifted our gun turret off its trunion"* (or more precisely "off its roller ring".)

Left. Twin barreled 5.25-inch dual-purpose turrets under construction at the Vickers Armstrong facility. Note the incomplete turret's rotating roller ring in the background left (1) and the working chamber beneath the turret on right (2). For scale comparison note the man standing to the left of arrow 2. Top right. The inverted 'working chamber' on the seabed as seen if approached from astern. Bottom right. A close-up of the chamber, but as seen when approached from forward; note the 'roller ring' at bottom left.

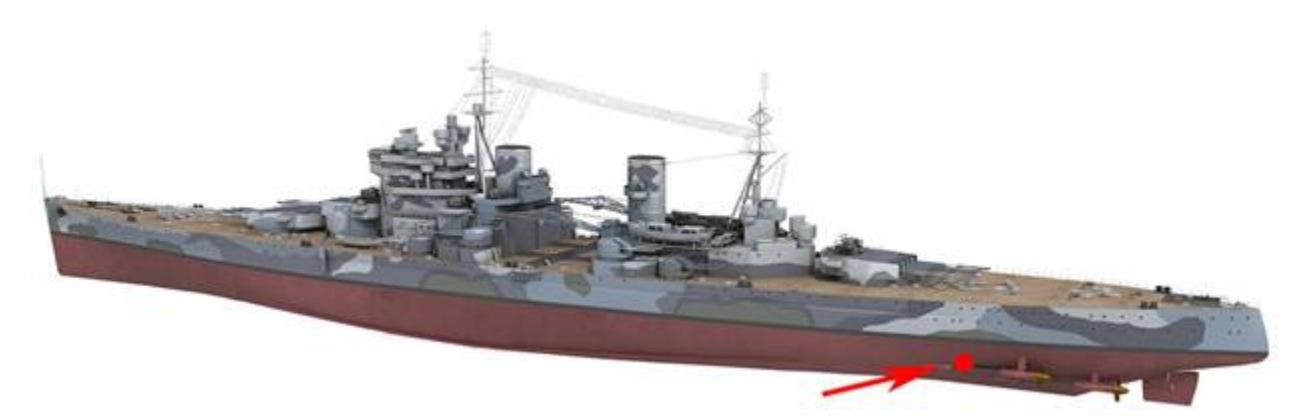
PORT SIDE TORPEDO HIT

On the port side aft there is a single torpedo hole approximately 4 meters high and 6 meters long extending aft from just forward of where the outer shaft exited the stern tube gland (this hole is centered at approximately Frame 280, Figure 1):

The initial damage was mainly confined to the outer hull structure, strut, and propeller. However, damage from the torpedo explosion also extended into the ship and forward into the outer stern tube receptacle, and the damage there was particularly devastating. No ascending water column was seen from this hit (apparently because of its location well under the hull).

- a) The blades of the propeller for the port inner shaft are missing large pieces of their edges, indicating that they were struck by debris from the initial torpedo explosion or by either the outer propeller or other debris when it broke away.
- b) The port outer shaft has come apart at the flange about 8 meters forward from the opening in the stern tube where the shaft emerges (Flange 'A', Figure 11). The receptacle for the stern tube has been ripped open large enough for a diver to enter forward along the shaft, and has a rip or tear on the outboard side which extends forward about two meters. The damaged web frames in the stern tube receptacle are now clearly visible, as is the one remaining intact flange (Flange 'B', Figure 11).

- c) There is a plate of armor collapsed inwards at the forward edge of the hole. Another plate just aft stands somewhat vertical, and appears precariously balanced. The hull forward and aft of this hole is significantly damaged and distorted for approximately 2 meters in either direction.
- d) The September 2009 excursion up the port shaft alley revealed the damage caused by the shaft rotating out of center, which was caused by torpedo damage to the stern tube, propeller shaft, and strut. The holes in transverse bulkheads at Frames 206, 228, 242, and 253 are huge, some 4-6 feet in diameter. Several hatches were discovered opened either from the intense water pressure or left opened by escaping crew. In the latter case, if the hatch had been quickly dogged and not firmly closed, the water pressure would have sprung them open.

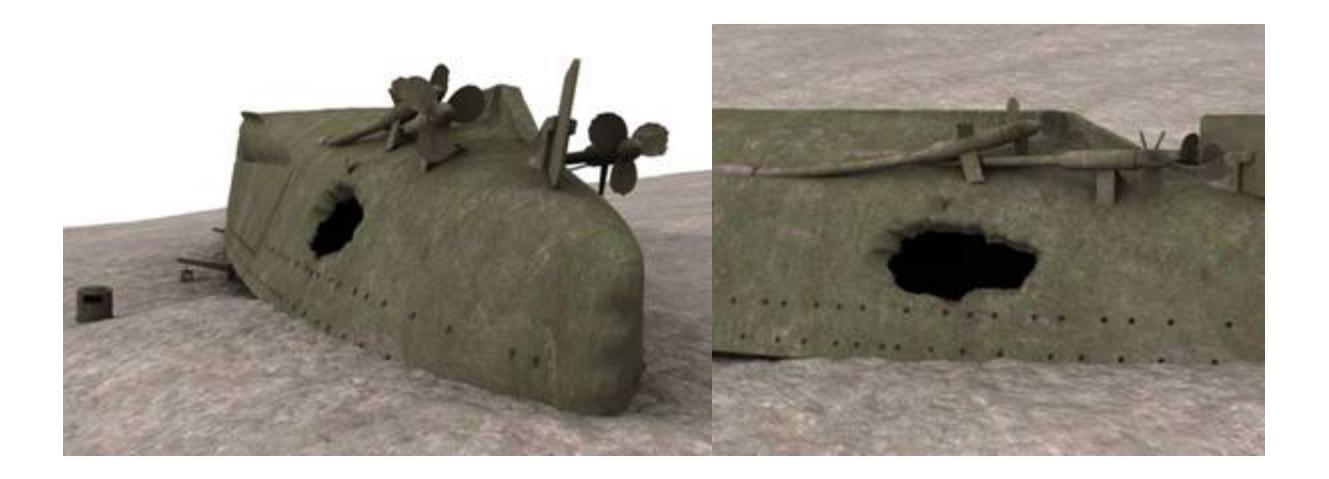
There are three well-spaced torpedo hits along the starboard side. Just which one was the last to hit is still a point of contention between authors and historians. The shaded area abaft the fore-funnel is the concave section of the hull as shown in Figure 7. Note again how much higher the aft hit is because of the stern having settled following the flooding from the first hit to port aft.

Of the three starboard hits the after-most one was the most serious (*the after-most hole is centered at approximately Frame 296, Figure 5*), the forward two being somewhat superfluous in the cause of her demise.

- a) The outer shaft strut is broken and the propeller (still attached to its shaft) and the remains of the strut are wedged over the inner shaft. (When the ship was upright this would actually have been, in reality, wedged 'below' the inner shaft.) The outboard propeller shows considerable damage to its edges as it was still rotating when it was jammed into its present position. The outer shaft struts' *inner* strut arm now points *laterally* down across the inner shaft, while the *outer* (half strut) points upwards. The remaining half of the outer strut arm is still attached to the hull just above the torpedo hole, while the inner strut has snapped off cleanly where it joins the hull.

- b) There is a hole approximately 4 meters high and 11 meters long in the area of the hull above the remains of the outer shaft struts outer arm. This indicates that the torpedo struck the ship on the hull above and only just abaft the *outer* strut arm and in comparison to all the other torpedo hits, this damage is located much higher on the hull side. This also

- c) The torpedo damage extends into the ship, with decks visible inside the hole.
- d) There are rips and tears in the surrounding plates and supporting structure that have been pushed in fore and aft of the hole for about two meters in either direction.

e) The flooding boundary that had been established before this hit occurred was now destroyed. Prior to this hit, the aft end of the quarterdeck had already been precariously close to the waterline and this hit now added even further to the 'down by the stern' trim. As the stricken battleship trimmed down more by the stern, the quarterdeck level settled into the water. The ship's remaining stability and buoyancy were now seriously compromised.

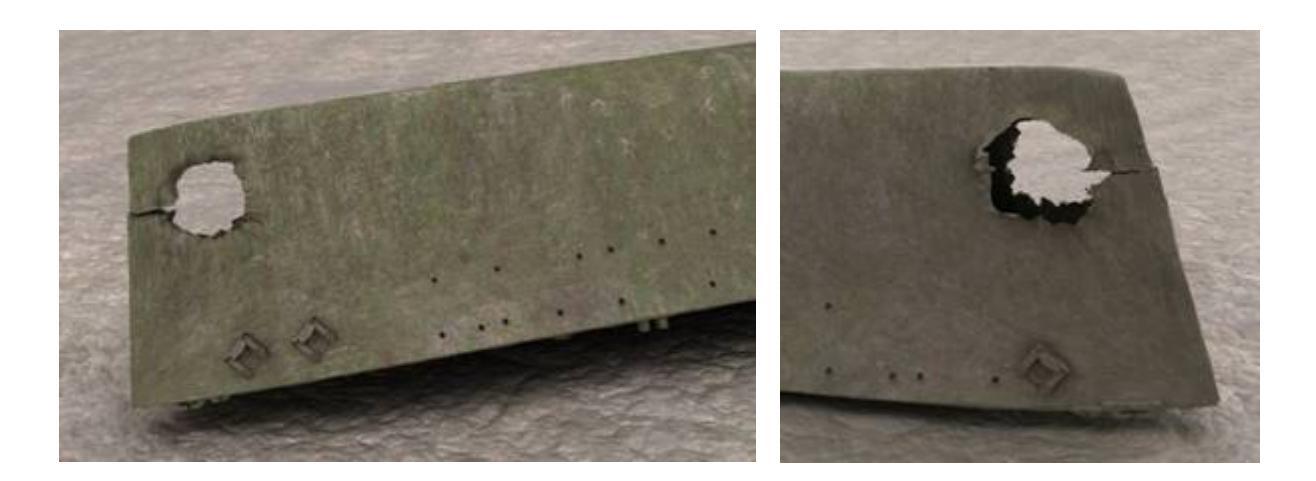
There is a ragged hole approximately 7 meters in diameter through the bow of the ship (*the hole is centered at approximately Frame 8*). The plating is bent outward to port implying a starboard torpedo explosion and the stem post is fractured, indicating just how far forward this torpedo hit. There is often a considerable amount of fouled/discarded trawler netting to be seen around this hole.

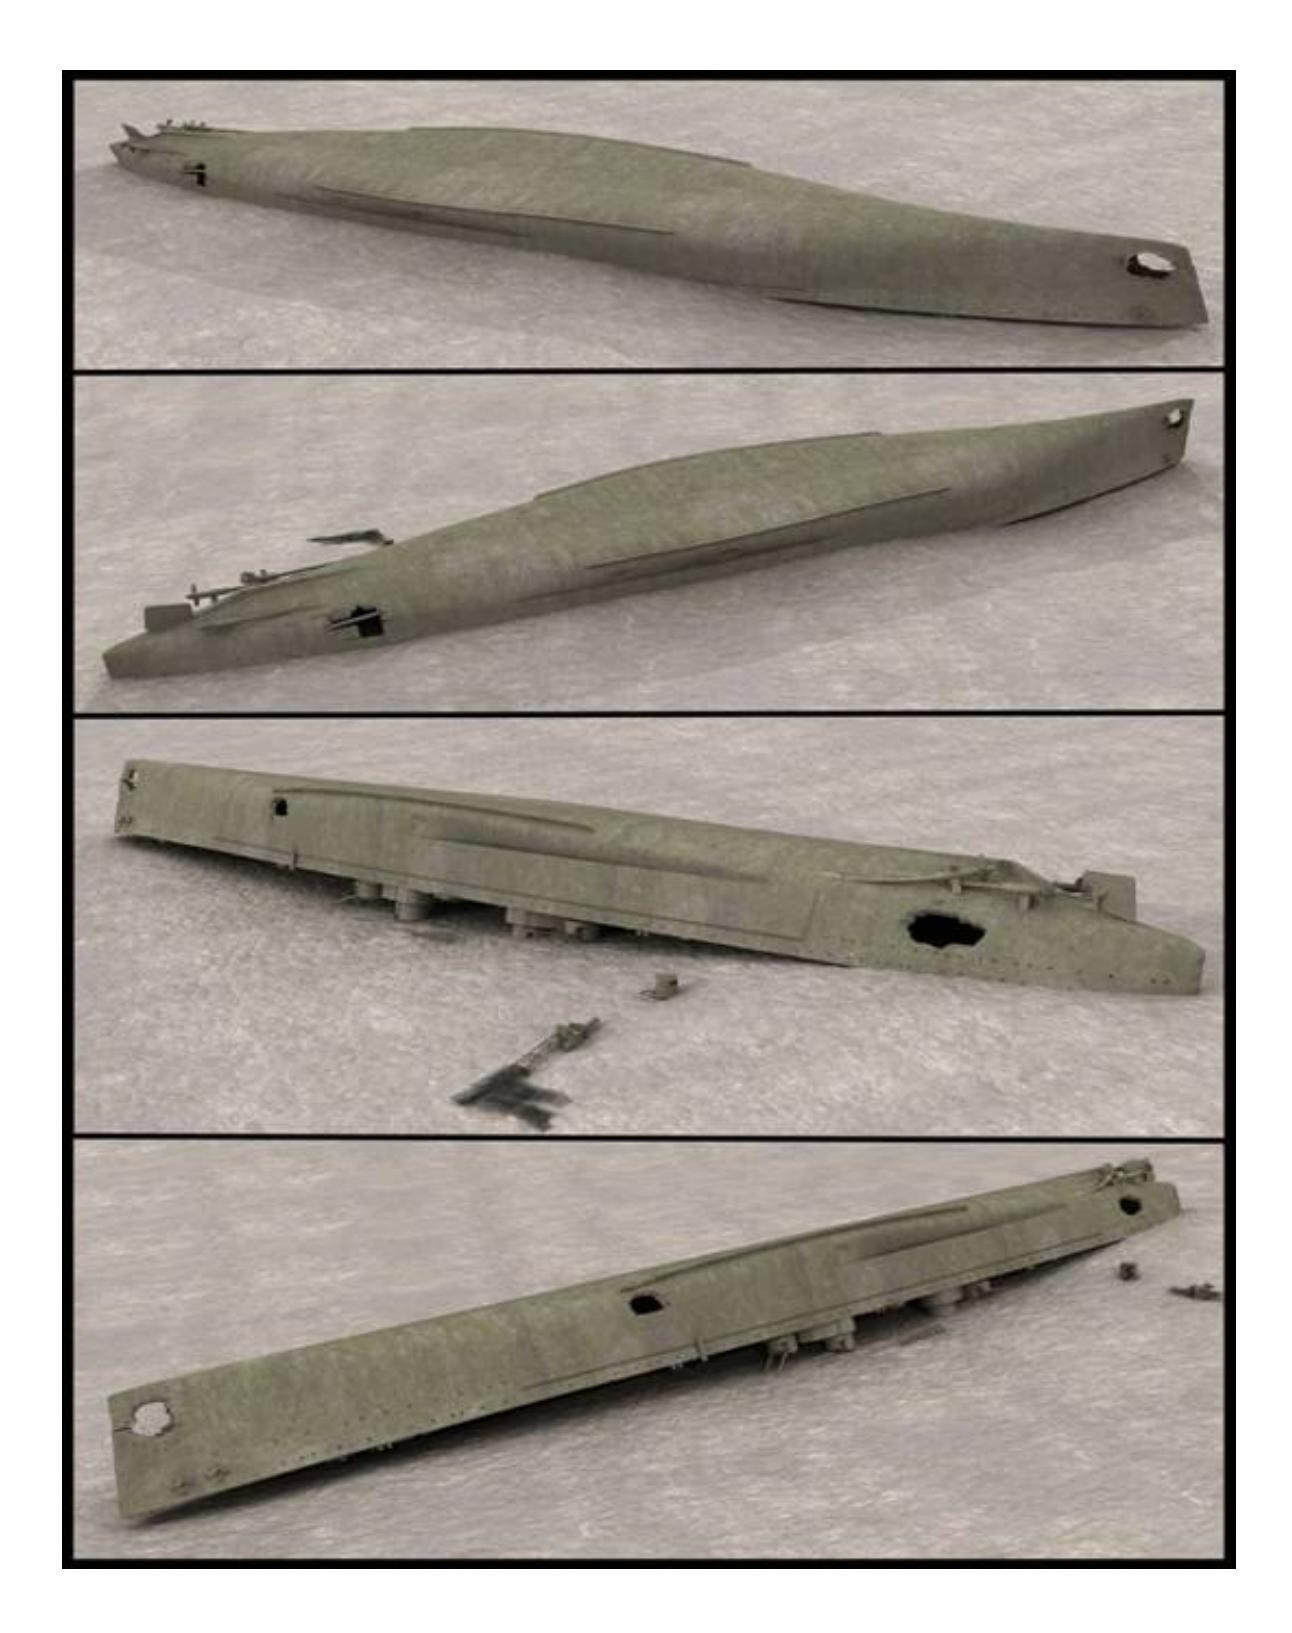
The wreck of HMS *Prince of Wales* shown from various angles as seen at the time of the Expedition 'Job 74' survey; May 2007.

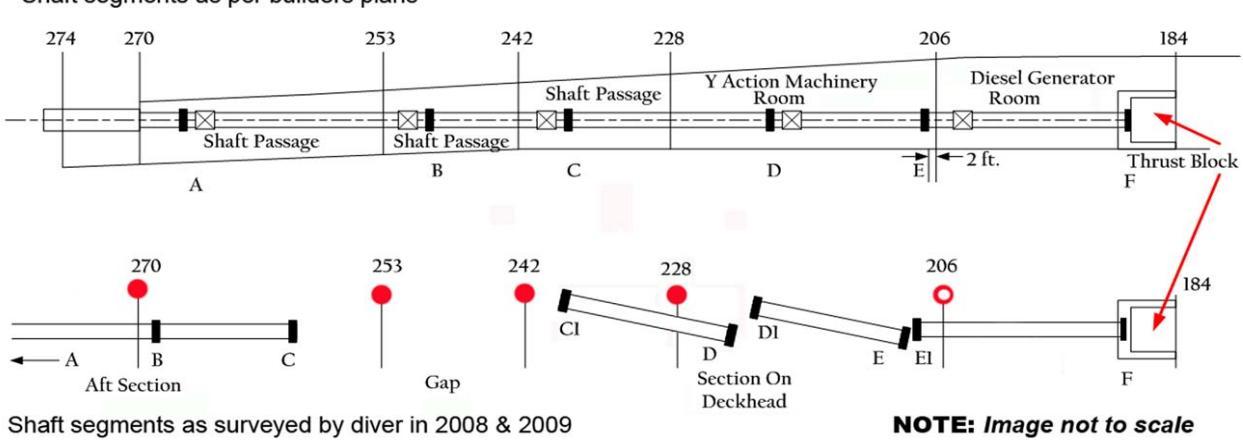
Figure 11 – Illustration Comparing the Port Outboard Propeller Shafting

A comparison of the intact port outer shaft (upper) and the separated sections as surveyed (lower), with bulkhead frames numbered and flanges marked A, B, C, D, E, F. Flange B is the *only* flange that remains intact aft of the Thrust Block itself; the length of shafting missing (approximately 17-meters) aft of Flange A having separated with the propeller when it broke away. The distance across the gap between separated Flange C is approximately 14-meters (C to C1). Solid red dots indicate the destroyed bulkheads along the shaft tunnel, while the outlined red dot (frame 206) indicates a partially destroyed bulkhead.

It is now clear that the shaft failed at the four consecutive flanges aft of the Thrust Block / Engine Room bulkhead; i.e. the forward flange in the Diesel Dynamo Room at the Thrust Block (*Flange F*), the flange in "Y" Action Machinery Room just aft of the bulkhead to the Diesel Dynamo Room (*Flange E, Figure 11, inboard Frame 207*), the flange *towards* the aft bulkhead of the "Y" Action Machinery Room (*Flange D Figure 11, inboard Frame 221*), and the *next* flange aft of "Y" Action Machinery Room (*Flange C, Figure 11, inboard Frame 239*). [At this point it can be seen that not only has the shaft separated at this flange, but the intact section of shaft (two lengths) further aft has also been pulled aft-wards from this flange – and partly out through the stern tube receptacle - when the separation took place.] The next flange aft of this 'break' remains intact (*Flange B, Figure 11, inboard Frame 251*), but is now situated in the damaged stern tube receptacle (*inboard of Frame 272*), i.e. approximately fourteen meters further aft than it should be located. The 'final' flange on the shaft, that was situated just inside the shaft passage itself also failed (*Flange A, Figure 11, inboard Frame 266*) and when the propeller broke away it took with it the stern tube and the approximately seventeen meters of

This, then, is the flange now seen on the end of the length of shaft protruding from the damaged stern tube receptacle that was first identified by John Roberts. So, all told, the port outer shaft parted at five separate flanges: one just forward of the stern tube, one two shaft lengths up the shaft tunnel, one at the end of the next length of shaft, one at the end of the next length of shaft where it abuts the Diesel Dynamo Room bulkhead, and one at the Thrust Block housing itself.

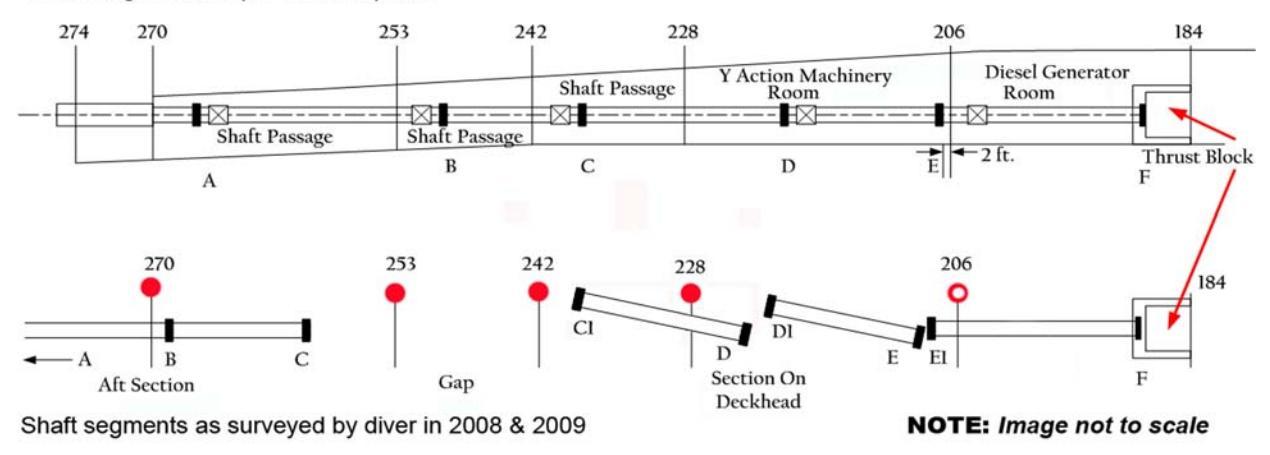
Figure 11 – Illustration Comparing the Port Outboard Propeller Shaft

The outboard shaft strut arms were weakened by the force of the explosion and a ragged hole was torn in the hull plating approximately four meters high and six meters wide just abaft the stern tube, and the shaft itself was damaged. The stern tube was also damaged (See Figure 1), but its degree of damage is not known, nor will it be until that missing section of shafting and the associated stern tube structure is found for further examination. The outer port propeller continued to rotate at high speed and, turning out of center, started to wobble and vibrate, putting additional stress on the weakened strut.

A comparison of the intact port outer shaft (upper) and the separated sections as surveyed (lower), with bulkhead frames numbered and flanges marked A, B, C, D, E, F. Flange B is the *only* flange that remains intact aft of the Thrust Block itself; the length of shafting missing (approximately 17-meters) aft of Flange A having separated with the propeller when it broke away. The distance across the gap between separated Flange C is approximately 14-meters (C to C1). Solid red dots indicate the destroyed bulkheads along the shaft tunnel, while the outlined red dot (frame 206) indicates a partially destroyed bulkhead.

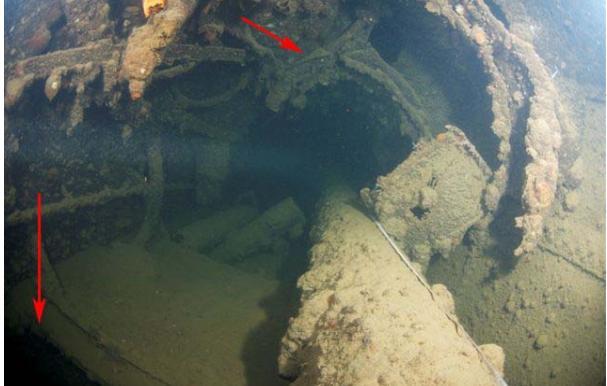
Lower arrow points to an open hatchway in deckhead, upper arrow to the remains of a Plummer Block.

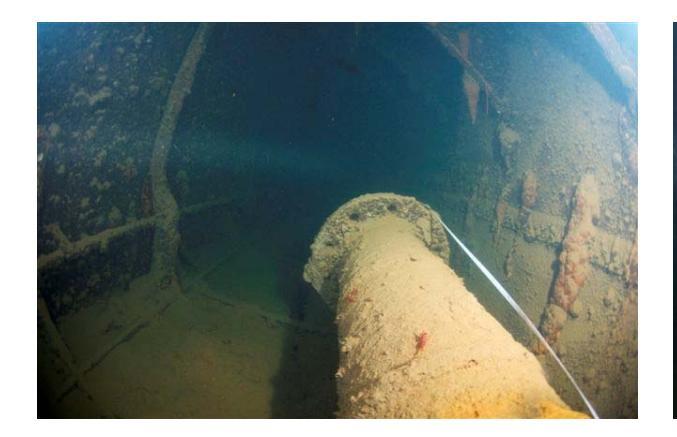
Looking towards / past Flange C.

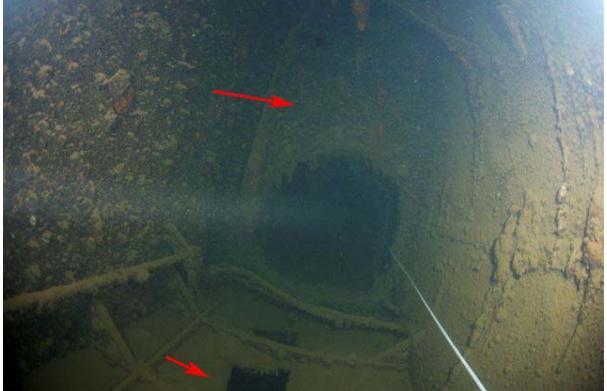
Looking towards remains of bulkhead (upper arrow) at Frame 253. Gaps in deckhead lower arrow.

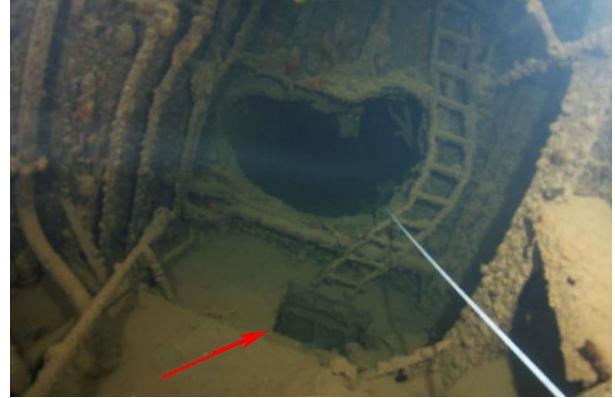
Bulkhead at Frame 242. Arrow points to an open deckhead hatchway. Another deckhead hatchway also remains open just behind (forward of) Frame 242

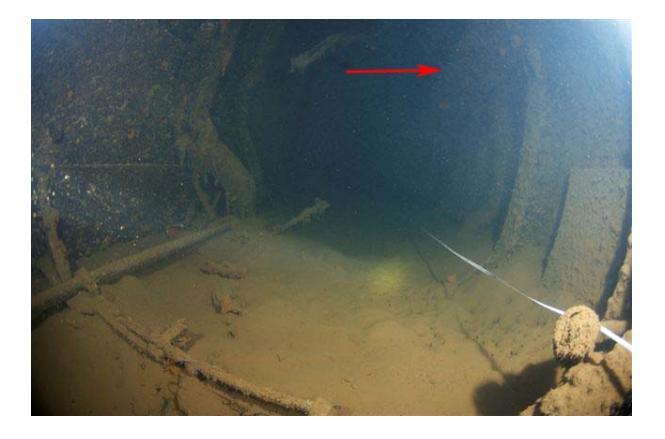
After this chain of events, there is a large gap which we now can see between the separated halves of Flange C (C/C1).

Arrow points to Flange C1, barely visible in upper right center

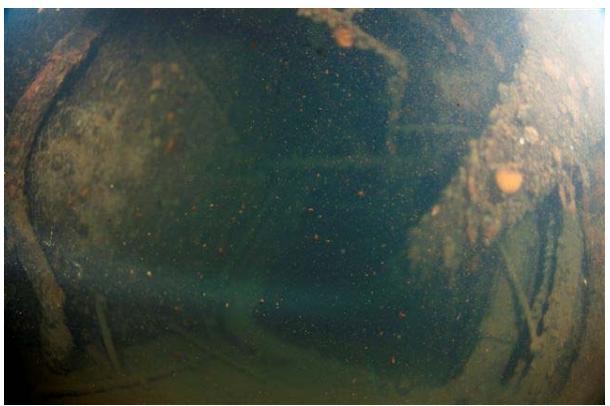
Shaft on angle at right, Flange C1 is just out of picture in upper right corner.

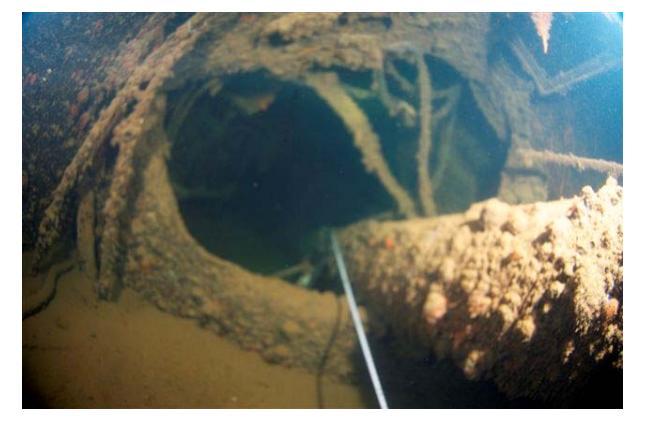
Aft bulkhead (Frame 238) of Y Action Machinery Room.

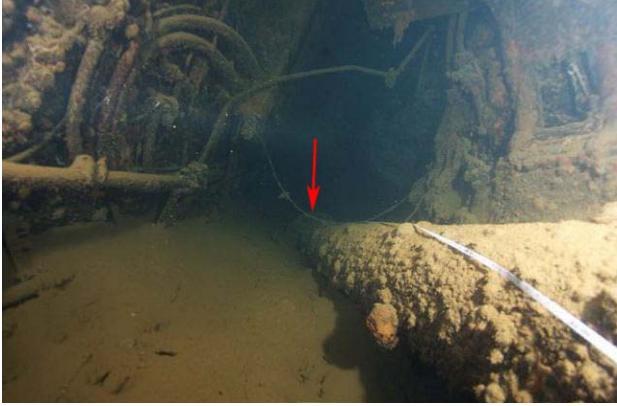
Arrow points to Flange D

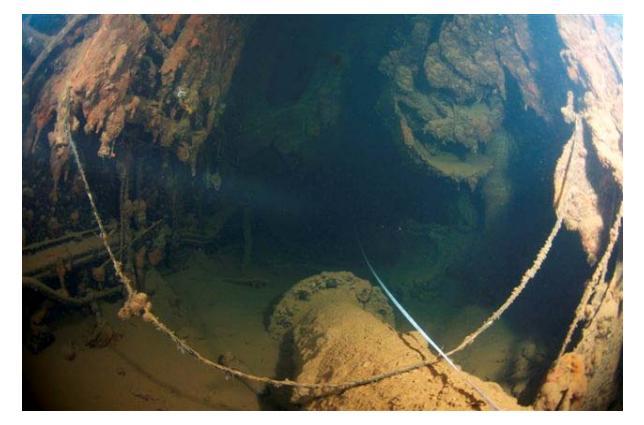
Flange D center, inside Action Machinery Room.

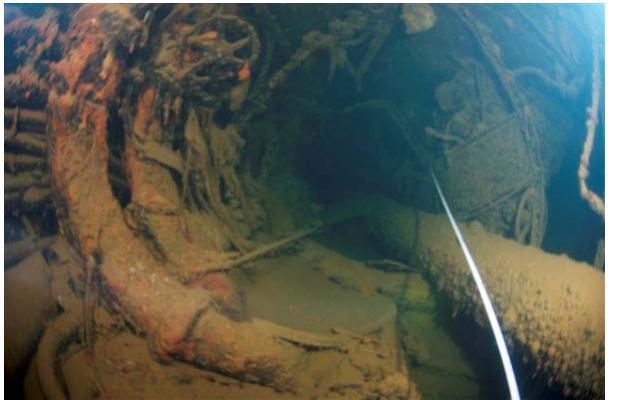
Shaft in Action Machinery Room

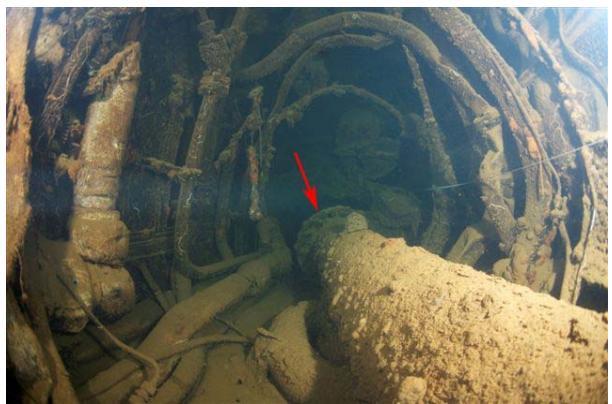
Arrow points to Flange E
