DEATH OF A BATTLESHIP THE LOSS OF HMS *PRINCE OF WALES* December 10, 1941

A Marine Forensics Analysis of the Sinking

Garzke - Dulin - Denlay

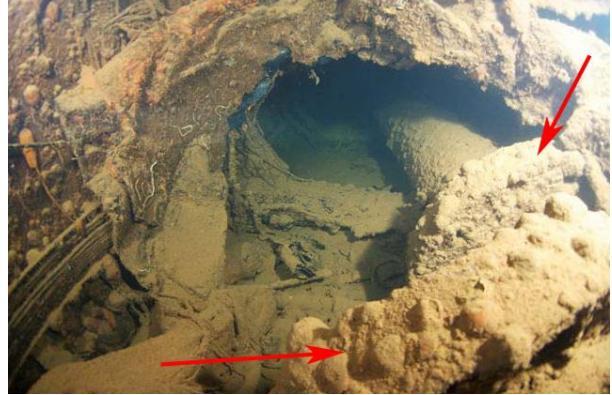
Flange E, left arrow: Flange E1, right arrow. Elongated gland in aft bulkhead to Diesel Dynamo Room (Frame 206) which survey diver squeezed through in 2009 (to continue his 2008 survey) in centre background.

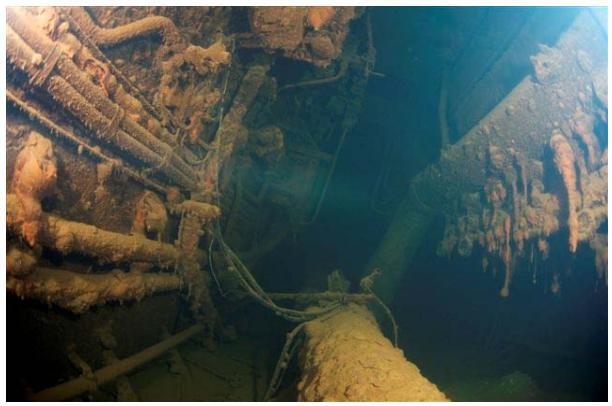
Shaft (at bottom) further into the Diesel Dynamo Room

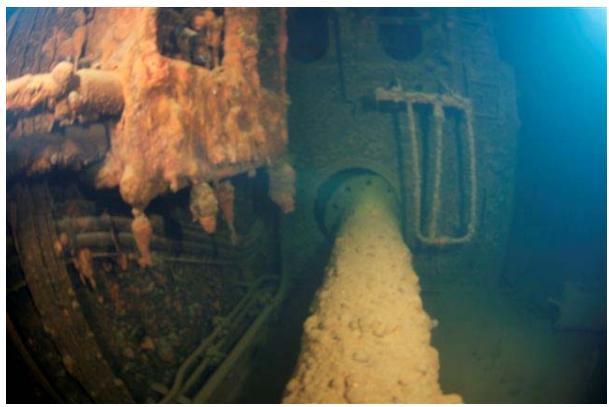
Looking further along shaft to Thrust Block enclosure

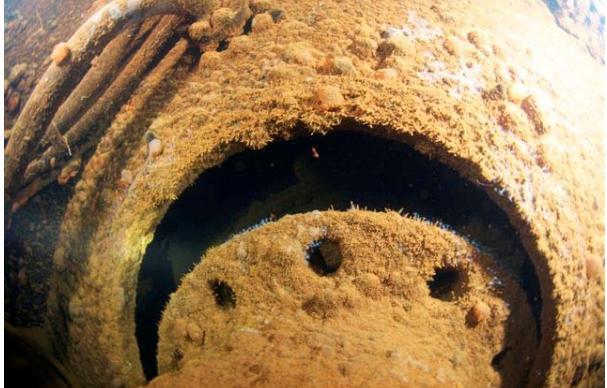
At the same time that all the foregoing was happening aft of Flange C, the shafting forward of Flange C starts flailing and begins to separate at all its flanges (D, E, F). However, given the failure at Flange C, there is no force available to pull these sections aft, so they basically fell in place, where we see them now and there are only small gaps between the several flange halves. This process happened almost instantaneously, hence with less and less damage to the bulkheads the further forward you go.

Flange F can be seen here completely 'dislocated' from the Thrust Block.

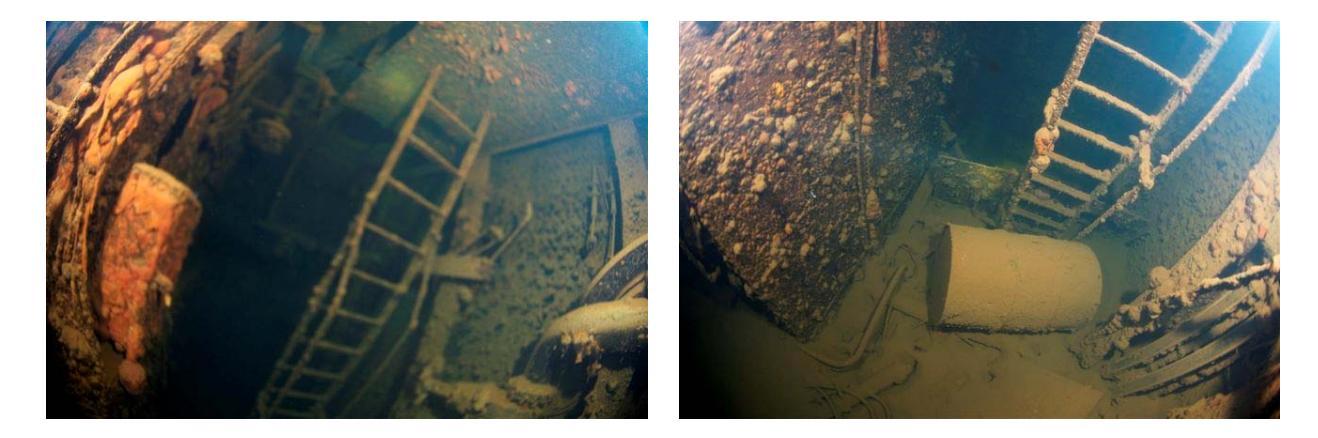
Alcove on outboard side of the Thrust Block enclosure. Behind ladder is the bulkhead to B Engine Room, Frame 184. Under the 'drum' in image on right is a deckhead hatchway.
