# HMS *Prince of Wales* – Stern Damage Survey<sup>1</sup>

A REPORT ON THE TORPEDO DAMAGE TO THE STERN OF  
HMS *PRINCE OF WALES* PREPARED AND SUBMITTED BY  
KEVIN DENLAY FOR THE SD-7 PANEL MEETING,  
WASHINGTON, D.C., OCTOBER 2008. (*Updated 4/09*)

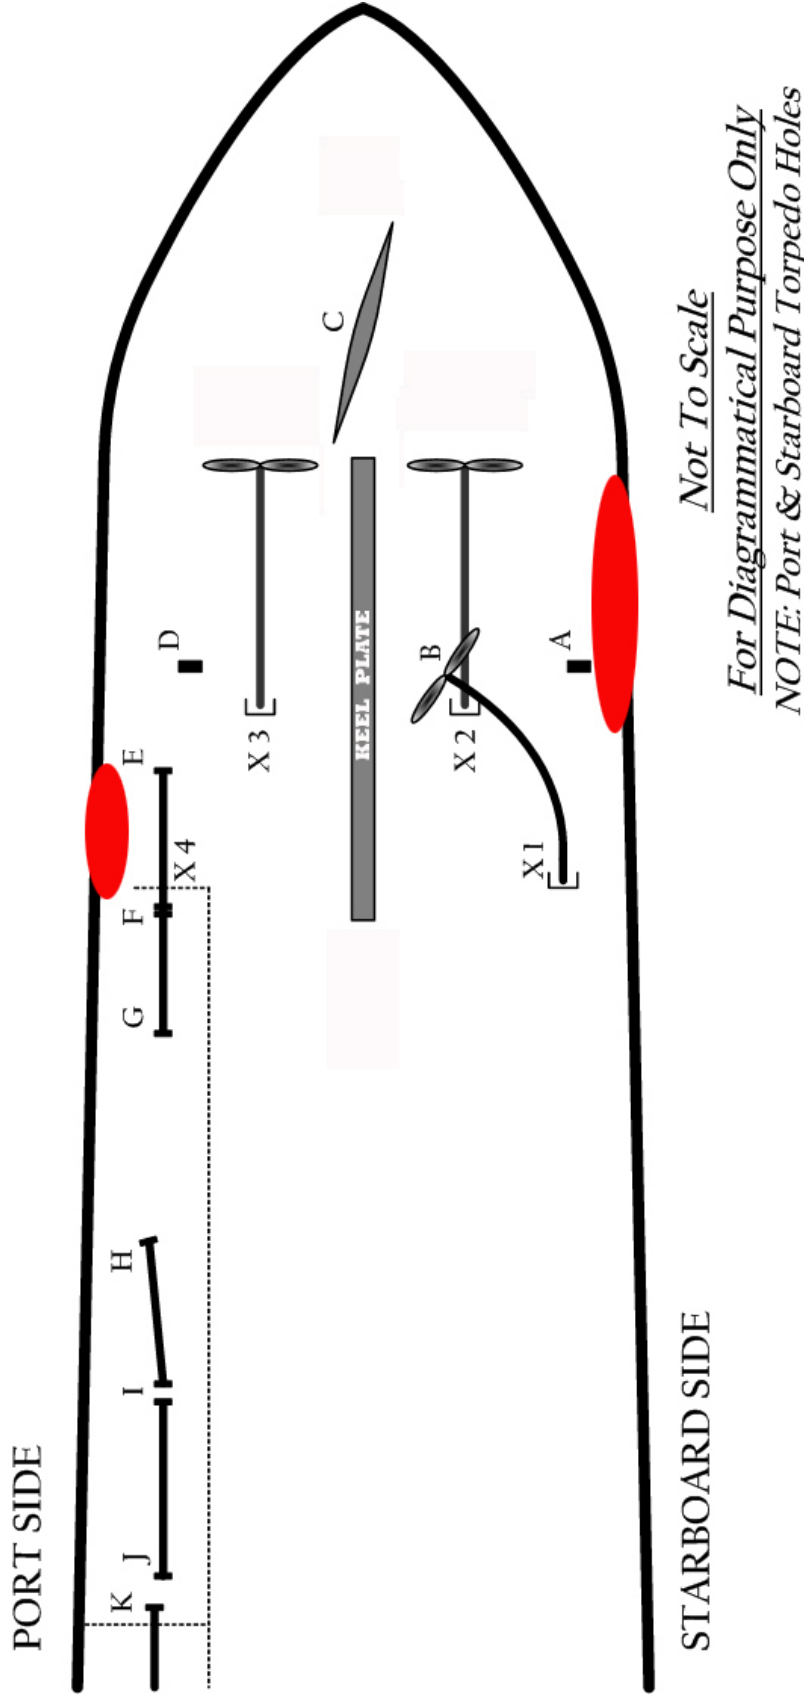
## H.M.S. PRINCE OF WALES

**X1, X2, X3)** These are the exit points out of the hull of the three ‘intact’ shafts at their stern tube glands. The Starboard outer shaft’s exit point - X1- shows only slight signs of deformation – seen underneath the shaft - from the damage caused by the flailing shaft prior to it jamming over the inner shaft. **See following images X1 and X1/1**

**A)** Only a short stub remains of the *OUTER* strut of the outer Starboard shafts A-Bracket. (The inner strut appears to have sheared clean at the hull.) The Starboard torpedo hole is directly above this stub, and extends almost up to what would have been the lower row of scuttles/portholes in the hull. (Actually a line drawn up from the stub would ‘cut’ the hole approximately in ‘quarters, i.e. leaving about three quarters of the hole *aft* of the stub ‘line’.) **See following images A1 through A4**

**B)** The propeller of the outer Starboard shaft is wedged firmly ‘over the top’ of the inner Starboard shaft, so much so that two of the blades are actually between the inner shaft and the Keel Plate. **See following images B1 through B4**

**C)** Rudder is angled to Port at approx 20 degrees. **See following images C1 and C2**

**D)** Only a small stub remains of the *INNER* strut of the Port outer shafts A-Bracket. **See following images D1 and D2.** (The outer strut appears to have sheared off clean at the hull.)

**E)** The aft ‘end’ of the exterior section of the Port outer shaft, with flange noticeable. **See following image E1** Distance measured from D to E = 5.3m/17.38ft. **See following image E2**

**F)** Two flanges, still firmly joined, link the protruding section of the shaft and the next section of shaft ‘inside’ the shaft tunnel. The after most of these two joined flanges can be seen just inside the ripped open stern tube entry to the shaft tunnel. **See following image F1.** Distance measured from E to center of flanges F = 10.9m/35.75ft. The position of where the stern tube exit gland would have been is believed to be at, approximately, the dotted line X4 on the schematic. **See following image F2 (NOTE: There are NO images from beyond this point.)**

**G)** The flange at the forward end on of the second section of (joined) shaft. Distance measured from center of flange F to G = 7.65m/25.1ft.

**H)** The flange at the aft end of the third section of (separated) shaft laying on what was once the ‘deckhead’ above, but is now the ‘floor’ of the inverted tunnel as it were. The large ‘gap’ or distance measured between G and H = 14.1m/46.25ft. **(NOTE: This was the LAST / INNERMOST measurement taken by the divers.)**

- I)** A small gap now exists between these two sections of shaft that have separated at the flange. (Note; both lengths of shaft still have their respective flanges on the end, illustrating that the shaft is not ‘broken’ per se, but separated at a flange joint.)

- J)** The flange at the forward end of the fourth (or innermost) length of separated shaft. This section of shaft also lays on what was once the ‘deckhead’ above, but is now the ‘floor’ of the inverted tunnel.

- K)** A short length of shaft with a flange at the end protrudes (‘several’ feet according to the diver) in its ‘rightful’ supported place from a relatively intact bulkhead (dotted line), although the gland around the shaft in the bulkhead has been considerably elongated by the flailing shaft when it rotated out of center after the torpedo hit. This bulkhead stopped the diver going any further forward along the shaft. (*NOTE; See additional information at the end of this document – i.e. after the Port side photographs – on pages 23 and 24 - in relation to this point.*)

- X4)** The dotted line across the shaft next to X4 marks the approximate position of where the shaft exited the hull at the gland, but the gland / stern tube is no longer there and the general area surrounding is severely damaged from the torpedo explosion and the flailing shaft as it ripped away. **See following images X4/1 and X4/2.**

Where the gland once was, approximately, is now the forward edge of the port side torpedo hole, which is ‘centered’ somewhat further aft along and just above the shaft axis. **See following images X4/3 through X4/7.**

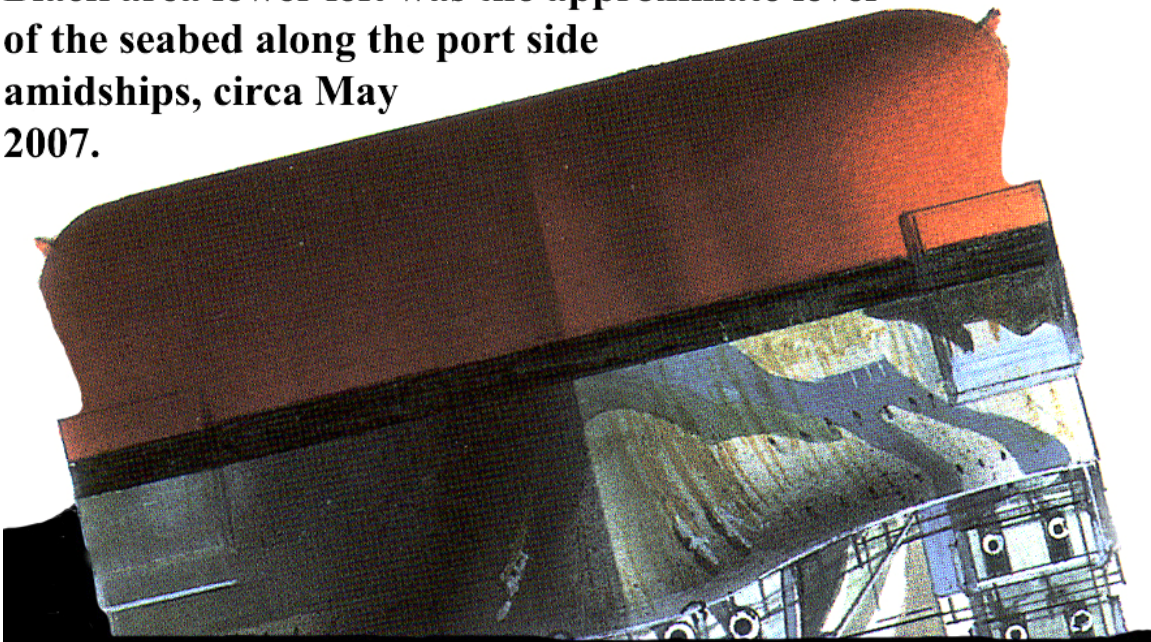
The wreck of *Prince of Wales* rests inverted on an angle to Port of approx. 15° amidships. (Concave indentations in hull below armour belt are discussed in a separate survey report.)

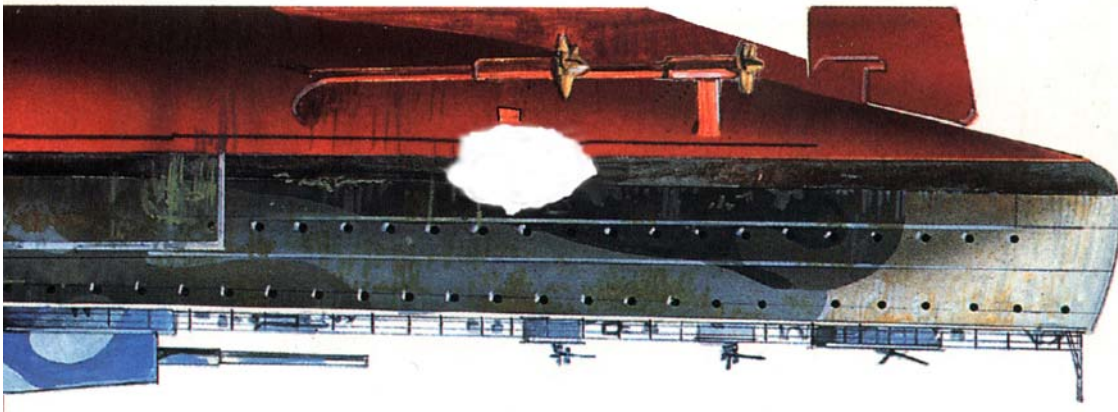
HMS *Prince of Wales* Starboard (Stbd) stern section inverted as it appears on the ocean floor. (Note: For diagrammatical purposes *only*, not to scale.)

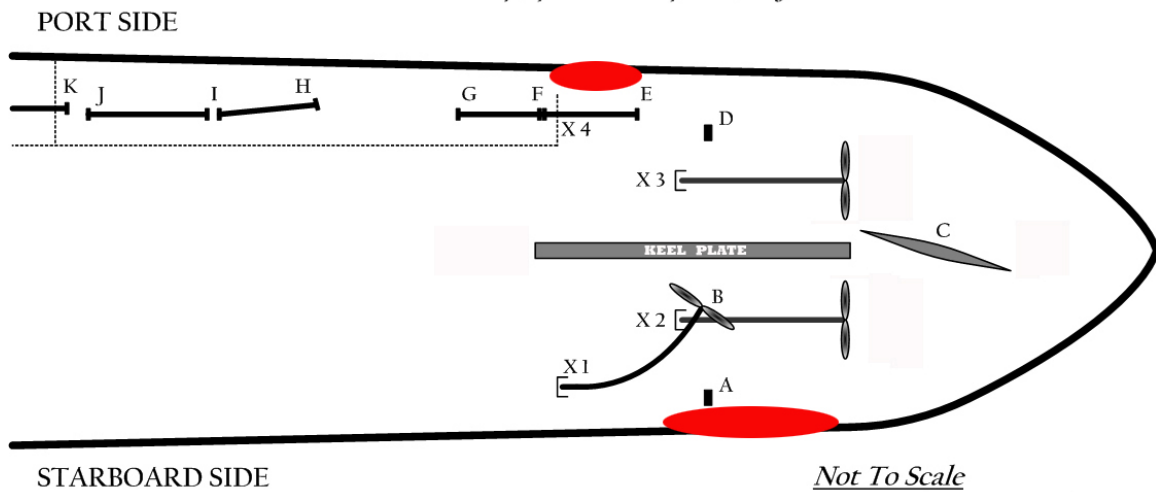
## H.M.S. PRINCE OF WALES

*Not To Scale*  
*For Diagrammatical Purpose Only*  
*NOTE: Port & Starboard Torpedo Holes*

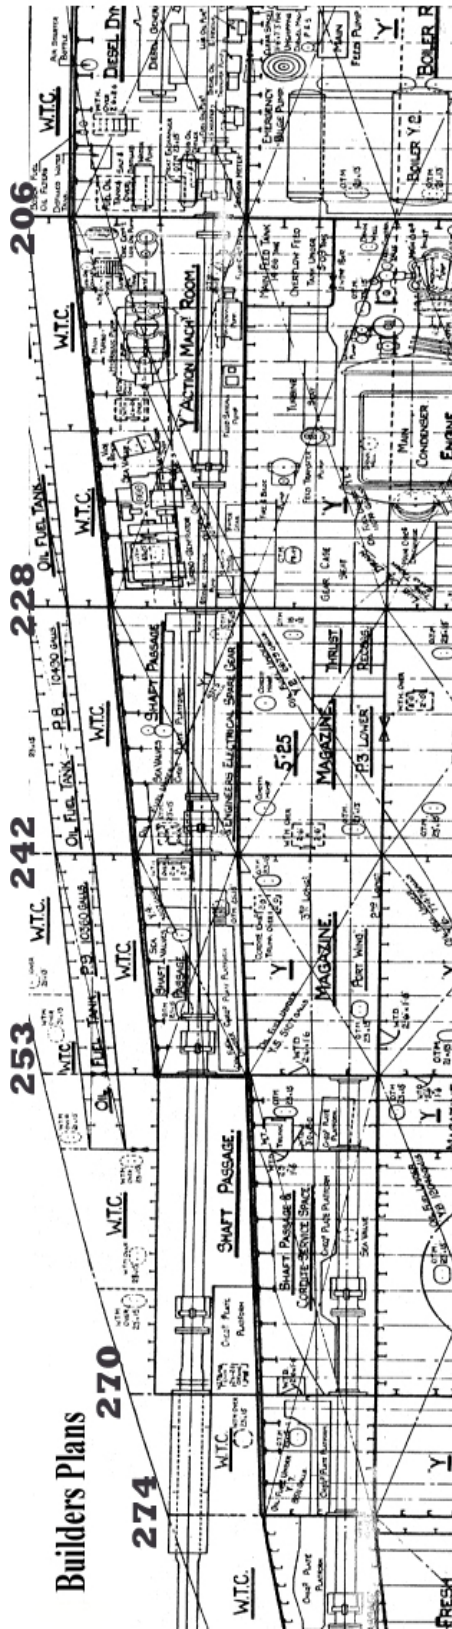
*Note on 'method' of comparison.* I obtained the figures below in **bold** by measuring the actual shaft lengths - centre of flange to centre of flange - as shown/depicted on the Builders Plans (of the *Hold Section*) and I believe they are, while not necessarily exact, as the hard copy I have of the plan is not full size, *very close* to what the shaft lengths actually are. *When comparing measurements from the plans to what the diver measured and observed, they match almost exactly. (It should be noted that the diver had never seen any plans or measurements of Prince of Wales prior to his excursion up the tunnel.)*

\*From the forward edge of the outer shaft A-Bracket enclosure (where shaft itself 'ends' as it were) to the centre of the first flange is approx **17.3m**. *This complete section of shaft along with the A Bracket and prop is missing from the wreck, having pulled away and separated soon after the torpedo hit.*

\*5<sup>th</sup> length of shaft on plan is approx **8.7m** (this section seen but not measured by diver).

\*The short length of shaft with flange that protrudes from the Diesel Generator Room bulkhead is approximately **0.6m** (diver reported seeing it protruding 'several' feet).

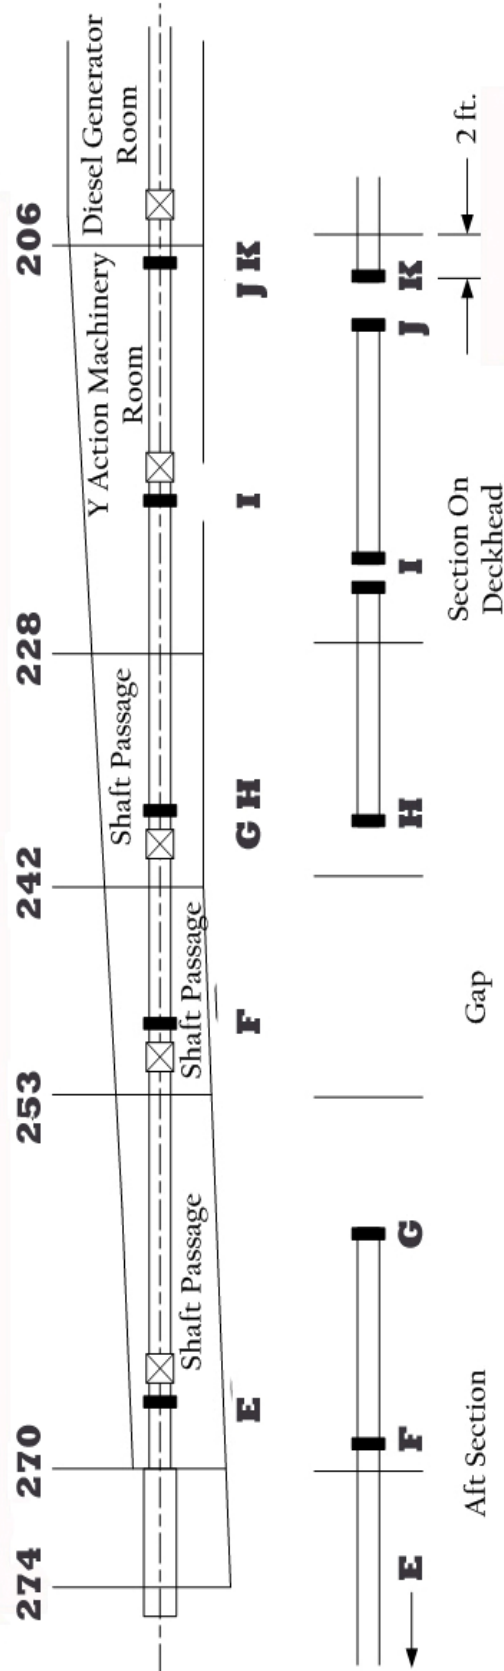
Shaft segments as surveyed by diver & described on pages 6 & 7 NOTE: Image not to scale

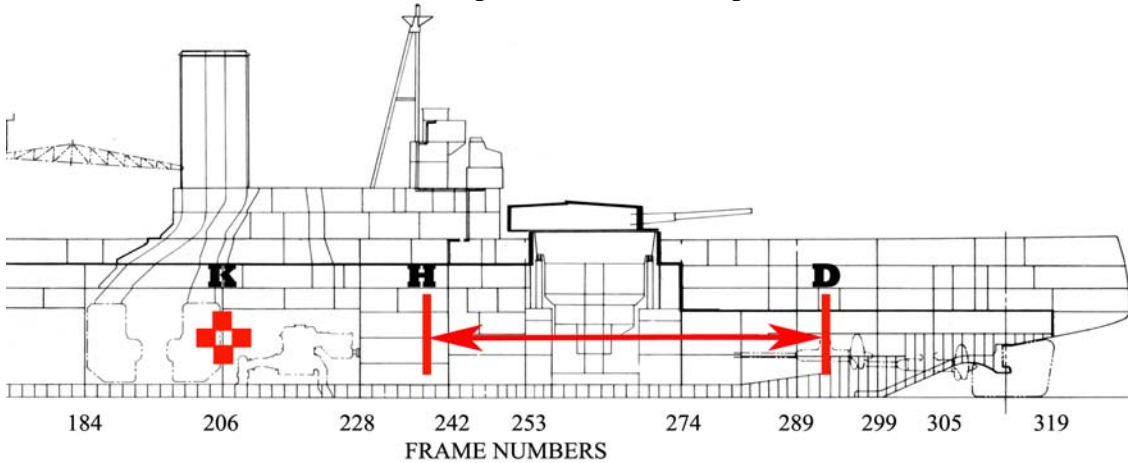
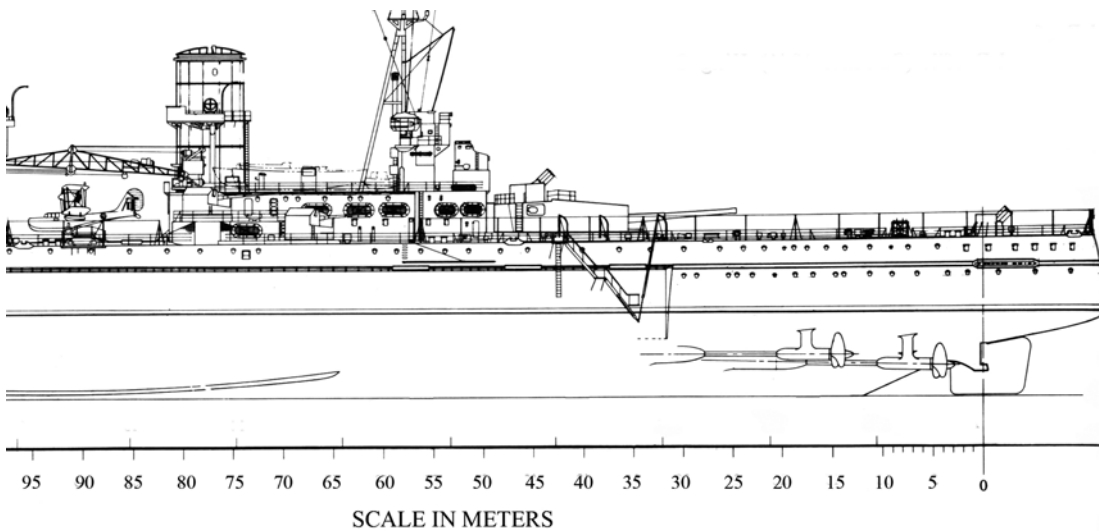
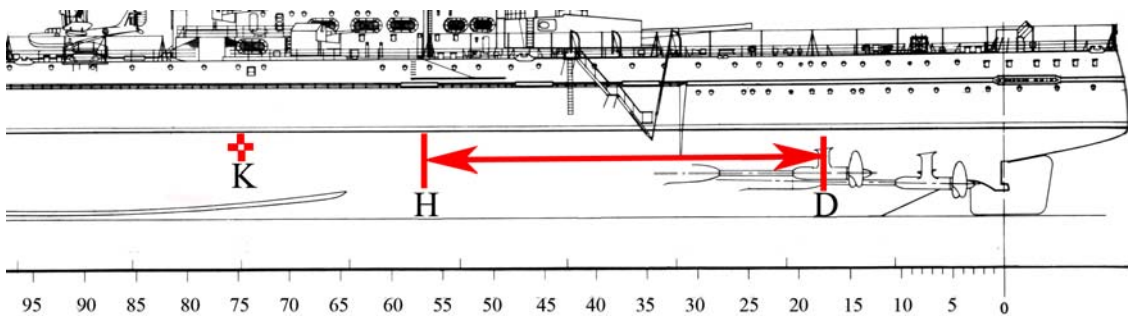
The overall distance on Port side measured by the diver was 37.95m/124.5ft, as marked by the red arrow, starting at strut stub D and ending at flange H, across the large 'gap' that separates the two lengths of shaft (i.e. flanges G and H) inside the tunnel. Letter K marks diver's furthest penetration point; to the aft bulkhead of the Diesel Generator (Dynamo) Room. These 'letters' can all be cross referenced to previous drawings above.
