EXPEDITION ‘JOB 74’

An overview of Expedition ‘Job 74’ which carried Explorers Club Flag #118 to the wrecks of HMS *Prince of Wales* and HMS *Repulse*, South China Sea, May 13th – May 25th 2007.

Report compiled and submitted by expedition member and flag applicant Kevin Denlay, Fellow International 1998. (Page 1 of 28)

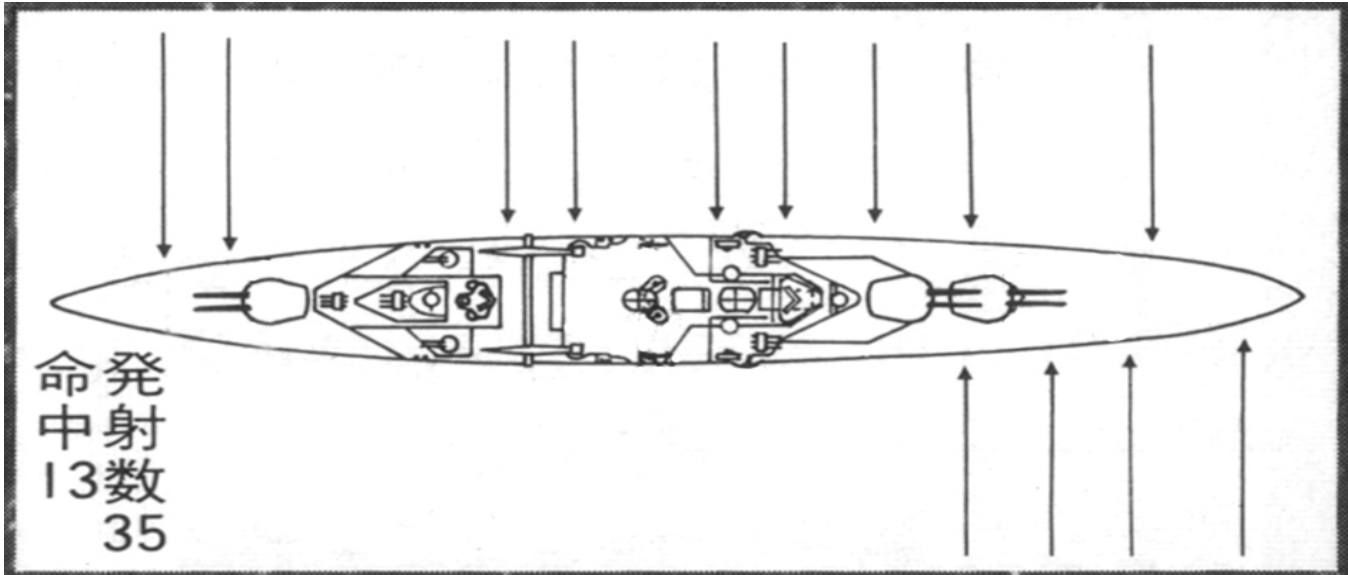
Arrows indicate where Japanese aircrews thought 13 of the 35 torpedoes launched at HMS *Repulse* hit. (Above diagram as reported by Japanese sources.)

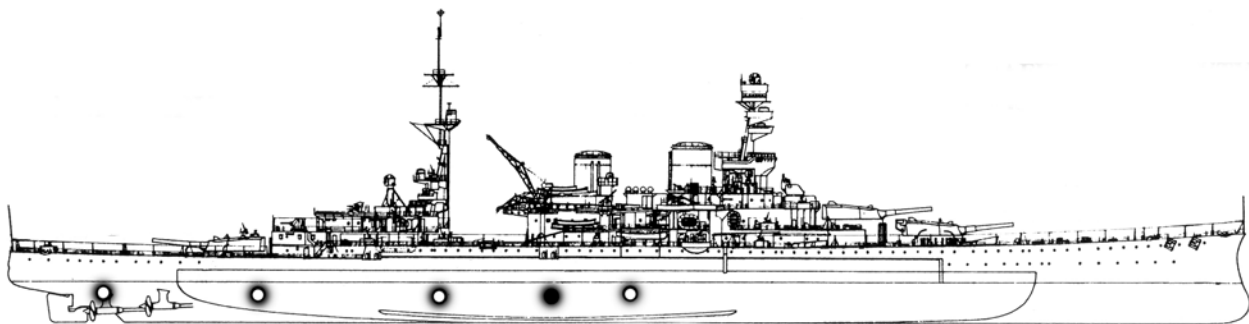
British sources record only five torpedo hits, as shown above.
Black solid circle on hull = Suspected starboard side torpedo hit.
Black outline circles on hull = Suspected port side torpedo hits.

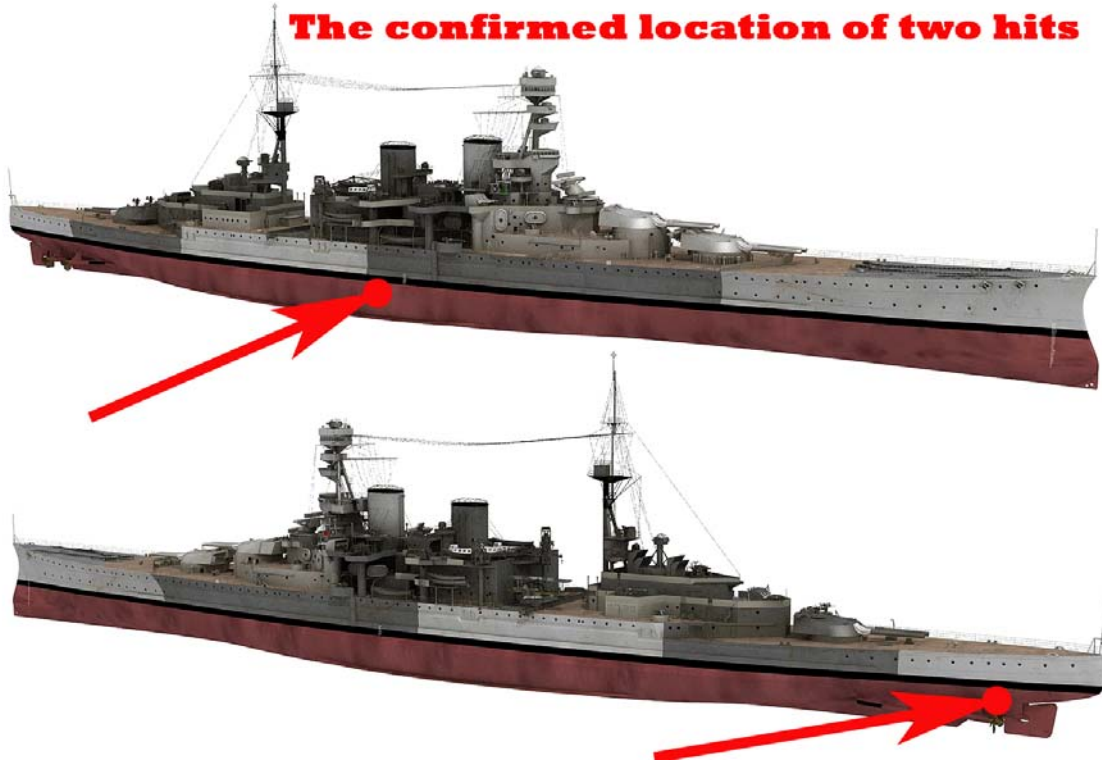
The confirmed location of two hits

However part of the reason for not seeing two of the hits/holes could be that where these two hits were reported to have been, port amidships, the sand/seabed has built up to such an extent against the hull in this area as to have covered any actual torpedo holes that may be there. There was some evidence in two areas along the port hull amidships, right on the seabed, where there was what appeared to be some 'dimpling' or crumpling of the hull, but no evidence of actual jagged penetrating holes, as can be seen say starboard amidships. There could be times however when the ocean currents scour the sand out 'deeper' along the port side hull, resulting in exposing a greater expanse of the hull side itself for investigation around these 'dimpled' areas, but while we were on site there was only about 2.5m/8ft of hull showing between the port bilge keel and the seabed amidships. Therefore any torpedo holes that may have been higher on the port hull itself in this area would have been buried (hidden) under the actual seabed.

It should be noted however that the other, or fourth 'reported' torpedo hit to port towards the stern, supposedly abreast Y turret - an area where the seabed/sand has *not* built up against the hull to any great extent and hence which should have left any hole clearly visible - was simply *not* seen to be there.

Expedition 'Job 74' could confirm only two hits as shown, although as stated previously the two port side amidships hits *may* have been buried beneath the seabed at the time the expedition was conducted. However, the suspected hit abreast the rear turret is *not* there.
Black solid circle on hull = Confirmed starboard side torpedo hit.
Black outline circle on hull = Confirmed port side torpedo hit.

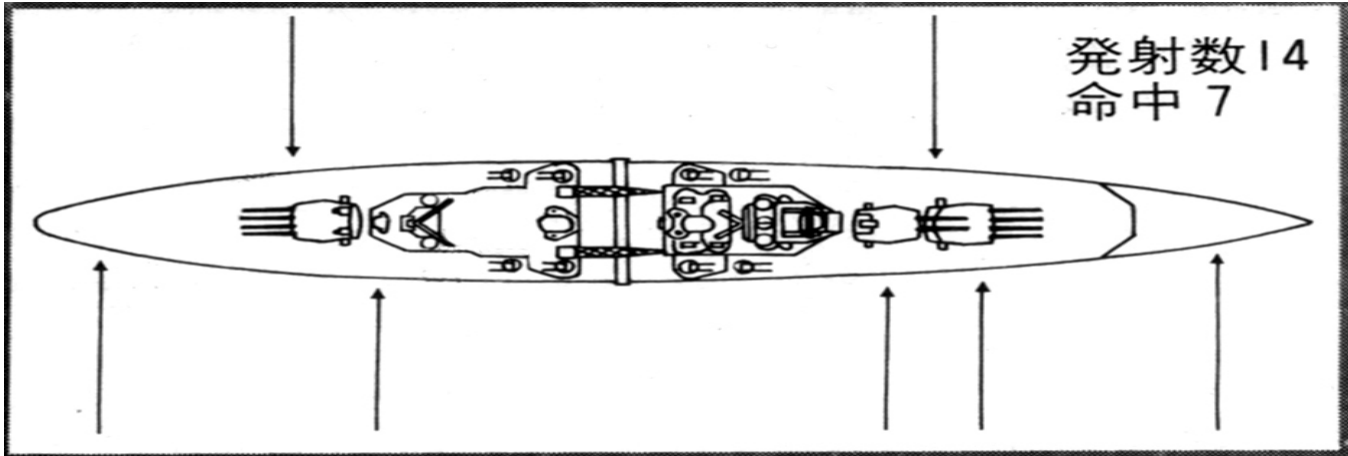
Arrows indicate where Japanese aircrews thought 7 of the 14 torpedoes launched at HMS *Prince of Wales* hit. (Above diagram as reported by Japanese sources.)

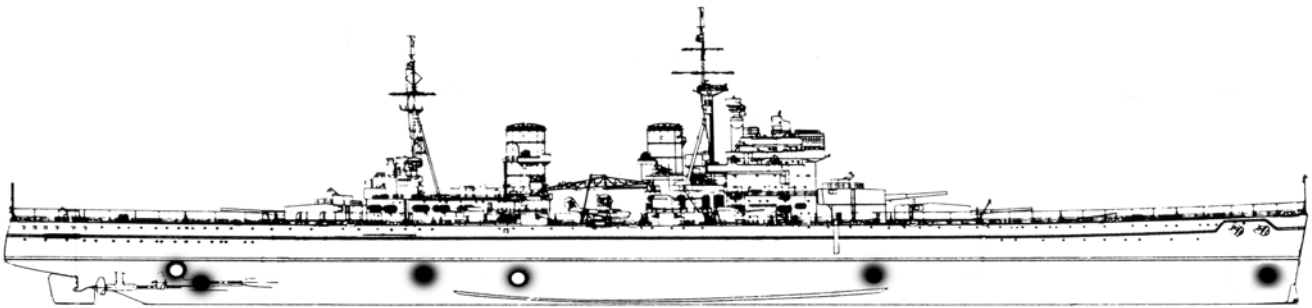
British sources record six torpedo hits, as shown above.
 Black solid circles on hull = Suspected starboard side torpedo hits.
 Black outline circles on hull = Suspected port side torpedo hits.

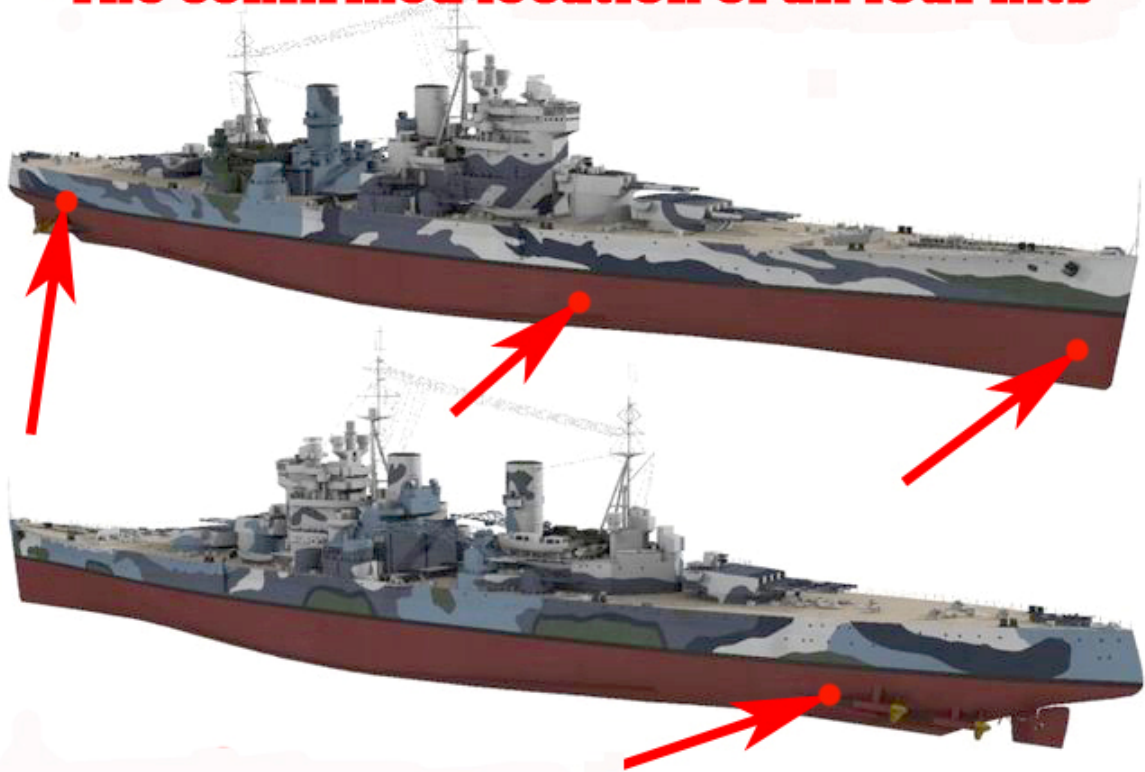
The confirmed location of all four hits

British accounts state that HMS *Prince of Wales* was hit by at least six torpedoes, four on the starboard side and two to port. Our survey results differ in the fact that we found only three large jagged holes to starboard and only one to port, and can categorically state that there are no 'jagged holes' where (two) torpedoes were reported to have hit on the starboard and port hull beneath the mainmast and the rear funnel respectively. The hull both fore and aft of this area is however 'dished in' longitudinally - from *about* Frame 170 to *about* Frame 282 on the starboard hull and *about* Frame 140 to *about* Frame 255 on the port hull - and is 'split' longitudinally along the base of the armour belt for quite some distance in those areas; and is 'crumpled' in places along there also. The damage observed along these two sections differs *dramatically* though from the gapping jagged holes in the four other areas where torpedoes have actually 'blown open' the hull.

Video survey footage shot along the entire *starboard hull* therefore confirms only *three* large jagged penetration holes centered at; 1) The very bow itself - *Frame 8* - so close to the bow stem that the stem itself is broken/fractured and the hole actually penetrates right through the ship from starboard to port; 2) Beneath B turret - *Frame 109* - just forward of the bridge; 3) The stern - *Frame 296* - *above* and slightly abaft the outer strut of the outer propeller shaft A-Bracket, i.e. higher on the hull than *all* the other torpedo holes, indicating that the surrounding area aft was already well submerged when this torpedo hit. Video survey footage shot along the *port hull* confirms only *one* large jagged penetration hole - *Frame 284* - which is at the stern between the port outer propeller shaft A-Bracket and where the port outer propeller shaft exited the hull. The same video footage however shows *no* jagged penetration holes whatsoever - as specifically seen in the above four areas - *anywhere* else along the port or starboard hulls and specifically *not* in the area around the mainmast or rear funnel where torpedoes were thought to have hit the ship.

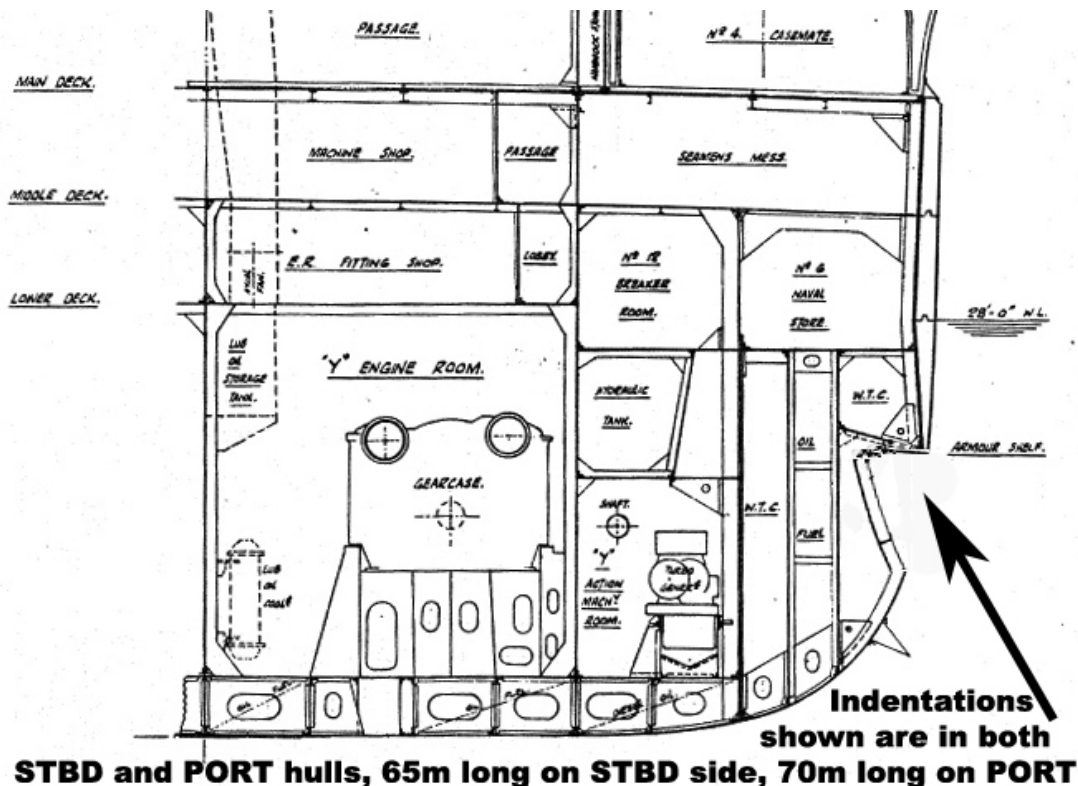
WRECK OF *PRINCE OF WALES* LAYS ON AN ANGLE OF APPROX. 15° TO PORT. Concave indentations in hull below armour belt are shaped as above throughout the areas as described in paragraph at bottom of page 9. This damage, and more information on the stern damage, is discussed - and shown in more detail - in two separate reports accessed at bottom of linked page; http://www.pacificwrecks.com/ships/hms/prince_of_wales.html
